**Bundesstelle für Seeunfalluntersuchung**  
Federal Bureau of Maritime Casualty Investigation

## **Investigation Report 236/20**

### **Serious Marine Casualty**

#### **Fire in the main engine scavenge air duct on board the EBBA MAERSK on 29 July 2020**

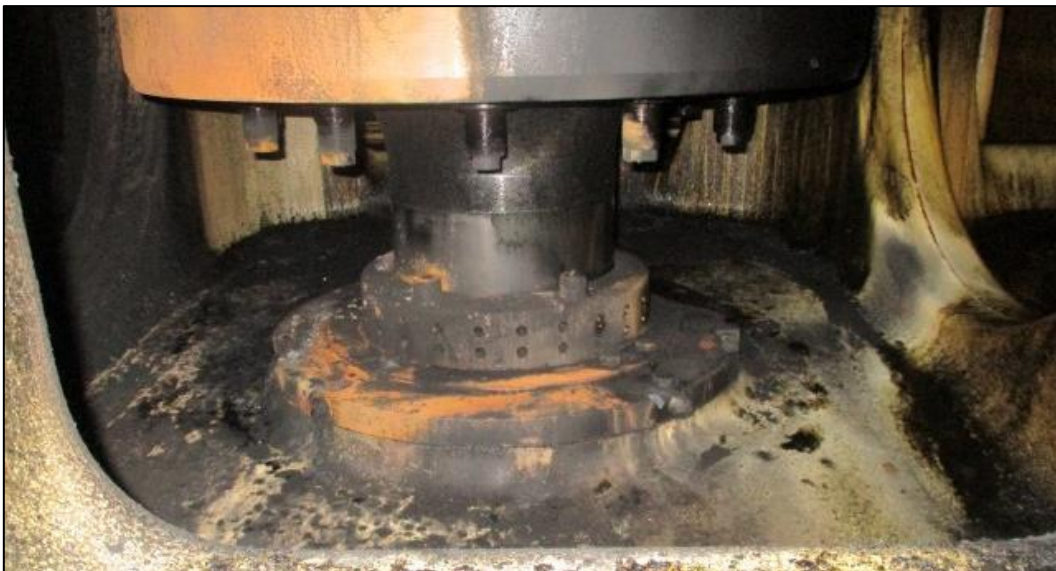
Figure 4: Stuffing box area of an affected cylinder<sup>16</sup>  
with traces of rust from the extinguishing water

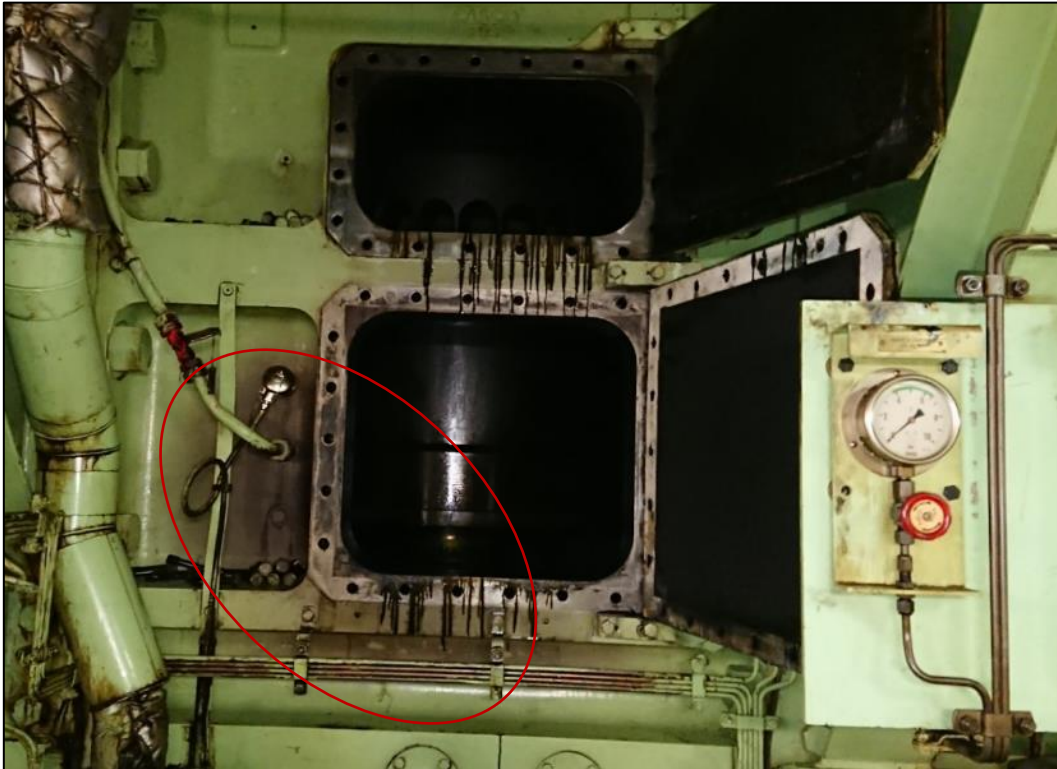
Figure 5: Paint on the main engine discoloured by high temperatures next to the scavenge air duct inspection hatch of a cylinder affected by the fire

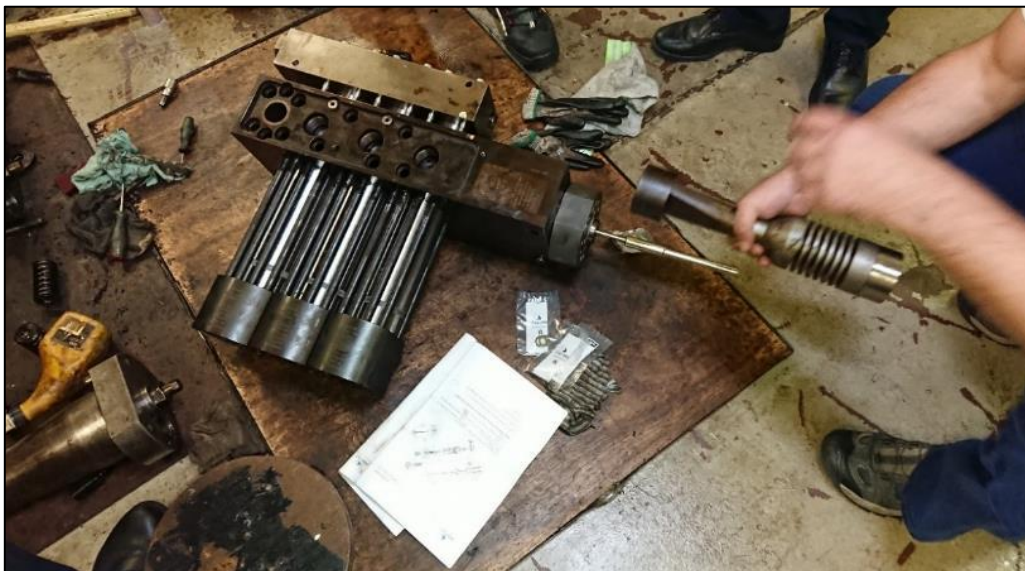
Cylinder 4's ICU was being overhauled on board and could be inspected in a disassembled state.

Figure 6: Removed and disassembled ICU with the three injection control valves (left) and the fuel quantity piston (in hand)

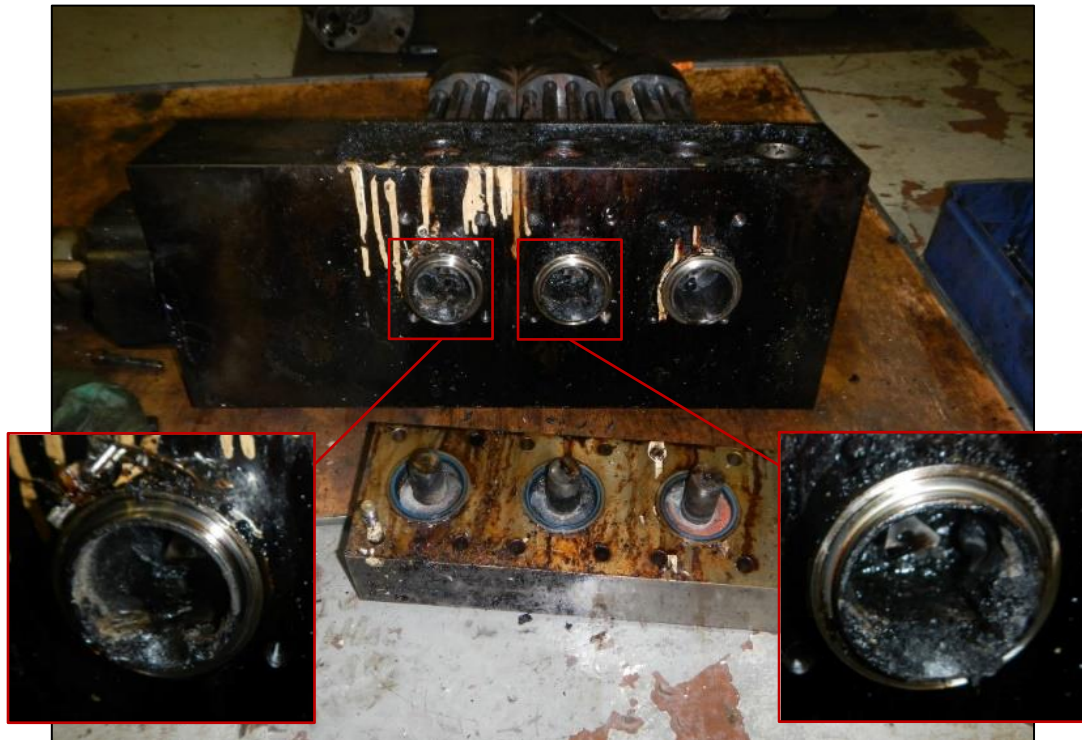
A detailed inspection of the scavenge air duct, including pistons, liners, piston rings, ICUs etc., was carried out after the main engine had sufficiently cooled down. No damage to the cylinder units was found. However, the ICUs of cylinders 10 and 5 were clogged with a tar-like substance.

The 'neutral spaces' between the 'rail valves' and the injection control valves were significantly clogged with a tar-like substance.<sup>17</sup>

Figure 7: 'Neutral spaces' of an ICU clogged with a tar-like substance

The EBBA MAERSK was allowed to continue her voyage after the classification society and the Ship Safety Division (BG Verkehr) were satisfied that there was no permanent damage and the faulty ICUs had been replaced or overhauled. A similar incident did not reoccur on the ship.

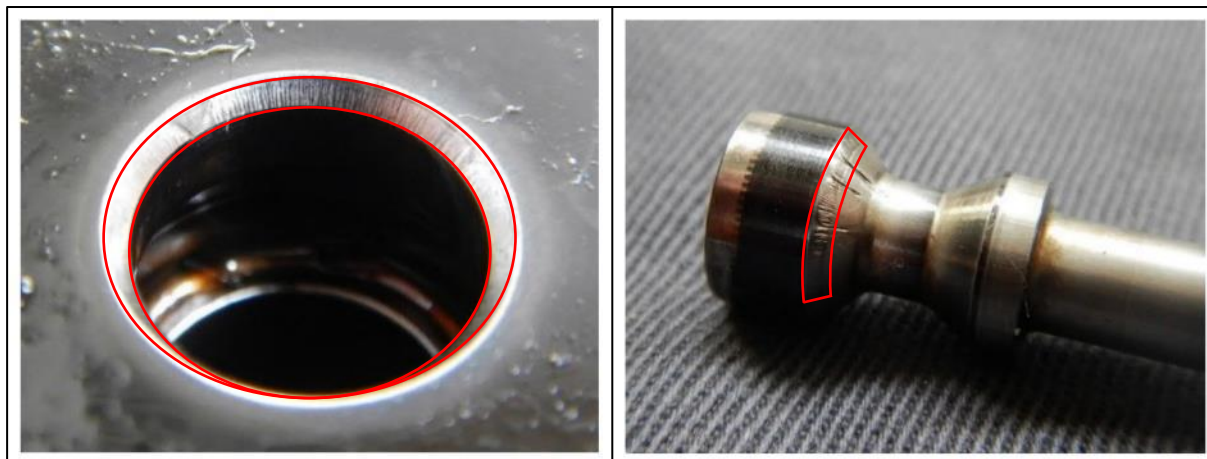
rate of 200 ml/min an ICU is assumed to be worn. According to the bulletin, long-term operation with light fuels can lead to prematurely worn valve seats (i.e. sealing surfaces, see above) of the injection control valves (see Figure 30), which in turn could lead to increased exhaust gas temperatures on large RT-flex models such as the RT-flex96C.

Figure 30: Traces of wear (e.g. grooves) on the valve seat and slider of an injection control valve belonging to an ICU of a RT-flex large diesel engine (sealing surfaces outlined in red)<sup>82</sup>

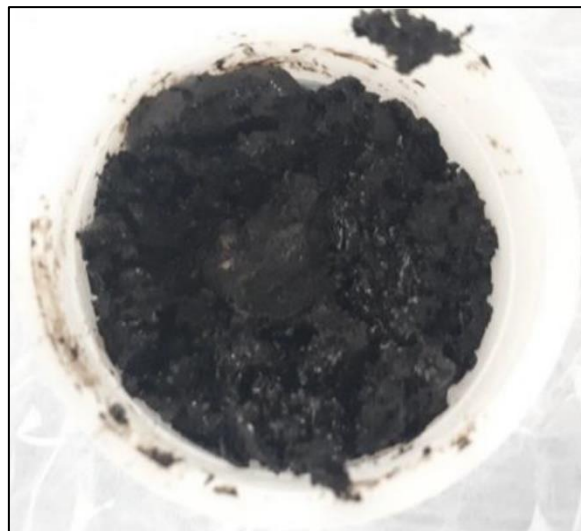
However, the tar-like deposit exhibited several anomalies. In addition to a conspicuous appearance (also contained solid lumps, see Figure 34), the XRF measurement revealed the presence of prominently high levels of phosphorus, molybdenum, zinc, iron, and calcium. Moreover, the vanadium level corresponded to that of the heavy fuel oil, and the sulphur content was increased (see Table 3).

Figure 34: Tar-like residue  
in the weighing bowl of the TUHH fuel laboratory

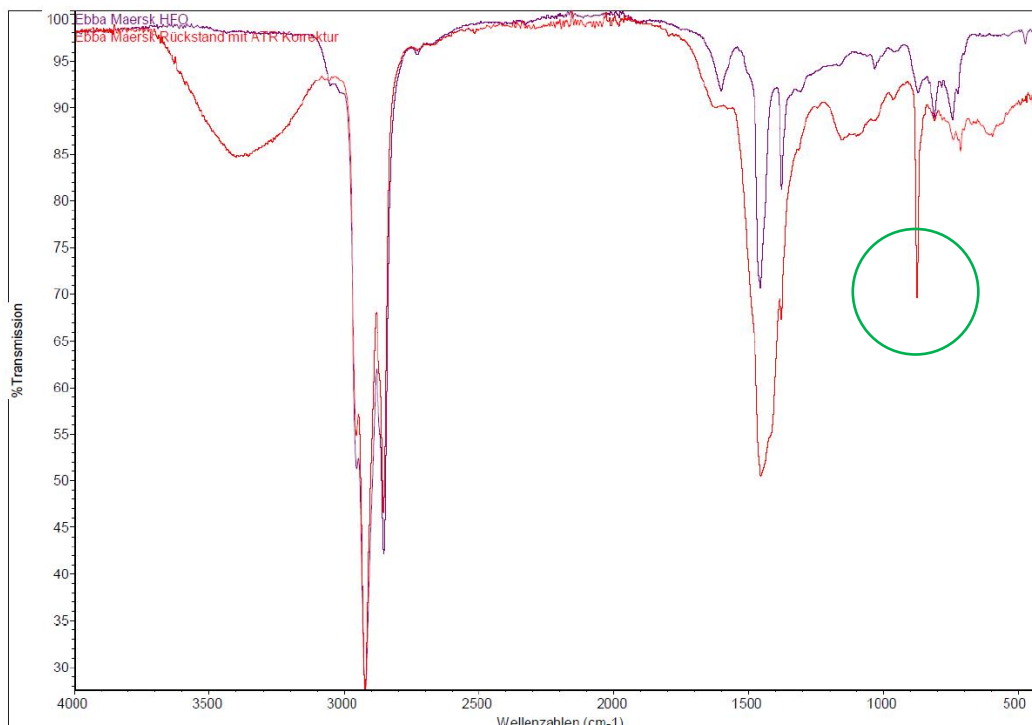
The image of the ATR spectrum revealed an initially unknown peak at 875 cm<sup>-1</sup>, which, after a comprehensive library comparison, turned out to be calcium carbonate. This was consistent with the unusually high calcium levels in the XRF measurements.

Figure 35: ATR spectrum of the tar-like deposit  
(calcium carbonate band marked)
