Bundesstelle für Seeunfalluntersuchung
Federal Bureau of Maritime Casualty Investigation

Investigation Report 300/21

**Fire in the engine compartment with subsequent
foundering of the fishing vessel FREYJA
in Schleswig-Holstein's Wadden Sea
during the night of 17 to 18 September 2021**

15 March 2023

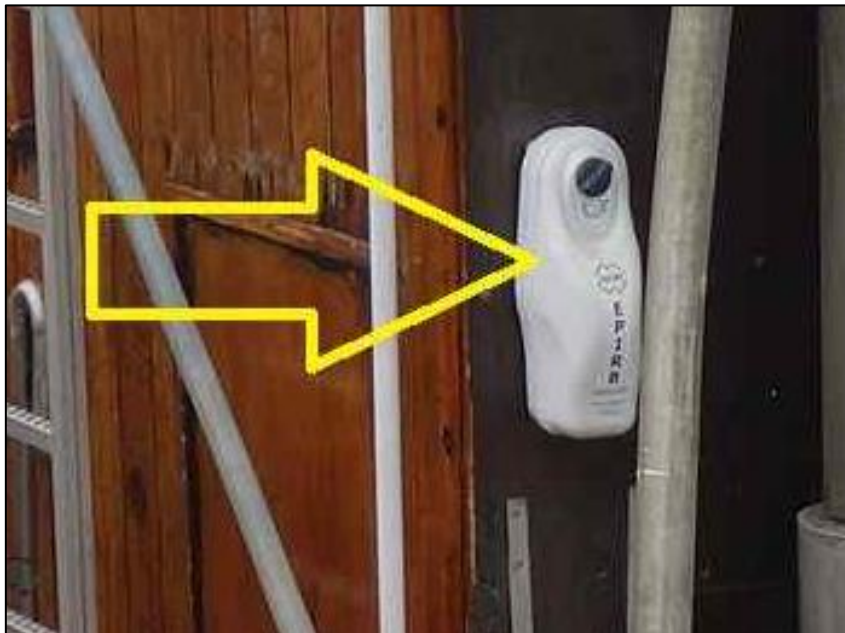
Figure 7: Close-up of the fishing vessel FREYJA's EPIRB

Widely used in commercial shipping, an RLB-41 EPIRB from American manufacturer ACR Electronics was installed on board the FREYJA in the port-side aft section of the fishing vessel's deckhouse (see installation position above in **Figure 4** and the magnified image extracted from it below in **Figure 7**).

According to information given by MRCC Bremen, no distress signal was received from the EPIRB after the FREYJA accident. Since the fire on the fishing vessel started in the engine compartment and then spread from the stern across the vessel and the entire wheelhouse fell victim to the flames, it is reasonable to assume that the EPIRB, which was in plastic housing, duly mounted on the wheelhouse and not removed from its holder by the skipper before abandoning the fishing vessel, burnt. Accordingly, it was inevitably unable to automatically detach from its holder, float up and transmit a distress signal when the fishing vessel foundered.

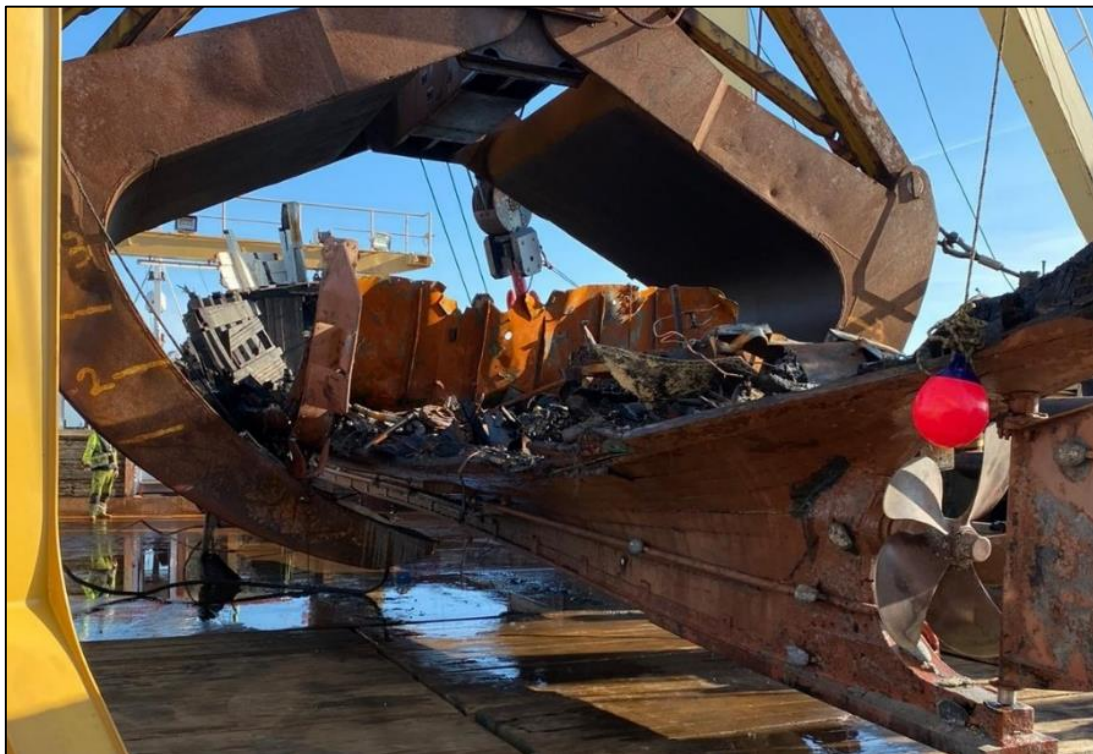
Figure 8: The FREYJA's hull being lowered onto the CATJAN by the ENAK

Due to the fact that the wooden fishing vessel with a considerable amount of fuel on board (about 3,000 litres of diesel) had been fully engulfed in flames for about five hours before foundering almost completely, the wreck was no longer a homogeneous object that could be salvaged with reasonable effort. Consequently, the FREYJA, which was largely destroyed by fire, could not be lifted out of the water in one piece. Instead, the floating crane ENAK, which was used for the salvage operation, lowered individual parts of the wreck that had been dismantled during the salvage operation (e.g. the auxiliary diesel engine) on the service vessel SANDSHÖRN. The largest single remaining section of the fishing vessel's wreckage was her hull and bottom. The section in question was lifted out of the water using the floating crane ENAK's grab system and lowered onto the service vessel CATJAN (see below **Figure 8**).

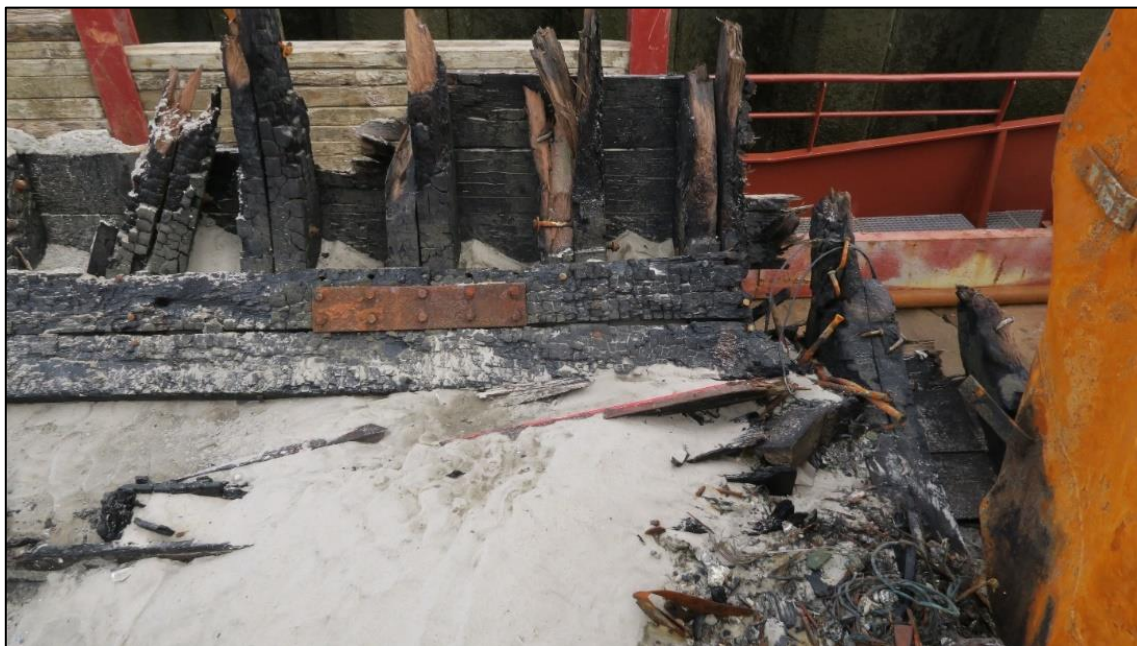
- the port and starboard sides of the hull exhibited differing degrees of destruction in that the remaining sides had a different height above the keel (**Figure 10 f.**). Although this observation is consistent with the impressions of the diver, it should be noted that the degree of destruction of the wreck is naturally also related to the salvage of the vessel and as such cannot be attributed solely to the course of the fire. Accordingly, it was not possible to reliably reconstruct the development and thus origin of the fire;

Figure 10: Frames in the area of the fish hold on the starboard side

Figure 11: Frames in the area of the fish hold on the port side

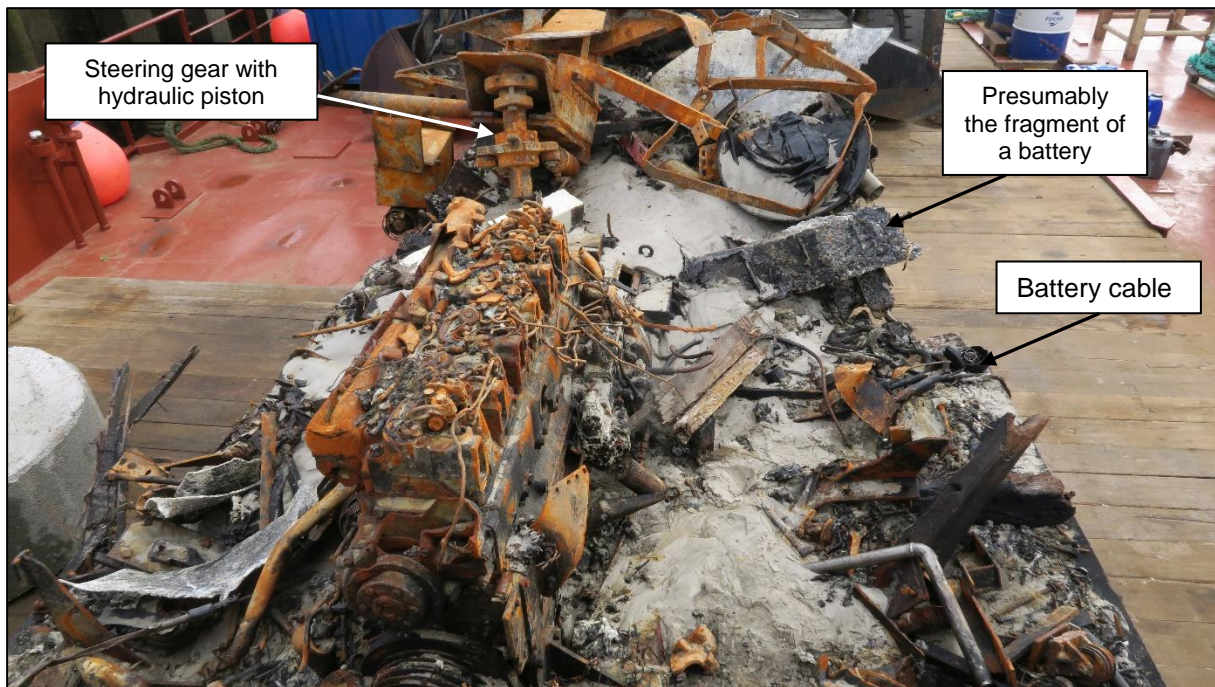
Figure 13: View of the main engine toward the stern

- only fragments of the batteries, also located on the port side, were left (**Figure 13**);

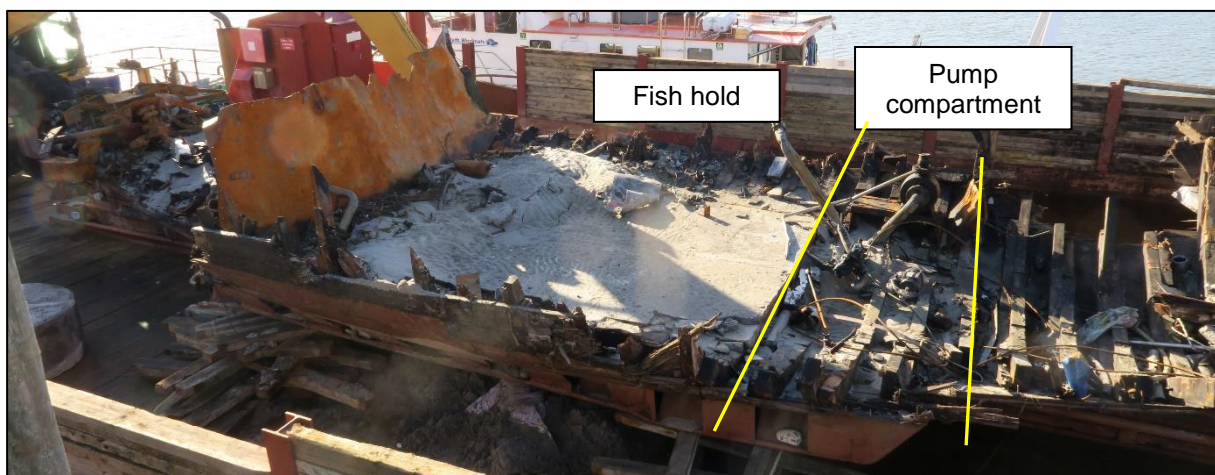
- the fire damage decreased toward the bow. No fire damage was visible in the remaining hull after the crew's accommodation. All in all, the debris gave the impression that the fire load on the port side of the engine compartment was greater than on the starboard side;
- it was striking that plastic and rubber parts on the floor of the engine compartment that could ignite or melt had not burnt or melted. The door to the engine compartment that was open may have allowed the heat to dissipate at the beginning. The heat was subsequently probably able to escape through the burnt deck above the engine compartment.

It is important to note that it was not possible to draw any conclusions as to the cause of the fire from the wreck in the condition found.
