**Bundesstelle für Seeunfalluntersuchung**  
Federal Bureau of Maritime Casualty Investigation

## **Investigation Report 343/22**

### **Serious Marine Casualty**

**Allision with the Old Kattwyk bridge  
by FAIRPLAY 82  
on 21 July 2022**

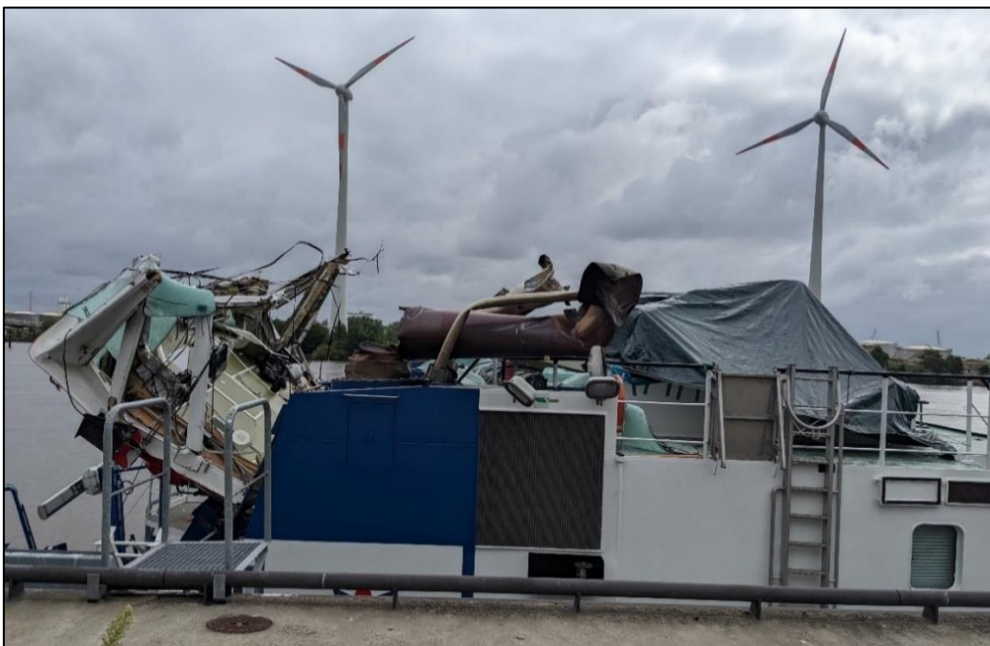
Figure 3: Photograph 1 of the damage<sup>3</sup>

Figure 3 shows that the wheelhouse was torn off completely and tilted to the stern. The control stations and operating panels remained standing and the crew had already covered them with a tarpaulin.

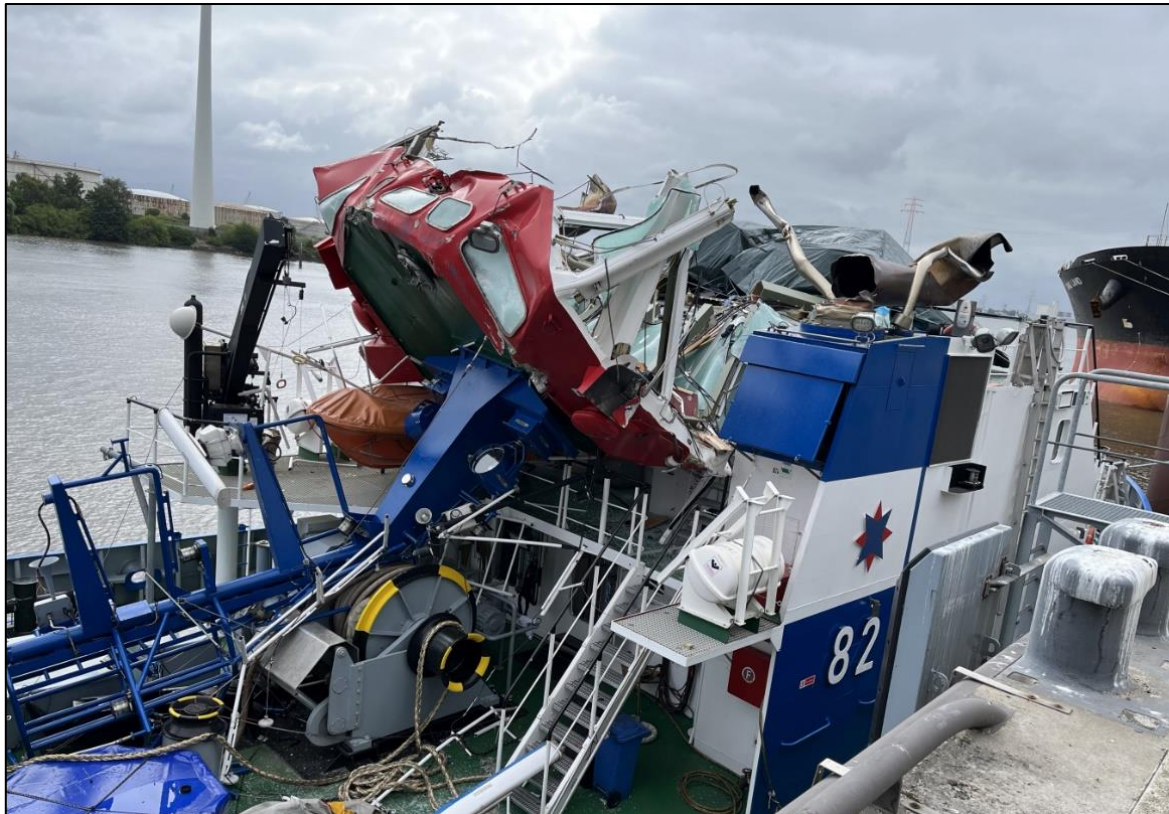
Figure 4: Photograph 2 of the damage<sup>4</sup>

Figure 4 illustrates with a view from aft how the upper half of the wheelhouse was torn towards the stern. The people in the wheelhouse only avoided being torn with it by kneeling down. They suffered only minor injuries, most of which were small cuts caused by the wheelhouse windows breaking into countless tiny shards, which flew into them.

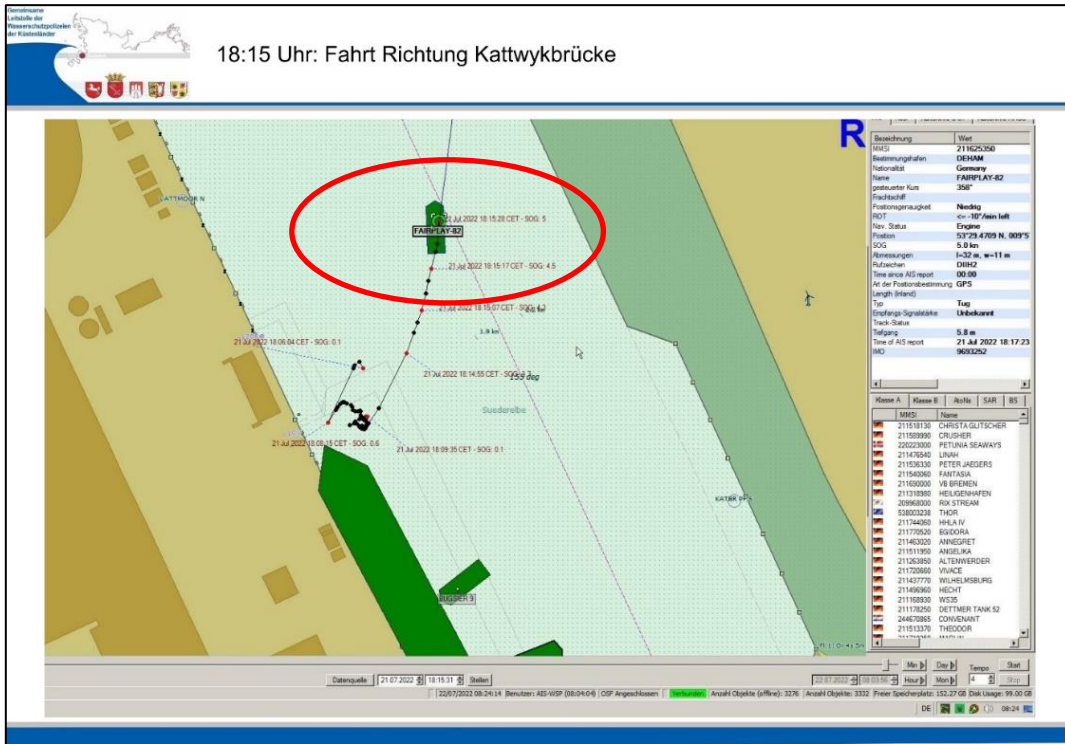
Figure 6: Course of the voyage at 1815<sup>9</sup>

The FAIRPLAY 82's involvement in the TANG LANG's berthing manoeuvre had finished by about 1810 and she left the berth at about 1814 to head for the Kattwyk bridge. Figure 6 shows the tug approach the bridge at increasing speed.

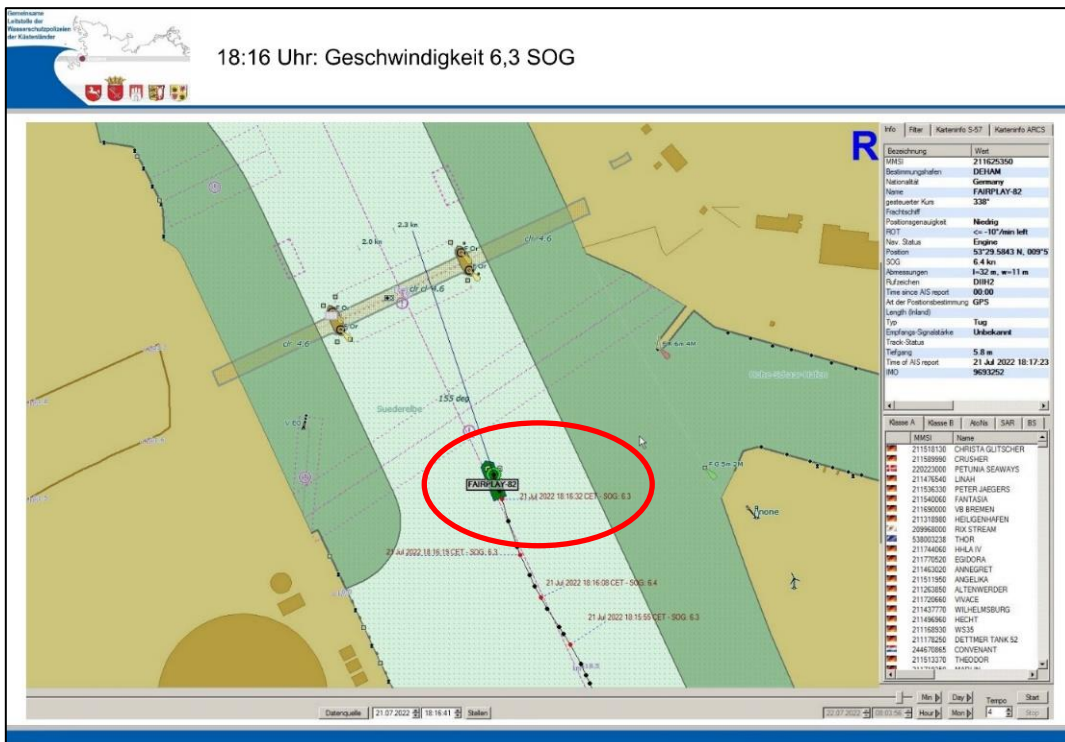
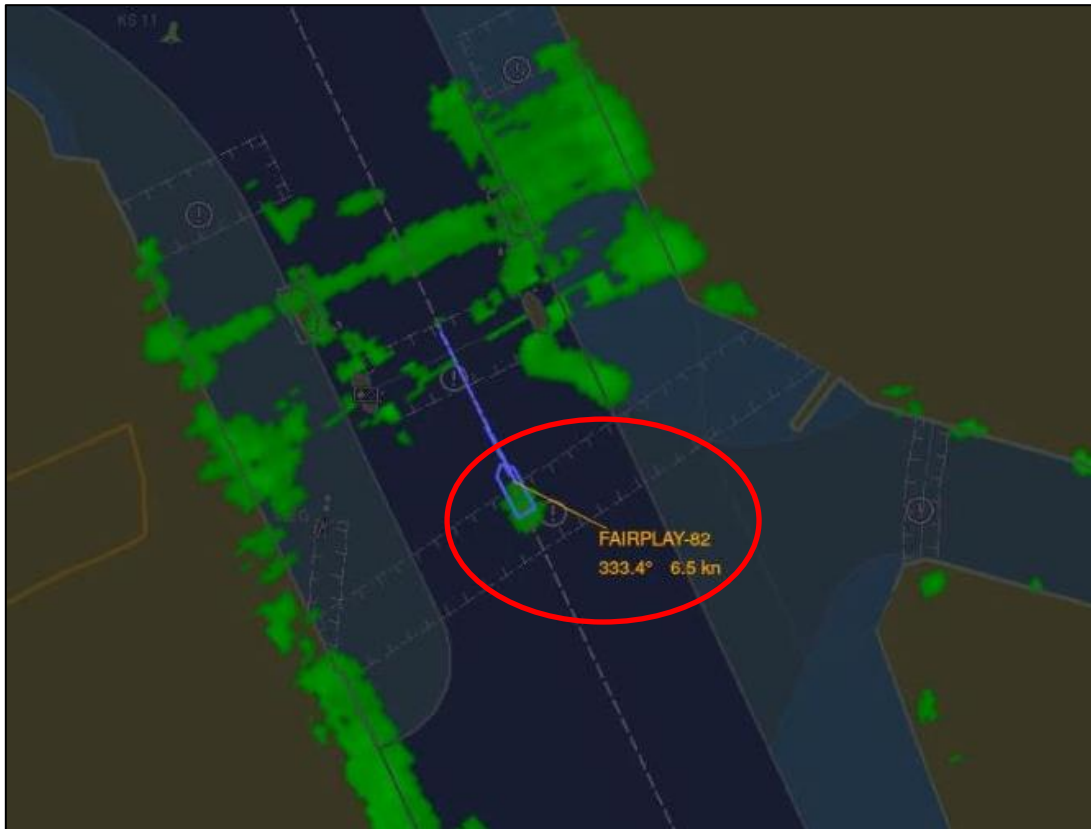
Figure 7 and Figure 8 show the same content: FAIRPLAY 82 is now moving directly towards the Kattwyk bridge at 6.5 kts.

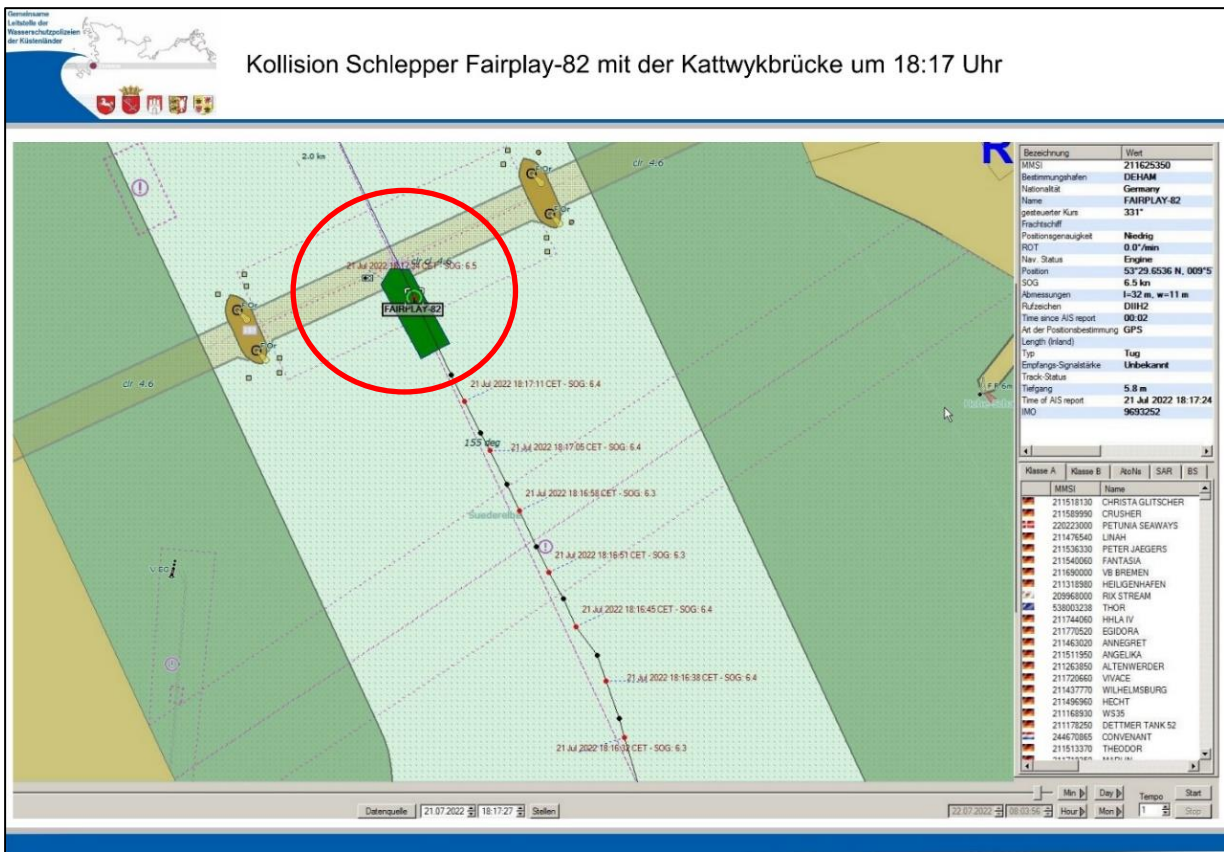
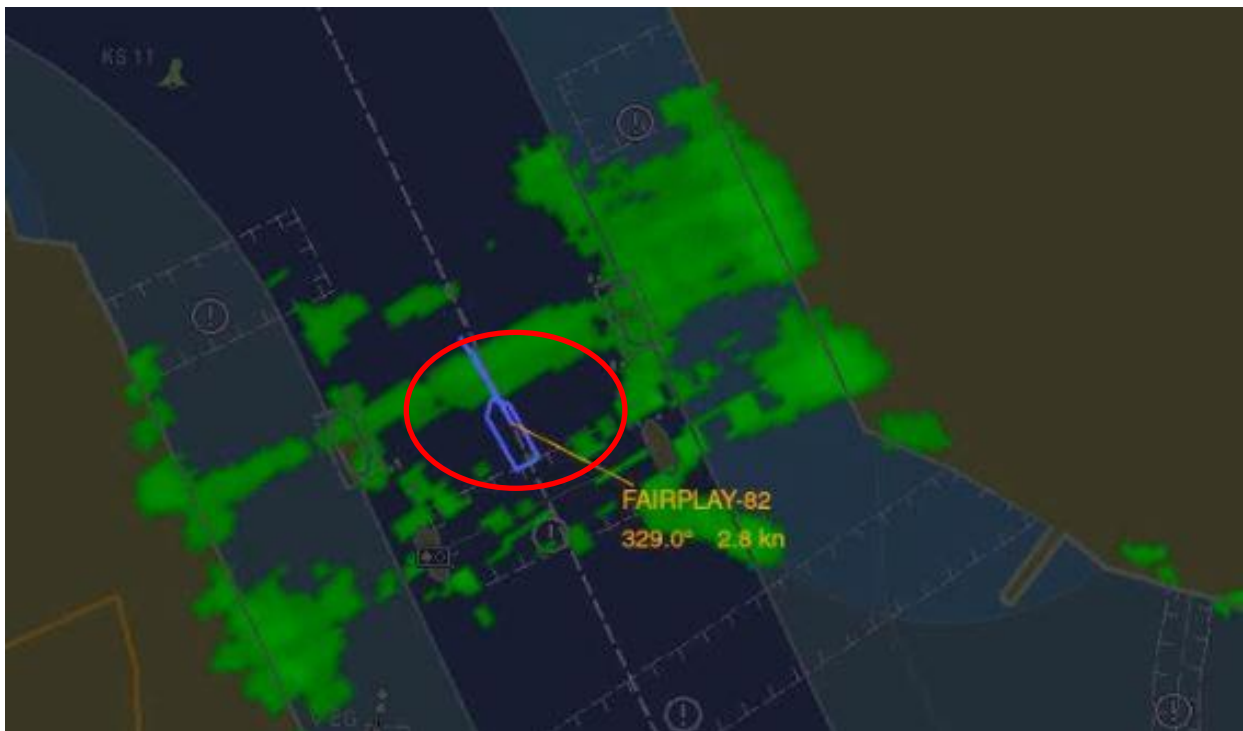
Figure 11 confirms the information on Figure 10. All subsequent images of the GLWSP are not credible, as they only refer to AIS signals. However, the FAIRPLAY 82's signal is no longer available due to the antenna being torn off. For this reason, more emphasis is placed on the HVTC's recording, which also includes the radar images.

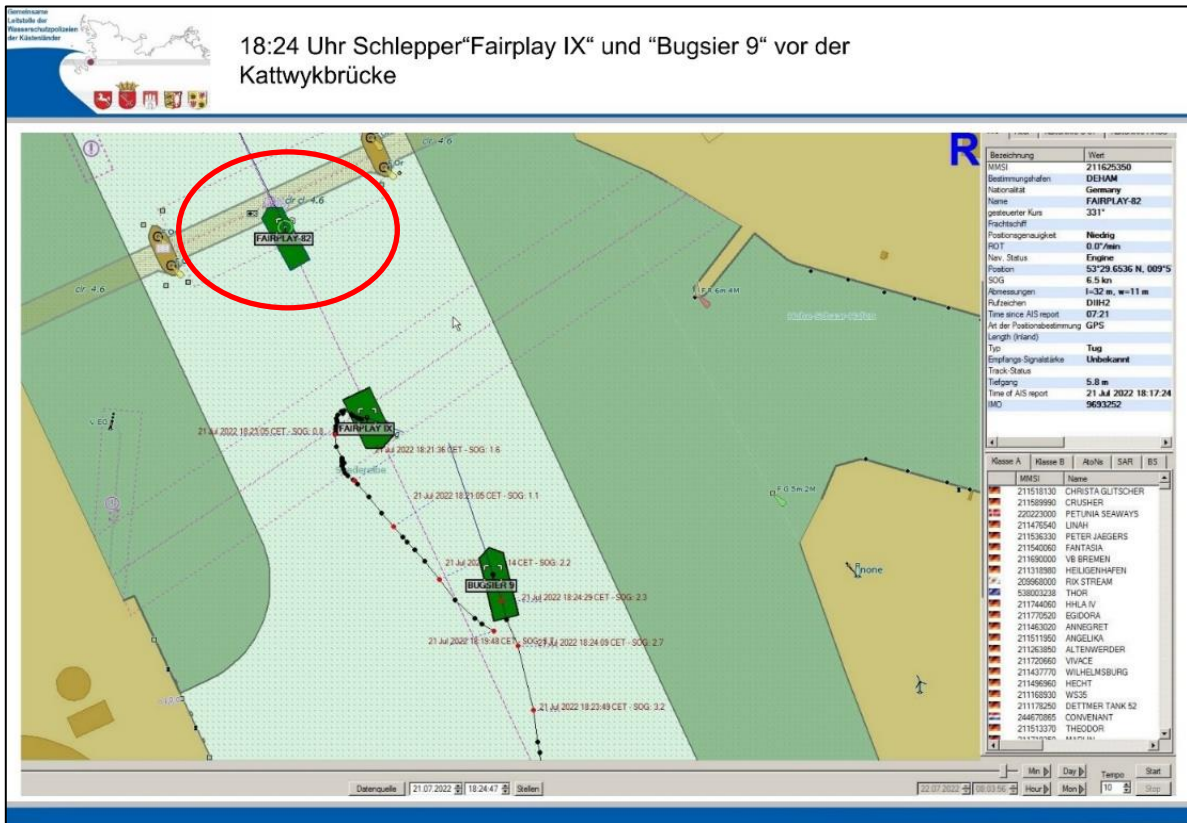
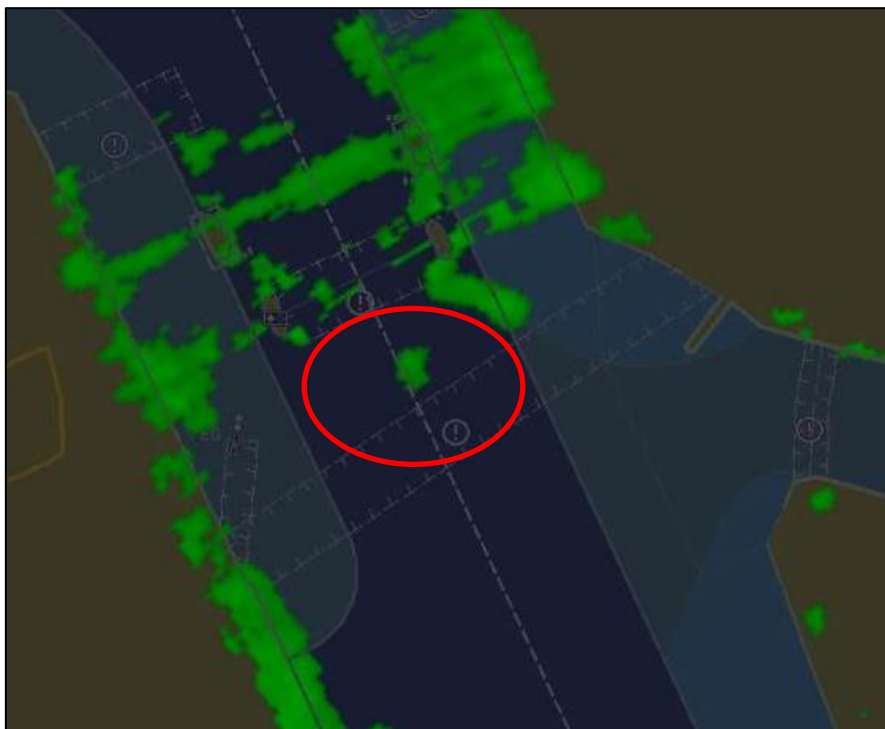
While Figure 12 shows that the FAIRPLAY 82 is still below the Kattwyk bridge, the radar recording in Figure 13 clearly shows that the tug has long since moved astern under the bridge and out.

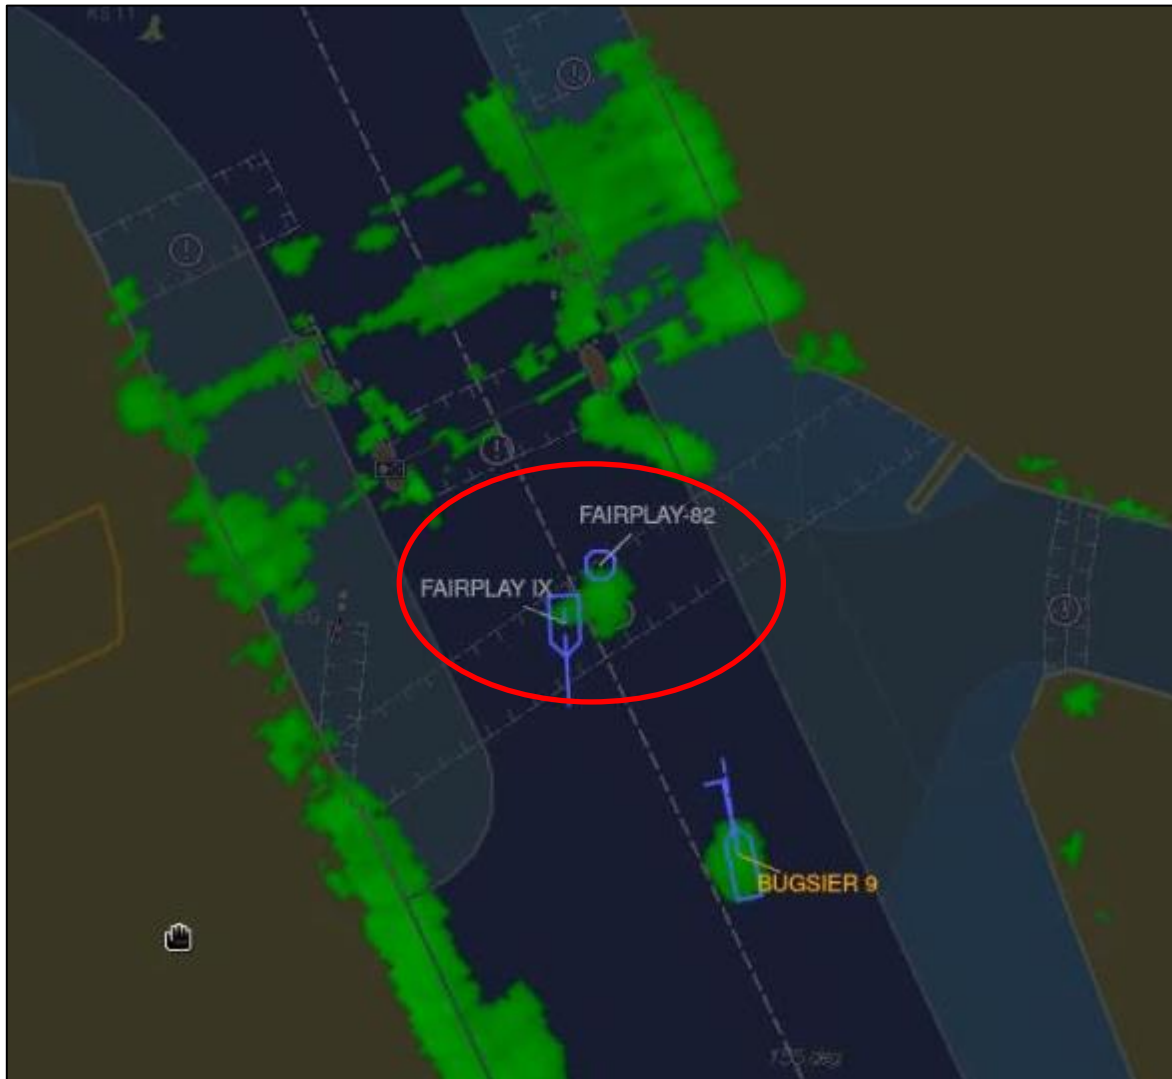
Figure 15: Radar image at 1824<sup>18</sup>

Figure 15 shows the actual situation at 1824: FAIRPLAY IX is already alongside FAIRPLAY 82 and towing her to the pier, while BUGSIER 9 is in the vicinity on standby.
