**Bundesstelle für Seeunfalluntersuchung**  
Federal Bureau of Maritime Casualty Investigation

## **Summary Investigation Report 284/21**

**Allision with a Pier Involving the Use of an  
Automatic Steering Control System  
by the Motor Yacht SANTA CECILIA  
in the Port of Hamburg on 5 September 2021**

15 November 2023

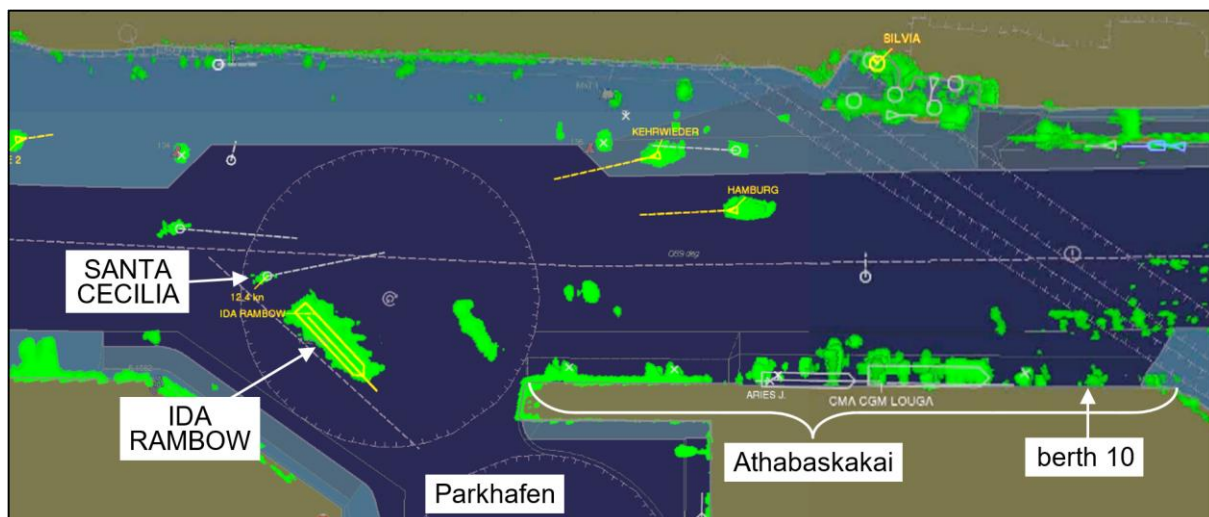
Figure 3: SANTA CECILIA Passes the Stern of the IDA RAMBOW at 12.4 kts SOG<sup>5</sup>

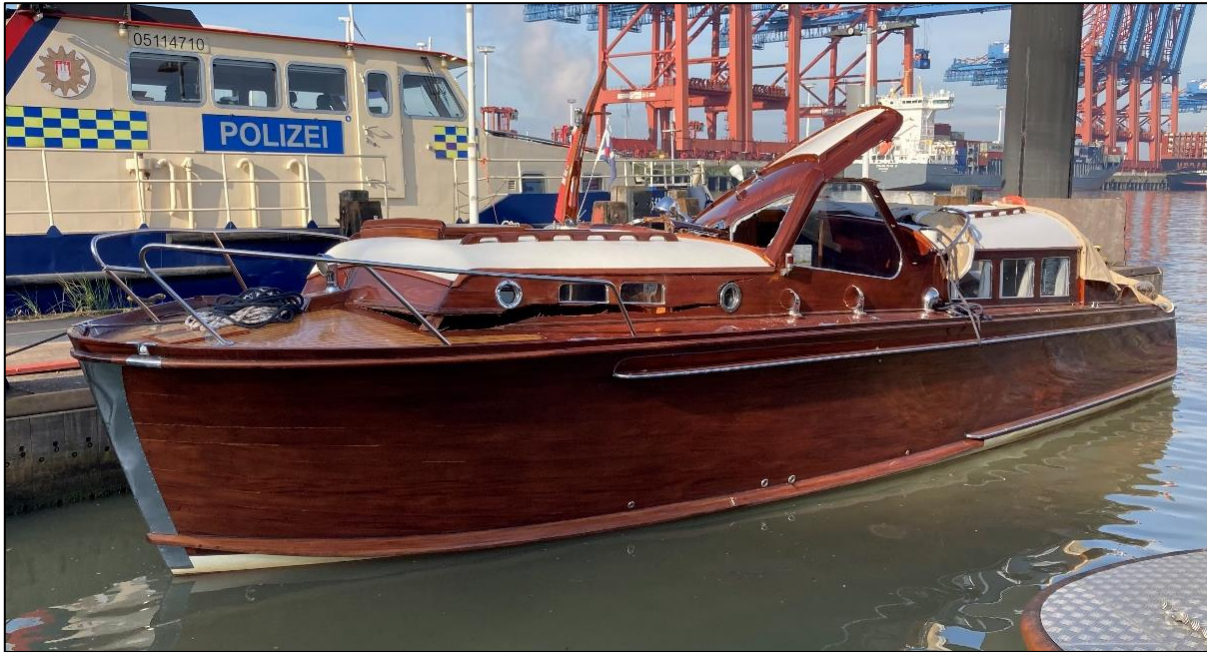
The SANTA CECILIA's starboard side struck the quay wall at a speed of some 7-9 kts. The forward superstructure was almost completely destroyed from above by a cylindrical fender that was suspended from the pier in an elevated position. A female passenger standing behind the skipper suffered an injury to her head caused by the control position's staved in roof and was bleeding profusely. For his part, the skipper suffered minor injuries in the form of lacerations caused by the panes of glass that had shattered.

Figure 4: SANTA CECILIA on 07/09/2021 – Side View<sup>6</sup>

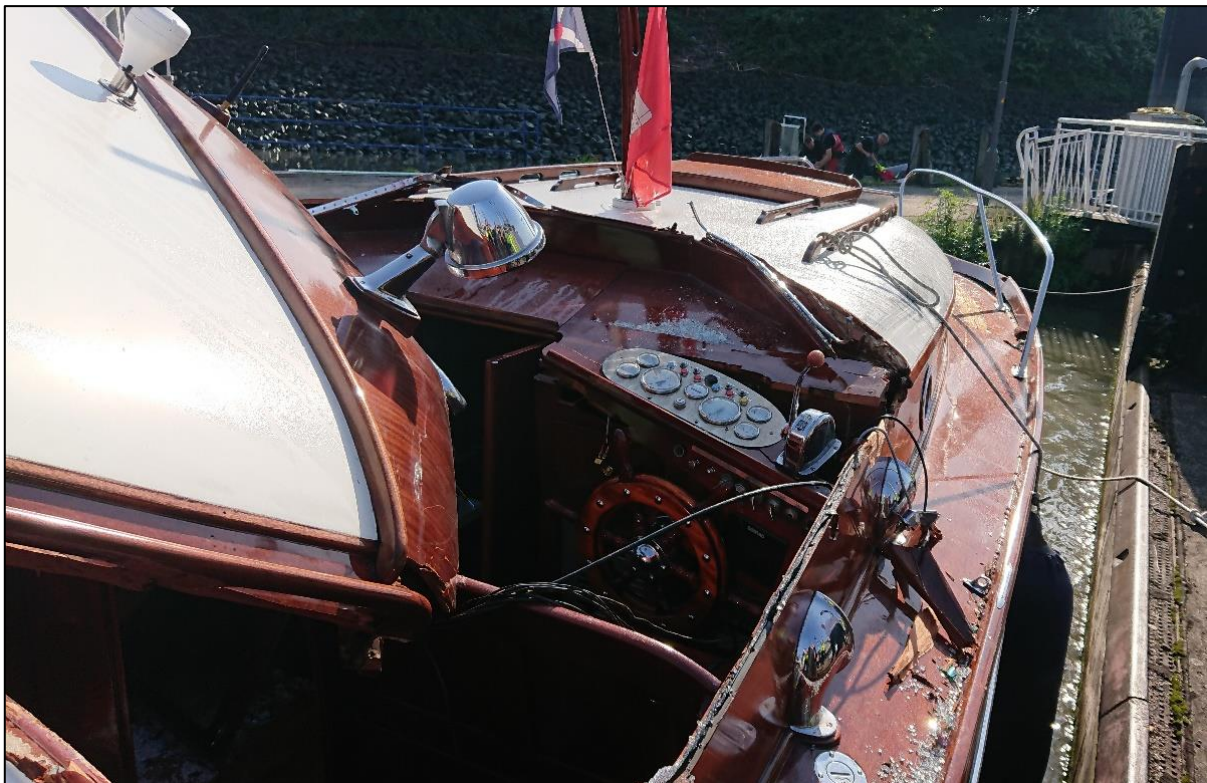
Figure 5: SANTA CECILIA on 07/09/2021 – Superstructure and Control Position<sup>7</sup>

The cause of the motor yacht SANTA CECILIA's allision with the Athabaskakai was chiefly a technical defect in the autopilot. The severity of the accident was facilitated by the fact that the autopilot was switched on in a busy area in close proximity to the quay facilities and by a relatively high speed during the allision. The accident was also facilitated by the fact that a loose object (mobile phone) in the vicinity of the control console was not secured in a seaworthy fashion against slipping or falling off.

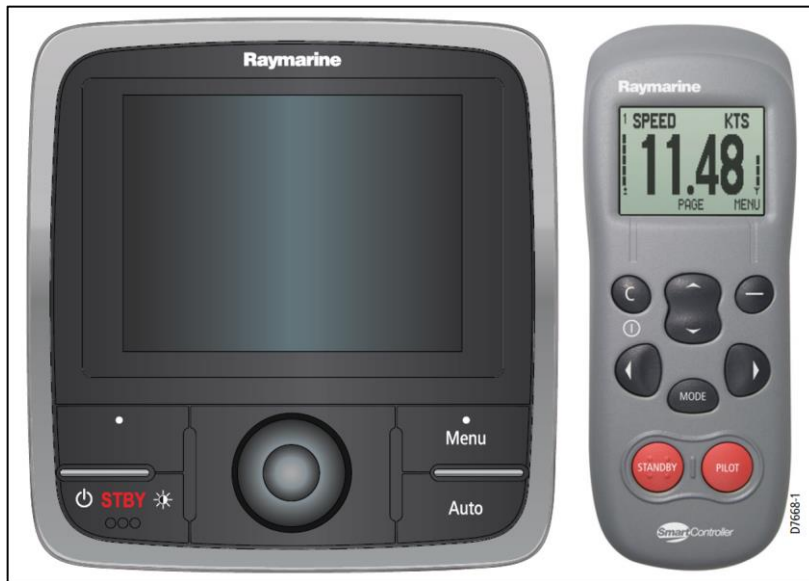
Figure 6: Autopilot Control Units on the SANTA CECILIA<sup>9</sup>

The manufacturer reportedly advised the owner of the yacht that the autopilot's software had frozen but the reason for this could not be clarified. Further investigations by the waterway police in cooperation with the autopilot's manufacturer regarding the system failure were inconclusive.

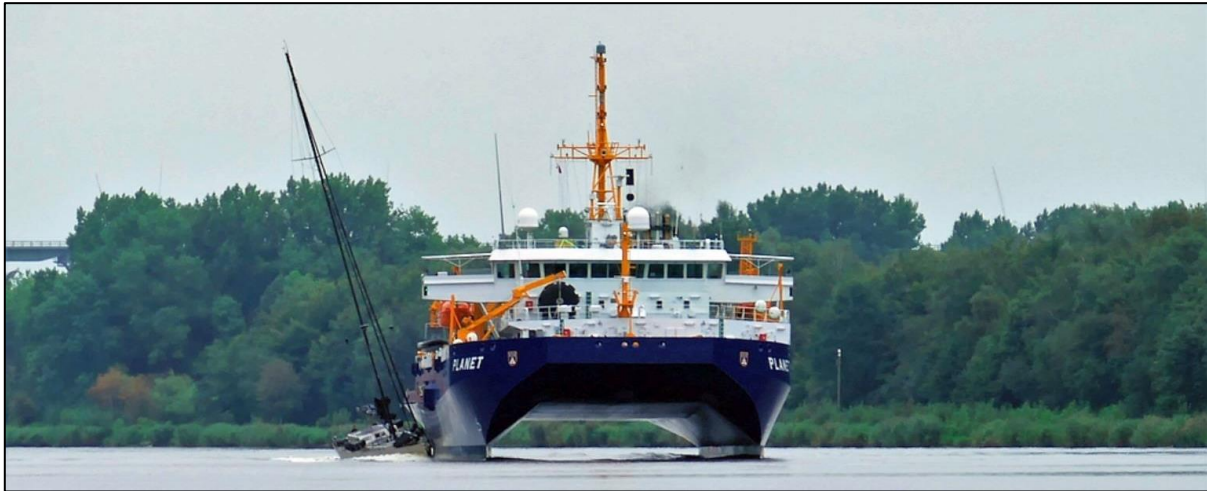
Figure 7: Collision between the WILDLIFE and PLANET<sup>10</sup>

The risk of collision was reportedly not recognised beforehand on the bridge of the PLANET. Everyone on the bridge (pilot, master, canal helmsman, officer on watch, rating) were reportedly looking ahead when reportedly a scraping noise was suddenly heard through the bridge wing door that was open on the starboard side. The WILDLIFE had reportedly become wedged with parts of the standing rigging on the upper edge of the railing (upper deck bulwark) of the PLANET, which according to the pilot reportedly immediately reduced engine power to a minimum and then stopped the starboard engine. Moreover, the course was reportedly initially maintained in spite of the right-hand bend in the canal. Following that, the sailing yacht reportedly broke free, creating a lot of noise in the process. The shroud on the port side of the WILDLIFE and her railing were damaged by the collision and parts that had broken off were found on the deck of the PLANET, which had sustained only minor damage to the paintwork. Nobody suffered any injuries.

The collision between the sailing yacht WILDLIFE and the research and survey vessel PLANET was presumably caused by the WILDLIFE's skipper leaving the cockpit. This meant that it was no longer possible to maintain a proper look-out and continuously verify the vessel's position. The collision was facilitated by the short passing distances of vessels on the NOK, which necessitate a short response time for required course changes when reaching a bend. The option of handing over control of the yacht to another crew member to make it possible to go below deck during the long NOK passage may have prevented the accident. However, due to the fact that the yacht was manned by only one person, this option was not available.

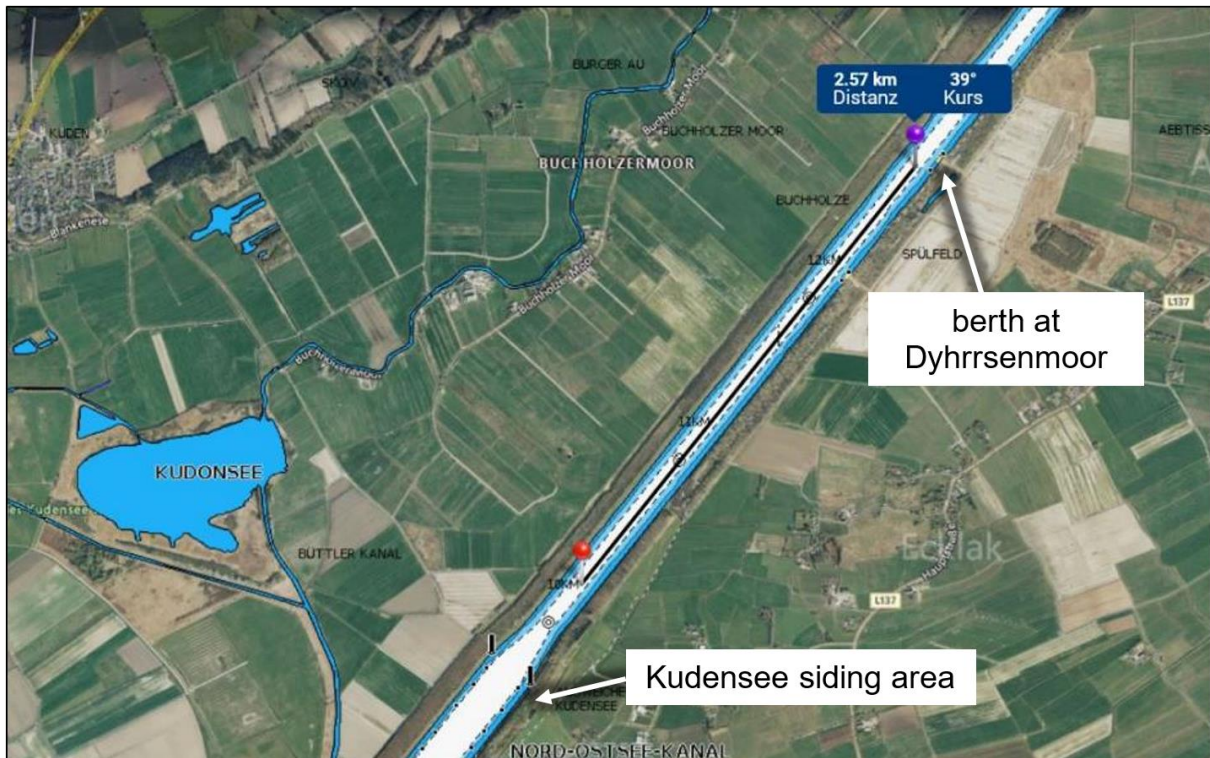
After the skipper had reportedly been busy at the backstay for some four to five minutes and while passing the inland waterway vessel CASTOR, moored at the Dyhrrsenmoor berth, at a distance of about 6-7 m, the autopilot reportedly suddenly made a  $90^{\circ}$  course alteration to starboard.

Figure 9: Stretch on which the Autopilot Was Active<sup>12</sup>

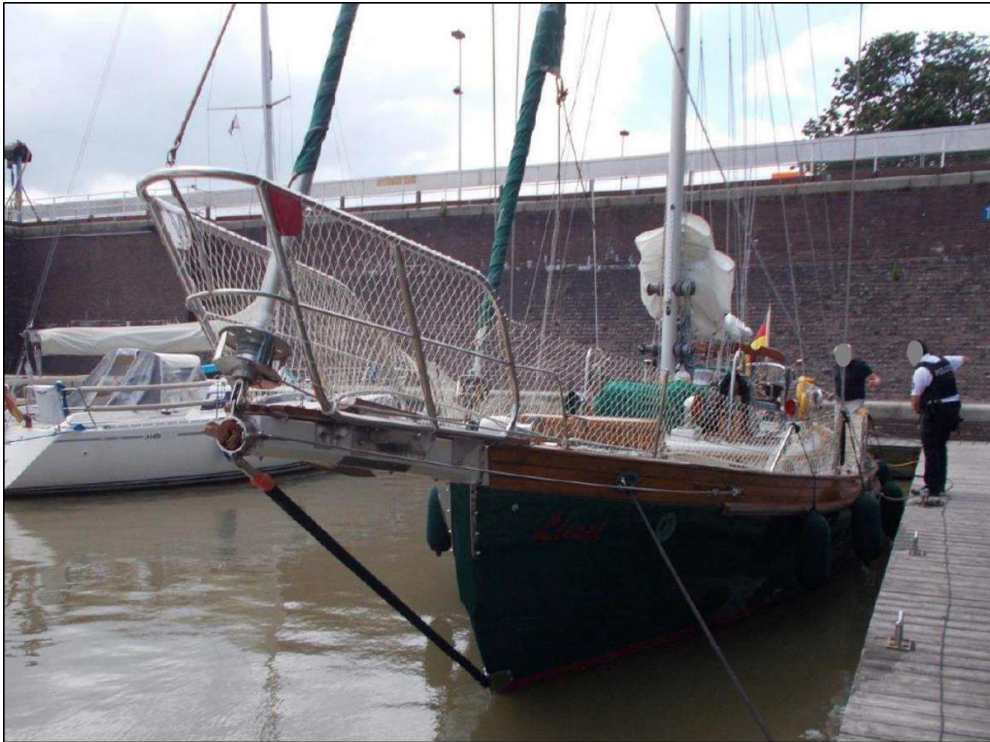
The waterway police did not find any damage on the dolphins. The LIESEL's wooden jib boom, which was about 2 m above the waterline, broke as a result of the accident. A sidelight was also lost.

The owner/skipper reportedly assumed that the wide metal reinforcement on the dolphins had deflected the fluxgate compass (see 2.2.5.4), which was installed on the starboard side, of his autopilot and that passing the dolphins at insufficient distance and inattentiveness reportedly contributed to the accident.

Figure 10: Photograph of the LIESEL After the Accident<sup>13</sup>

From the perspective of the investigation team, the allision with a dolphin by the sailing yacht LIESEL was also due to the deflection of the autopilot's sensors by external influences, facilitated by the fact that the skipper left the cockpit and was thus unable to intervene in the steering quickly enough. A close passing distance to the dolphins and the skipper's failure to delegate tasks (stand at the helm or fasten lines) to the crew member facilitated the allision. The accident could have been avoided had the autopilot not been used and the helm been continuously manned while the lines were being cleared.

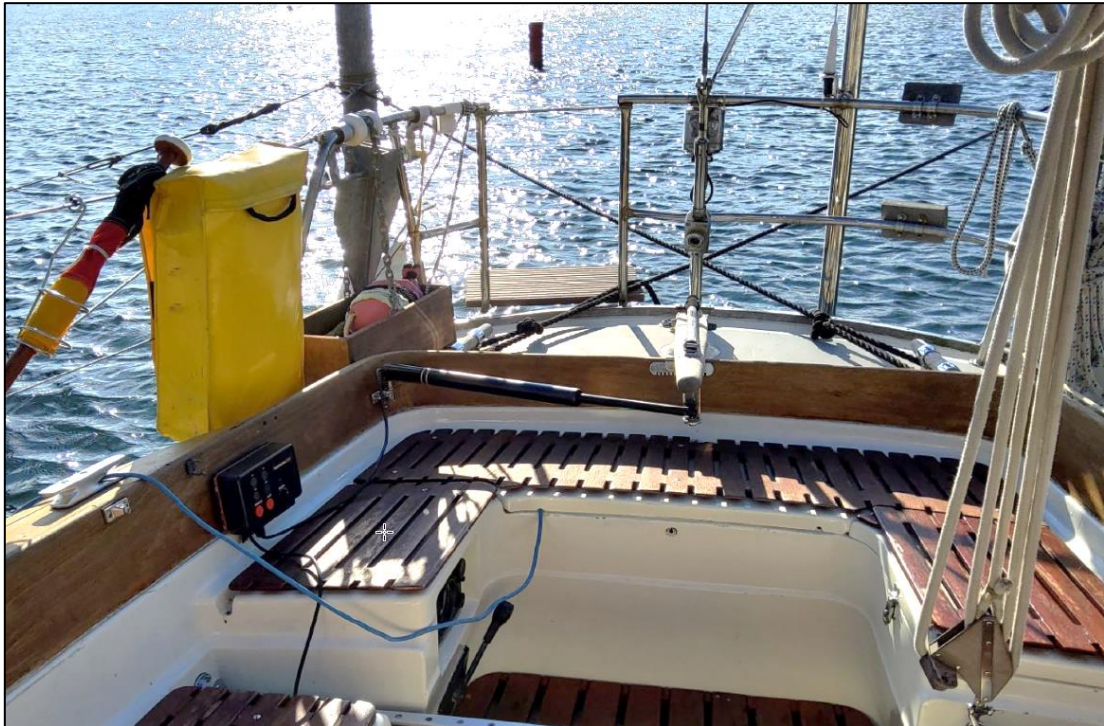
Figure 12: Tiller Drive on the FRÄULEIN VOM RHIN<sup>15</sup>

The sailing yacht FRÄULEIN VOM RHIN collided with the moored inland waterway vessel CASTOR because the skipper did not take into account the possible deflection of his tiller drive's sensors by external influences, was not able to intervene in the steering quickly enough and passed the inland waterway vessel at relatively close proximity. The incident was facilitated by the failure of the boat hook attachment, an incorrect assessment of the potential risk of using the autopilot and the skipper's failure to delegate tasks to his crew member. The accident could have been avoided if the tasks involved (steering/re-attaching the boat hook) had been divided among the existing crew members.
