Bundesstelle für Seeunfalluntersuchung
Federal Bureau of Maritime Casualty Investigation

**Summary Investigation Report
359/22 and 513/22**

**Accidents involving a person on board the
ROBIN HOOD
in the Baltic Sea
on 19 June 2022 and on 26 June 2022**

30 August 2023

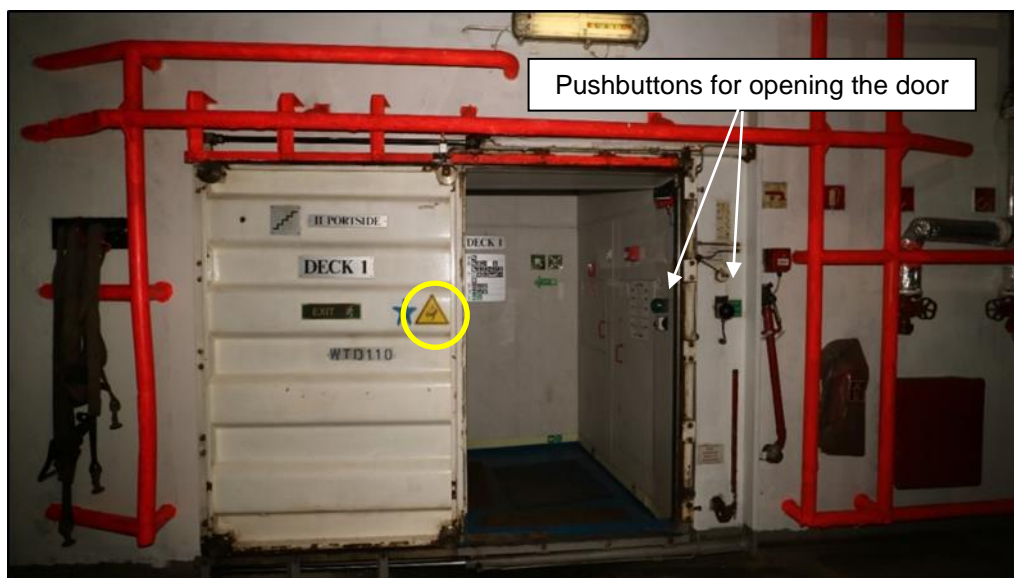
Figure 4: Watertight door number 110 on deck 1 in the open condition⁷
The yellow circle marks the warning sign indicating a risk of crushing.

The operator of the vessel did not install any notices at the sliding door or in the vicinity of the doorway on either the stairwell side or vehicle deck side stating that people should not and were not permitted to pass through the doorway until it had opened fully. The sign indicating a risk of crushing was on the stairwell wall (see Figures 8 and 9) and on the vehicle deck side of the sliding door (see Figure 4). Since the warning sign in the stairwell is installed on the side on which the door closes, a hazard is only immediately evident to the user on the closing side.

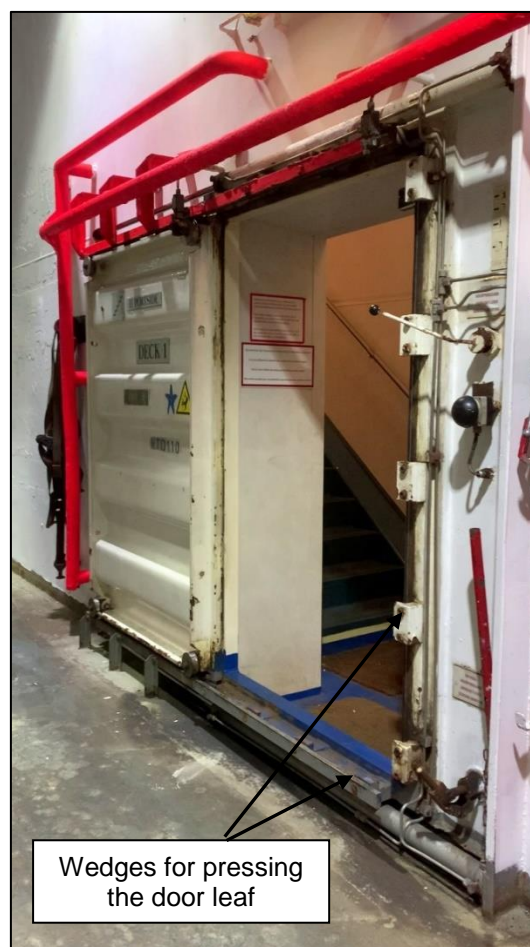
Figure 5: Watertight door number 110 on deck 1 in the open condition⁸

The red tubing is installed to protect the door mechanism. The guide at the top of the door is also red. The stairwell is visible on the other side of the doorway.

The sliding door runs on rollers mounted on the upper and lower edge of the door leaf. The hydraulic cylinder for moving the door is located near the floor on the side of the vehicle deck. Accordingly, there is a threshold of some 20 cm in height due to the design.

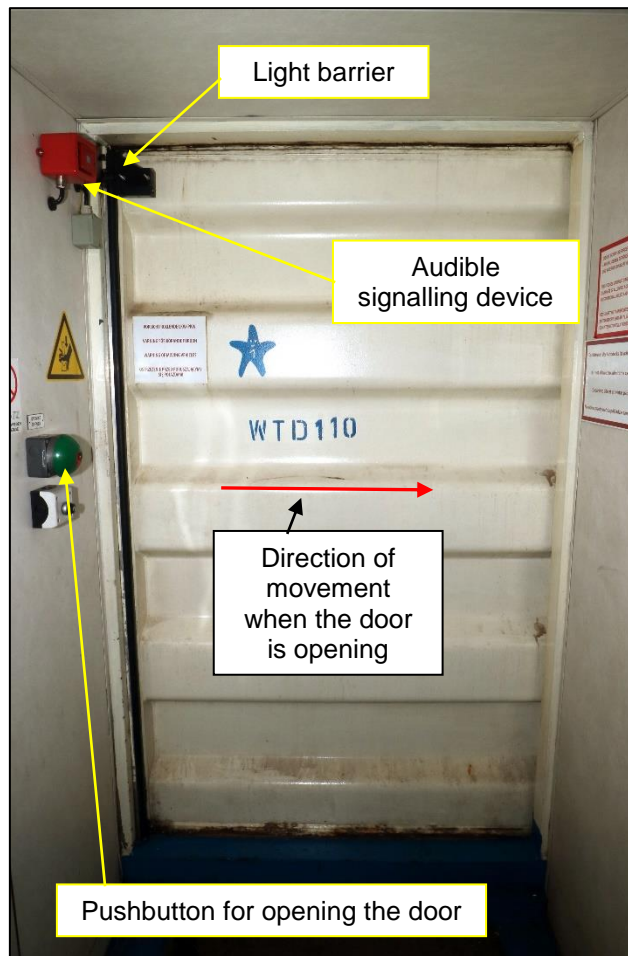
The sliding door has two independent safety systems designed to prevent a person or object from becoming trapped when the door closes. One is a non-contact light barrier, which is installed on the stairwell side. The light barrier monitors the area of contact between door leaf and door frame, i.e. between the main and counter closing edges, from an upper position.

Figure 8: View of watertight door number 110 from the stairwell¹¹

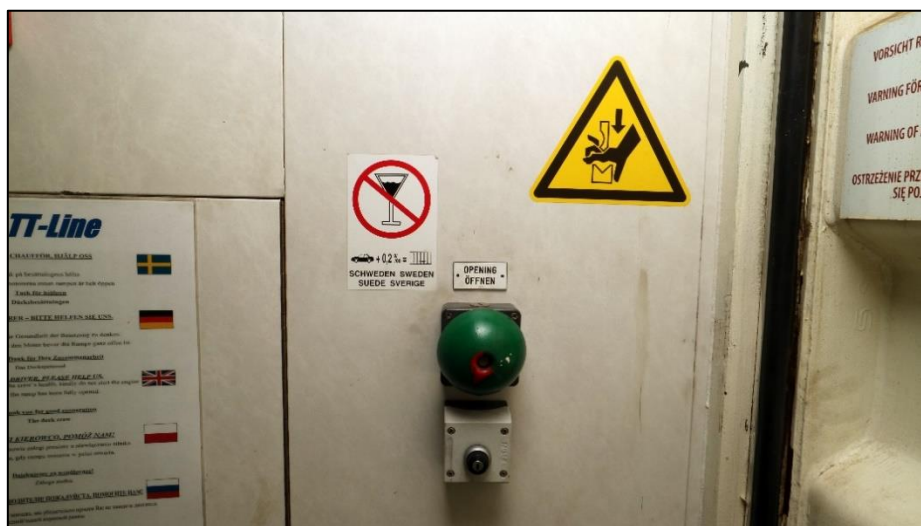
Figure 9: Pushbutton for opening the door and 'Risk of Crushing' warning sign¹²

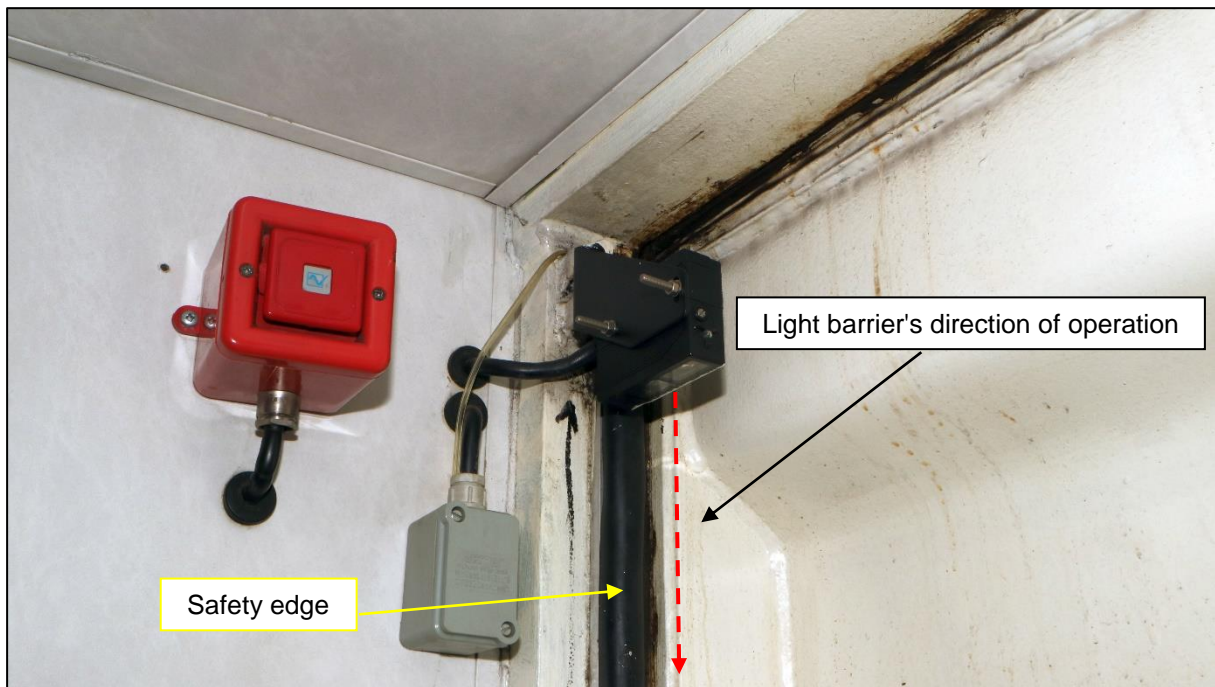
Figure 10: Audible signalling device, light barrier and safety edge¹³

The other safety system is a pressure-sensitive safety edge. This safety edge stops the sliding door closing when the rubber-encased edge is pressed in with minimal force.

The door stops moving immediately when either safety system is triggered. There is no overrun. The door then opens again.

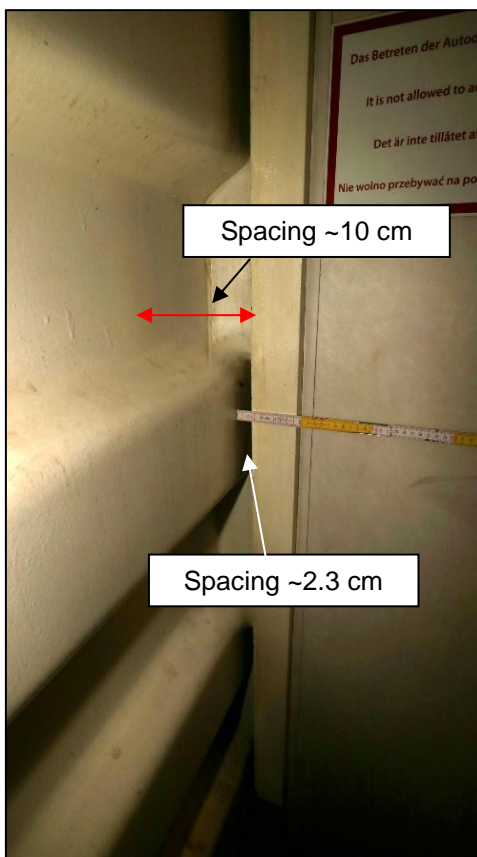
Since there was evidently no risk of crushing when the door was opened, there were no structural or technical safeguards on the side towards which the door moves when it opens. However, when the sliding door was closed and closing, the wave-shaped design of the door leaf made it possible to reach into the free space that existed on this side until the door was fully opened. At the same time, the smallest gap between door leaf and door frame was about 2.3 cm. The biggest gap was about 10 cm. After the door was fully opened, a gap of about 0.3 cm remained between door leaf and door frame. Accordingly, the risk of crushing a finger only existed in the final phase of the door opening operation.

Figure 11: Gaps between door leaf and door frame when the door is closed¹⁴

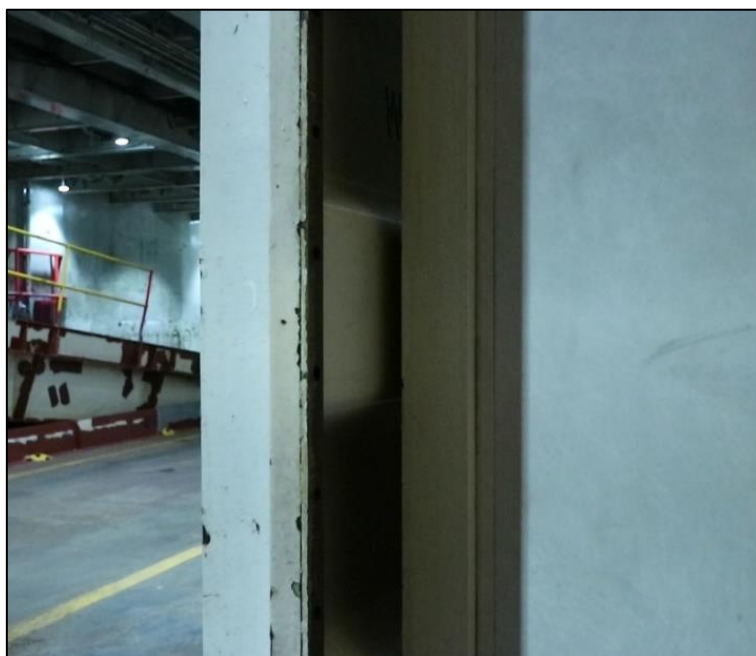
The ferry reached the port of Trelleborg at about 2000. The couple then went to their vehicle via the stairs. When they arrived at the door to the vehicle deck, the opening operation of sliding door 110 had already been triggered by a previous passenger, who had already passed through the doorway. The door continued to move slowly towards the right-hand side to open fully. The casualty was on the right-hand side of her husband and their arms were linked. They began to pass through the doorway before it had opened fully. The wife sought additional support on the door frame with her right hand when she started to cross the higher threshold at the latest. In the process, she put three fingers into a gap, which at this point still existed, between the door leaf and door frame (see Figures 11 and 12). The investigators assume that the couple had not completely passed through the doorway before its opening operation was completed. Accordingly, the wife's right hand was still on the door frame. When the door was fully opened, the gap closed and her fingers were crushed.

Figure 12: Watertight door number 110 when it is opening¹⁵

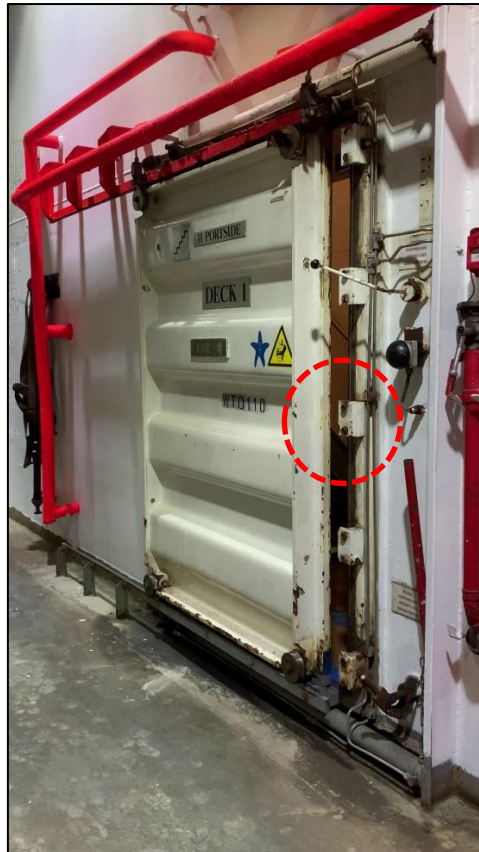
During the inspection of the ship, it was found that the light barrier on the stairwell side of the sliding door did not cover the area around the wedges. Accordingly, there was neither a technical nor a structural safeguard against the risk of being crushed there. Since the wedges protruded somewhat and one of them was at hand height, it could not be ruled out that the wedge was grasped for use as a handhold.

Figure 13: Assumed location at which the injury occurred¹⁶

This figure is based on door number 110 on the opposite side. All four sliding doors in the lower vehicle deck that can be used by passengers are technically comparable.

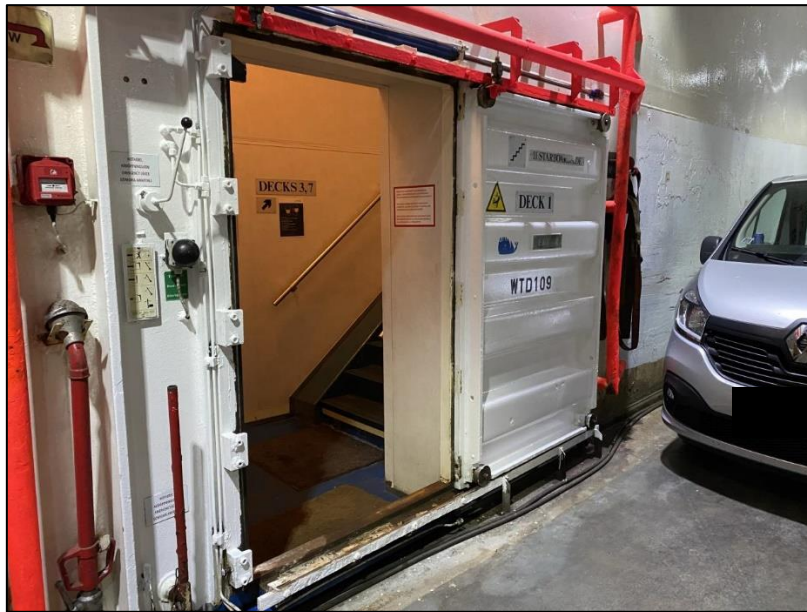
Since both women were disorientated, the casualty first entered the lower vehicle deck via the watertight sliding door number 109 on the starboard side of the ship. In the process, fingers on one of her hands were crushed.

Figure 14: Watertight sliding door number 109 on the day of the accident¹⁷

In the course of the investigation, it was found that the left hand, on which four fingers were crushed, was injured during this accident. The surgical intervention ensured that all the fingers were saved. However, mobility is severely restricted.

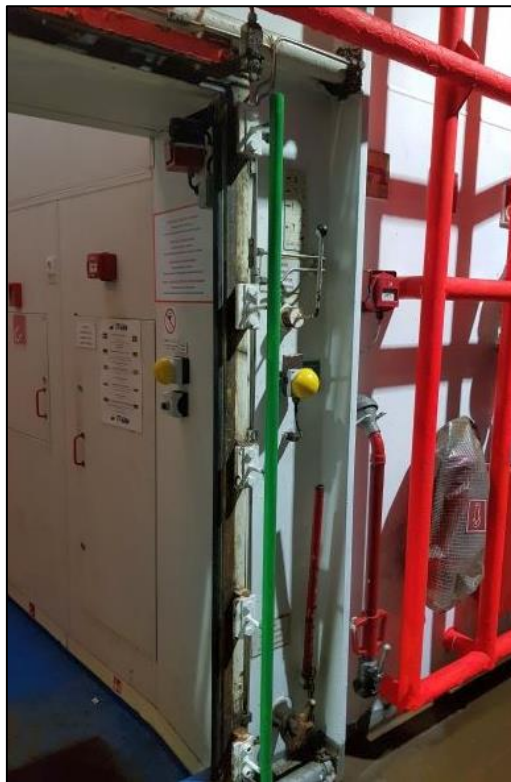
Figure 15: Watertight door number 110 with the new green handrails on the vertical wedges²⁰

- to comply with the obligation to notify the BSU in the event of an accident under Section 7 of the German Ordinance on the Safety of Shipping in the future, the internal instructions were adapted to include the reporting obligation to the BSU after the accident of 19 June 2022 became known and the ensuing criticism of the BSU;
- in the vehicle deck, the vertical wedges were furnished with a protruding handrail (see Figure 15). This is to prevent the wedges from being used as a handhold, providing something of a passive safeguard against crush injuries in the process. The colour of the handrail and the pushbuttons was chosen to make them easier to distinguish from other components;

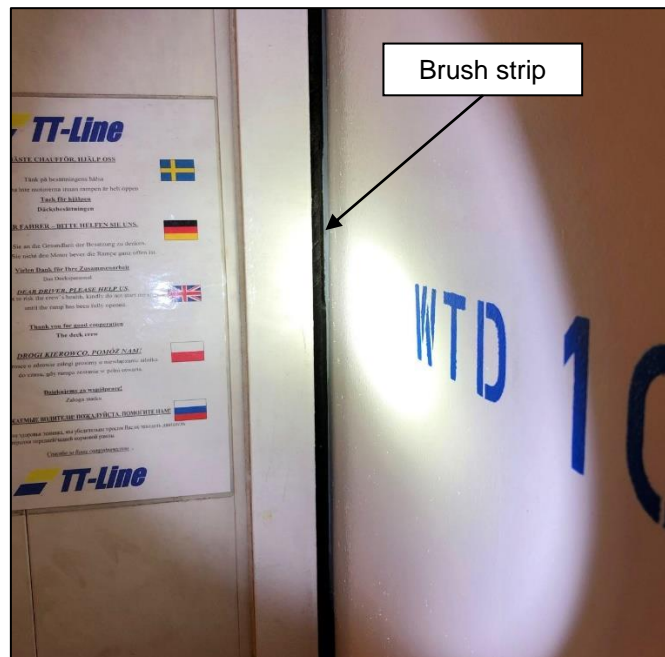
Figure 16: Watertight door number 108 with a smooth surface on the inside and brush strip on the side to which the door opens²¹

- on the side of the stairwell, the sliding door wings were completely clad with a panel, which produced a smooth surface. The existing small gap between the door leaf and door frame (about 0.2 cm) was covered by a brush strip (Figure 16);

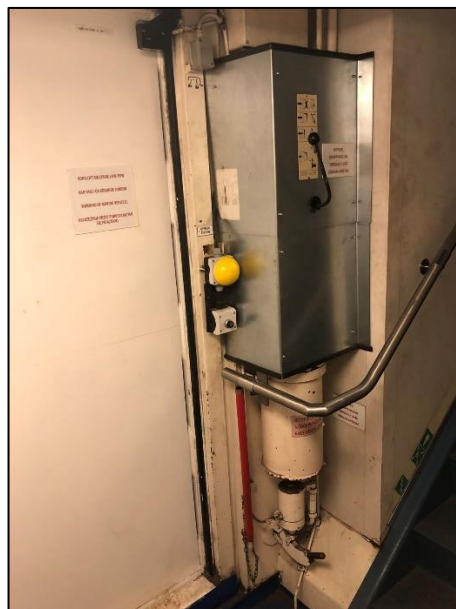
Figure 17: Watertight door number 108 with the new extended handrail reaching around the corner²²

- the inner handrail in the stairwells was extended so as to reach around the corner, meaning it now provides a handhold for a longer period. Installation of a handrail or other handhold in the door frame was rejected, as the ensuing reduction in the width of the doorway would have been too great;
