Bundesstelle für Seeunfalluntersuchung
Federal Bureau of Maritime Casualty Investigation

Summary Investigation Report 6/22

**Serious accident involving a person while a mooring
line was being handled on the tug ZP BOXER
in the port of Hamburg on 4 January 2022**

19 April 2023

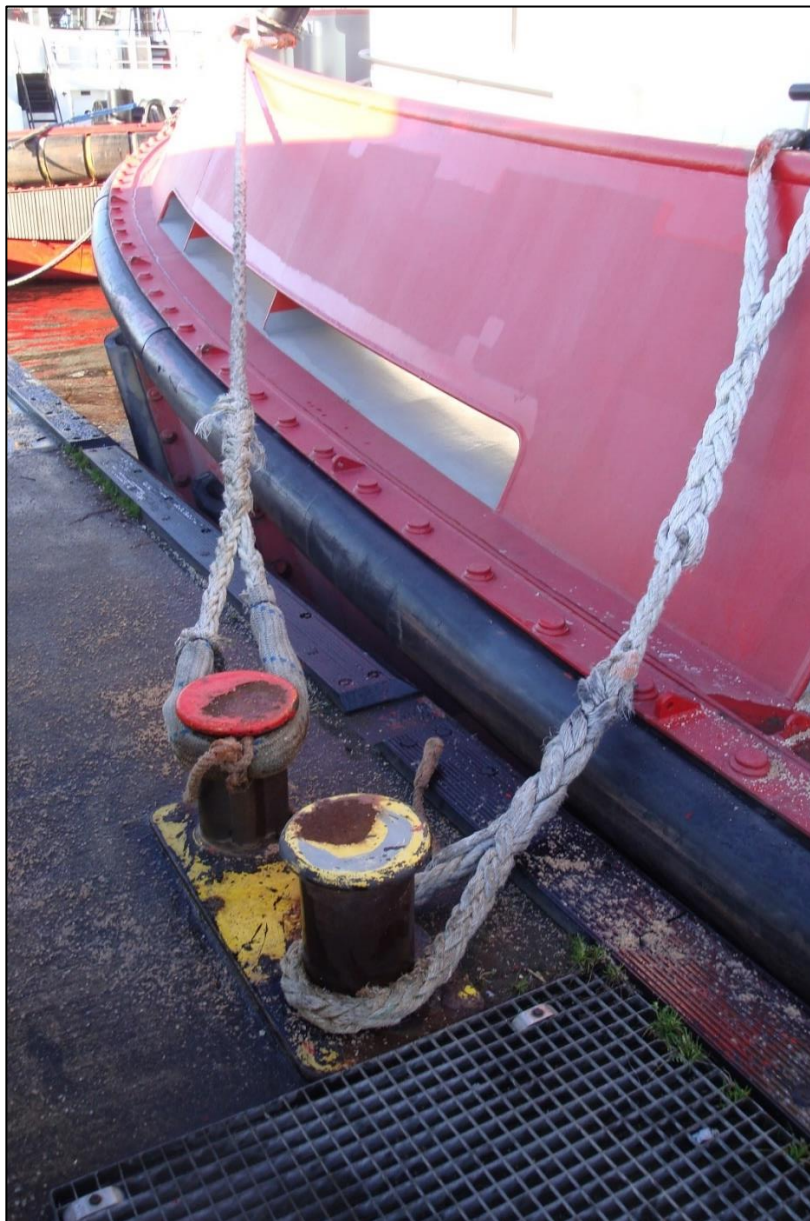
Figure 4: Arrangement of lines after the accident⁶

ahead to take the slack out of the lines, which were already preconfigured in terms of length, before the two head lines were then to be placed over the bollard. Suddenly, the deckhand reportedly went back to the spring in order to pull the head lines that were on top of it (or rather the eyes of the head lines, which he was holding in his hands) under the spring. Without realising, he reportedly put his right foot into the eye of the fore spring, which was still lying loose on the ground (without any tension on the line) but which he had already placed over the bollard. At that very moment, the fore spring tightened, as the tug was slowly moving forward to take up her final mooring position. The eye of the spring on the bollard pulled tight instantly and severed the deckhand's foot.

In cooperation with the expert for occupational safety appointed by the shipping company, the procedure for berthing (or making fast) was changed immediately after the accident to the effect that the skipper still remains on the bridge, a second person takes up a position on deck and the third person goes ashore. The lines previously laid out in front of the bulwark are passed to the third person ashore by the person who remains on board and no longer pulled from the pier as before. Furthermore, the lines on board were exchanged for lines with a smaller eye so as to prevent people from stepping into one inadvertently.

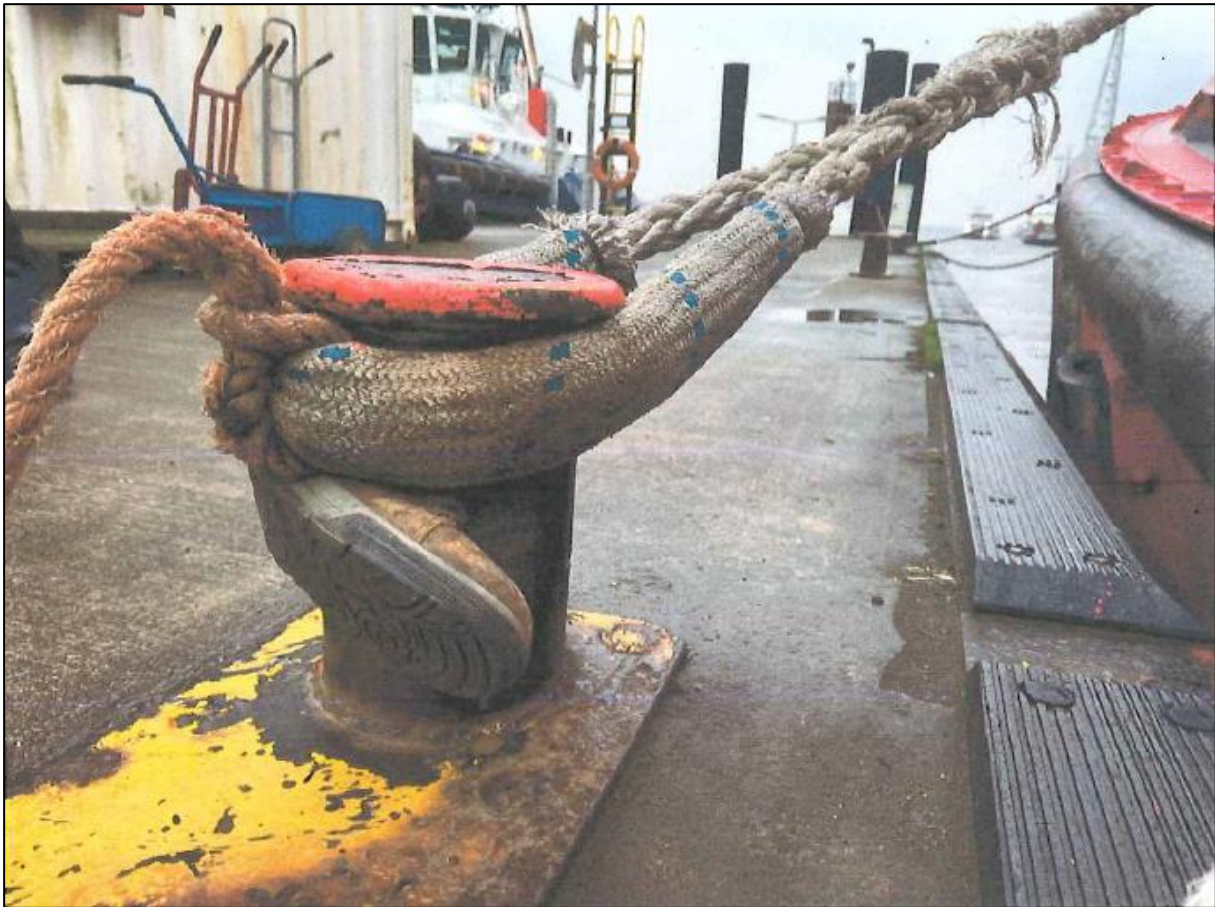
Figure 5: Situation after the accident (RECONSTRUCTED)⁷

At any event, and as already discussed above, it was stated that the deckhand suddenly noticed that the two head lines were laid over the spring and that their proper direction of pull would be impaired. To prevent this, the deckhand went back to the double bollard with the two head line eyes, which were undoubtedly in his hands at that time, and wanted to pull them under the fore spring, which was initially still slack, in the immediate vicinity of the double bollard. While doing so, he inadvertently stepped into the eye of the spring with the disastrous outcome that his right foot was severed.

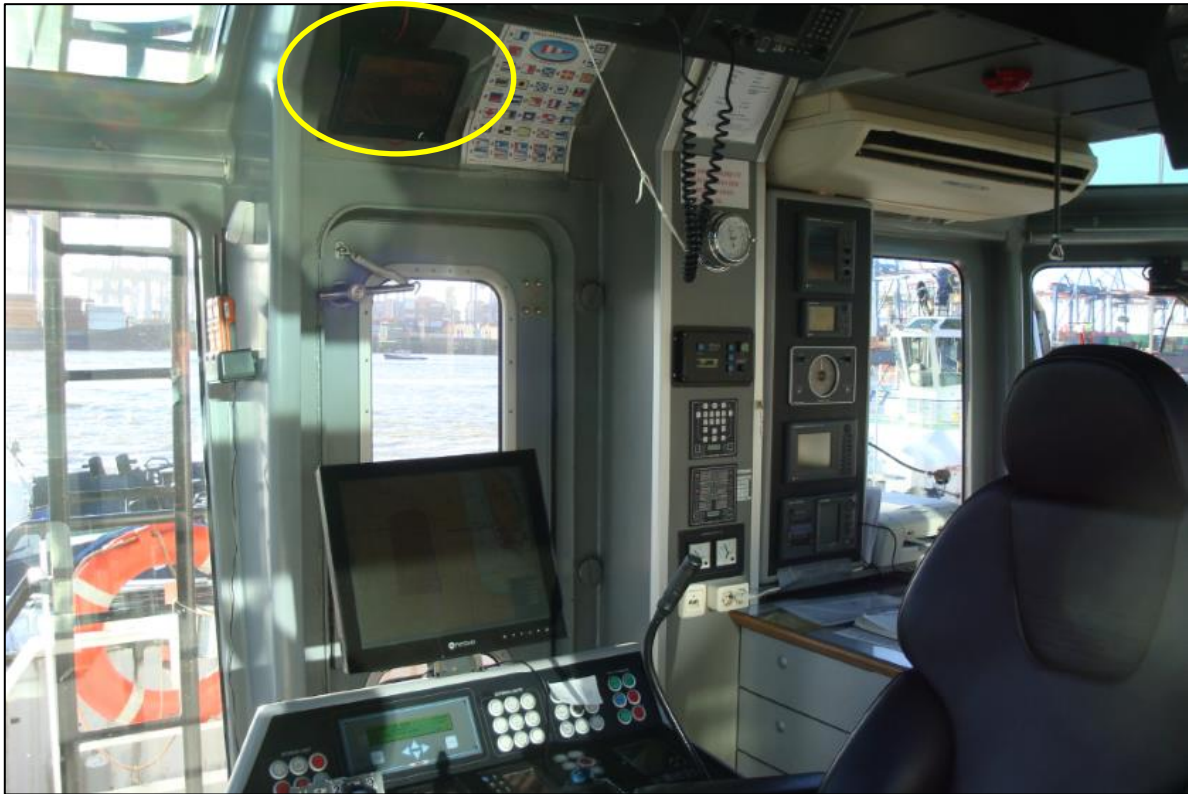
Figure 6: View of one of the two monitors on the bridge⁸

The skipper's statement that the scene of the accident was not visible to the naked eye from the bridge for reasons of design but rather 'illuminated' by a camera, which neither includes a video recording nor an image zoom function, was confirmed during the survey of the bridge.

That the monitors have an extremely small screen diagonal by today's standards (about 30 cm max.) and that the image is difficult to see in glaring/bright lighting conditions, as was the case on the day of the survey (but not on the day of the accident) merits criticism. Figure 7 shows the investigators' view.

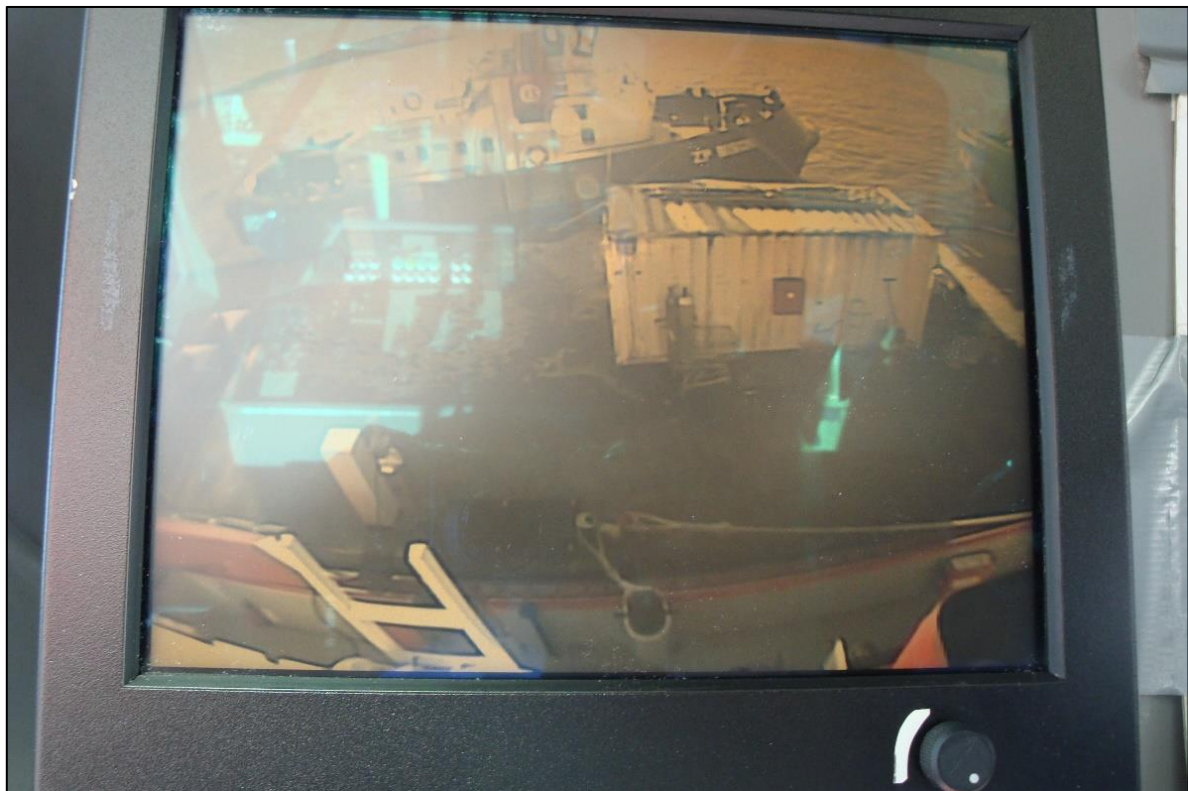
Figure 7: Close-up of a monitor (switched on)⁹

Conditions on the bridge were also discussed during the conversation, the two flat-screen monitors, in particular. These relatively small black and white monitors are mounted on the starboard and port sides above the bridge entrances. The resolution of the monitors can be described as rather low and their picture is even worse in unfavourable light conditions. At this point, it should be explicitly mentioned again that the design and arrangement of the monitors was not relevant to or responsible for the accident.

It is reasonable to assume that the skipper would have had a better view of the pier had the monitors been larger and suitable for changing light conditions. However, it is doubtful that this would have enabled him to prevent this or a similar accident because the deckhand stepped into the eye of the line almost simultaneously with the tug's short and slow forward movement and it all occurred in fractions of a second.

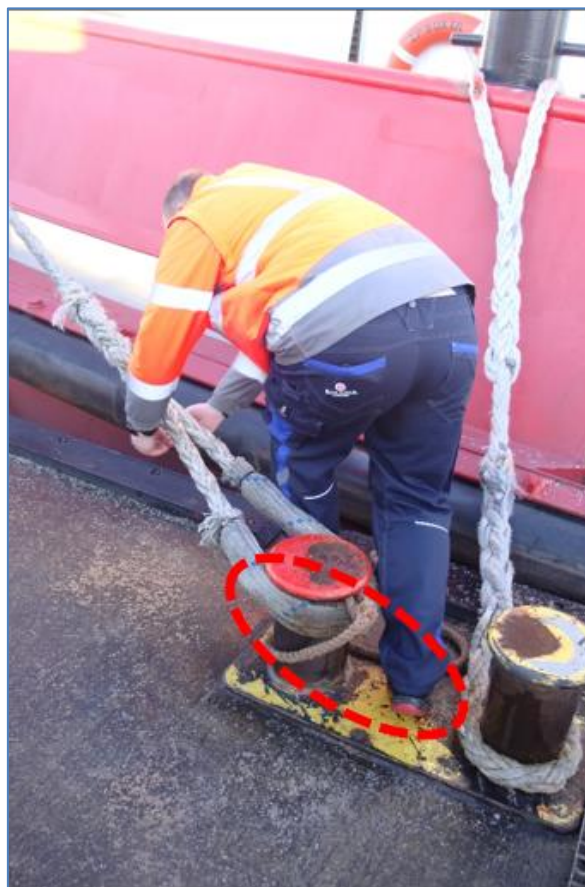
Figure 8: Working position and line position; scene reconstructed¹⁰

The following image shows the engineer during a reconstruction of the casualty's posture while handling the lines as described above. At the same time, the right foot was inside the eye of the spring line, which was laid loosely over the (red) bollard at the time of the accident and under tension (only) in the photograph.

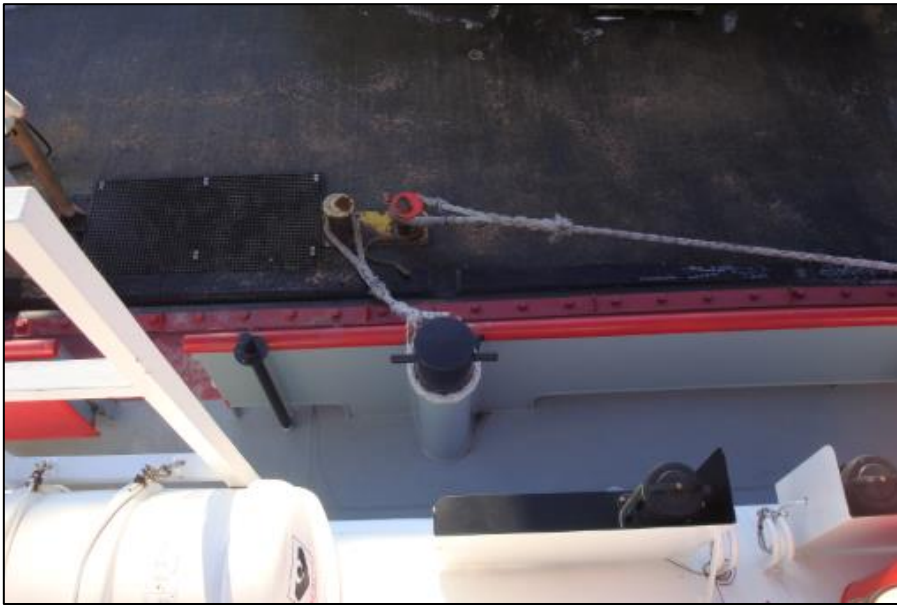
Figure 9: View of the scene of the accident from the bridge¹¹

There is no direct line of sight between the skipper's wheelhouse and the shore/ship-side area amidships in which the accident occurred because of the design. However, cameras are installed on the port and starboard sides above the wheelhouse. The image of each camera 'captures' the area in question on the respective side of the vessel and transmits it to a small flat-screen monitor (approx. 30 cm diagonal). The monitors are mounted beneath the ceiling on the port and starboard sides of the wheelhouse.
