Investigation Report 134/04

15. May 2005

Accident involving personal injury with fatal consequence on board MV HAMBURG EXPRESS on 7 June 2004 off the French Atlantic Coast

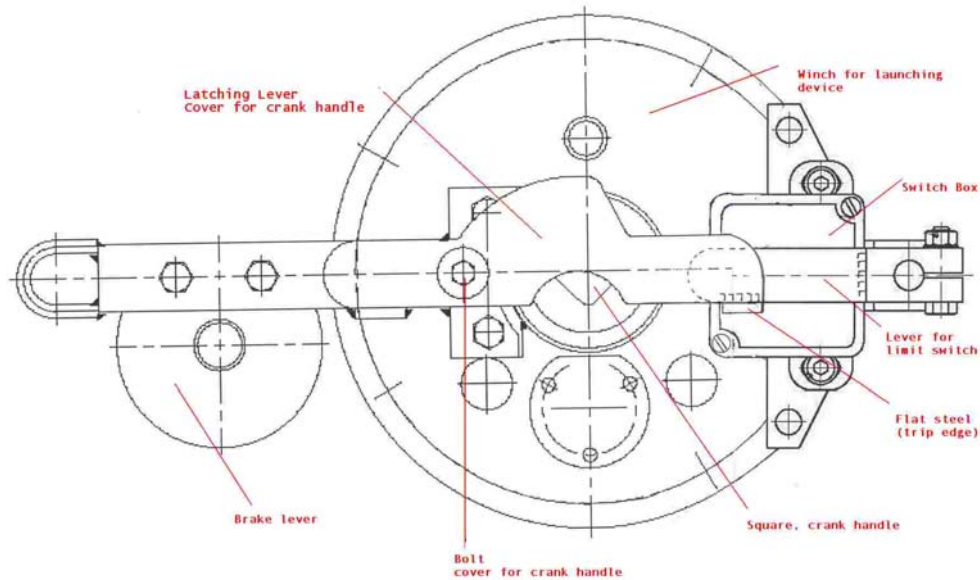
In both cases the fatal consequences of the accidents are in all probability attributable to the fact that it was possible to start up the winch motor despite the crank handle being in place. The rotating crank handle thus became an uncontrollable striking tool. According to Chapter VI No. 6.1.2.6 of the International Life Saving Appliances (LSA) Code, it is stipulated for launching and embarking devices that crank handles and hand wheels may not rotate with moving parts of the winch when heaving down or heaving up with (electrical) power drive. The launching device used on the vessel H. basically satisfies these design requirements. In the launching device used the heaving down movement is blocked with the aid of a latching lever. This lever must be moved by hand (upwards). This operation alone releases the square mounting onto which crank handle can be fitted and blocks the heaving down movement. By drawing up the latching lever over a trip edge at its bottom side (flat steel), a second lever is activated that triggers a limit switch. This ensures that the electricity supply to the winch motor is interrupted (see attached sketch). During trial operation on board the vessel the entire system functioned without any problem.

The blocking system described above is installed on many vessels in this or a similar version and has basically proved successful in practice. The system is not known to be susceptible to any particular malfunctions. Despite this a second fatal accident has occurred because the winch motor started despite the fact that the crank handle was in place. It is not yet clear in detail how the accident currently being investigated could occur and why the blocking system failed. However, within the framework of the investigation to date it has been generally ascertained that although the safety system used functions soundly and is suitable for use in practice in every respect, there is at any rate a theoretical possibility that the safety mechanism can be switched off

relatively simply – for whatever reasons and possibly in ignorance of the accompanying dangers. On the one hand it is possible to unscrew the latching lever quite easily – it is only secured to the housing box by a bolt. In addition it is possible by using a little force to push the lever of the limit switch past the trip edge of the latching lever and press it downwards, thus cancelling the current interruption to the limit switch.

On all vessels whose boat launching systems have a mechanism corresponding or similar to that shown in the sketch for blocking the electric winch when a crank handle is mounted, the latching lever should be secured especially, for example by the use of a bolt with a split pin, in order to raise the inhibition level for thoughtless, negligent dismantling by simply loosening the only screw. In addition it is recommended that the flat steel beneath the latching lever (trip edge) be extended in order to make it impossible to force the limit switch lever past the latching lever.

In addition a weatherproof, permanent warning (sticker or the like) should be affixed both in the area of the crank and close to the winch switch drawing attention to the fact that winch operation with the crank handle in place can involve the risk of fatal injury and is strictly prohibited."
