Investigation Report 176/05

Serious marine casualty

Engine Room Fire on Board MV LIBRA RIO GRANDE on 23.05.2005 in the Port of New Orleans

15 November 2006

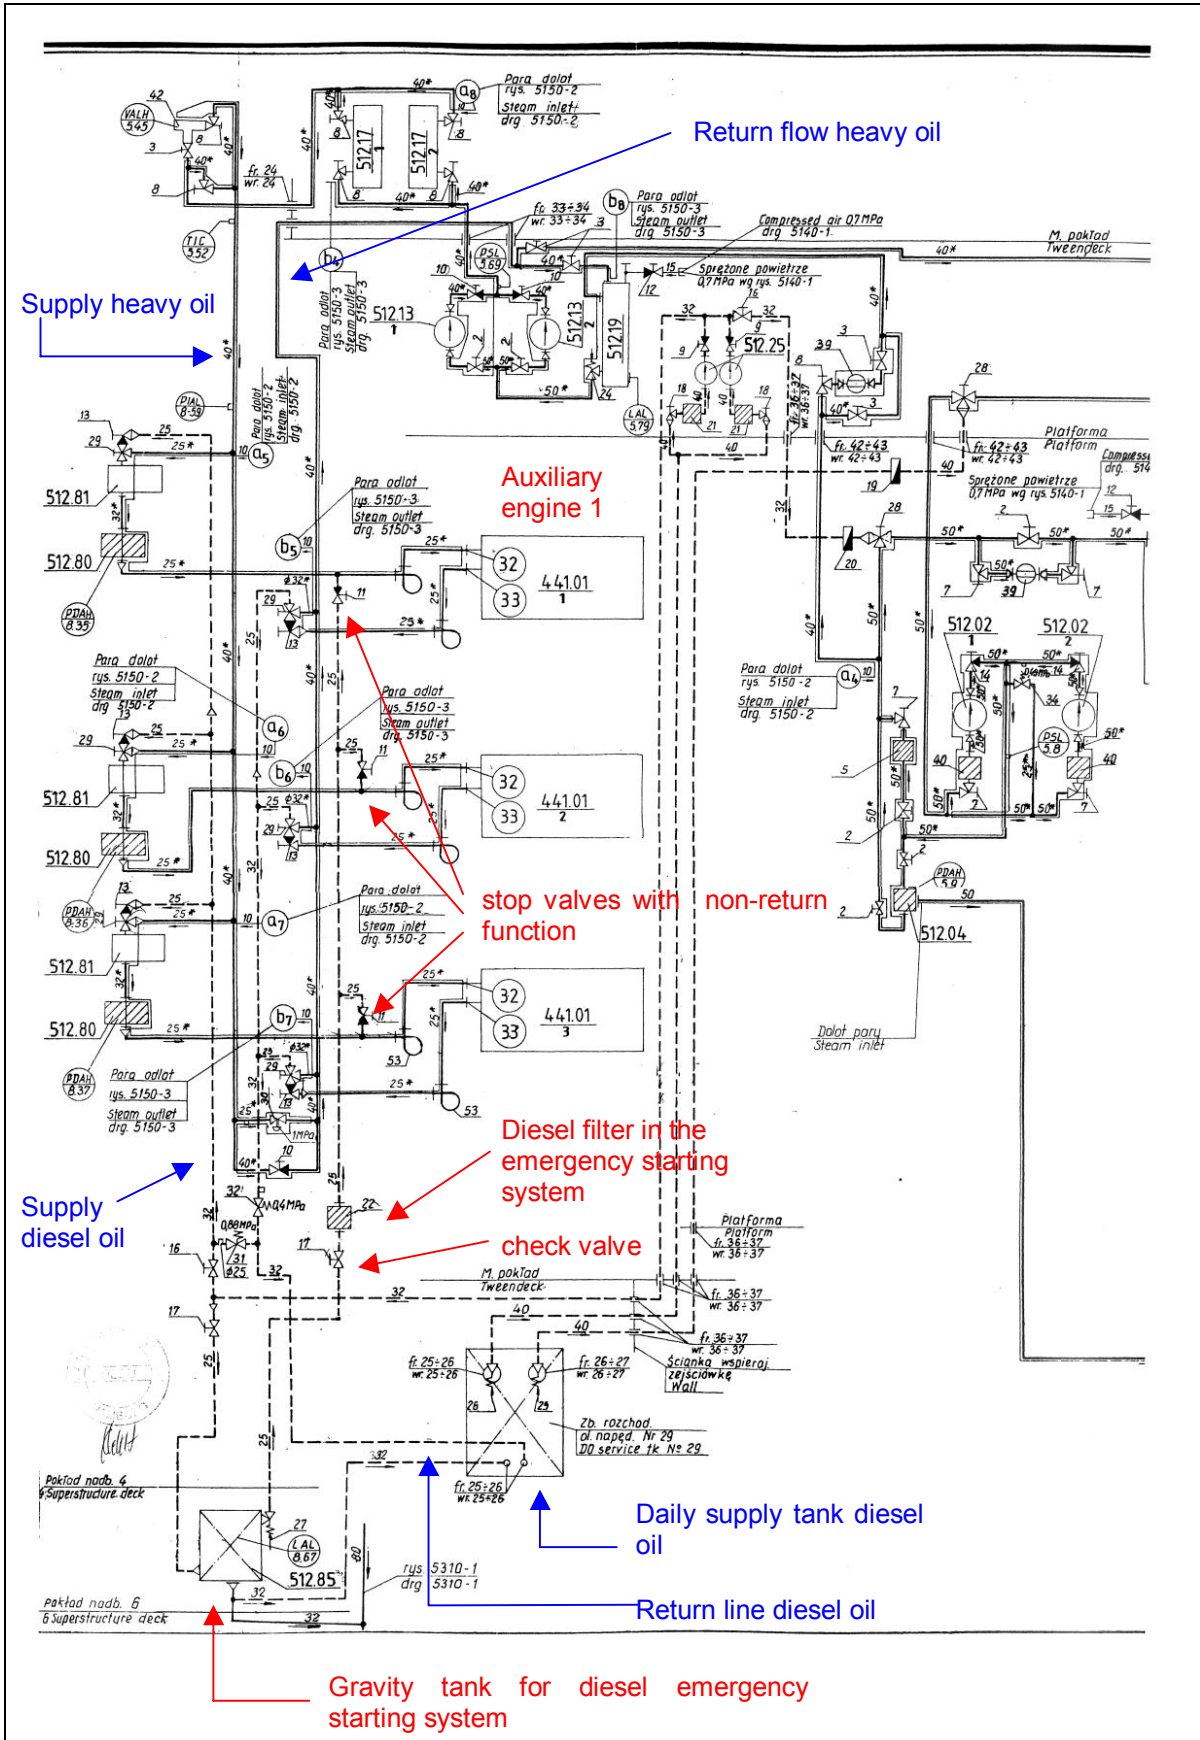
Figure 4: Piping and instrumentation plan of the fuel system of the auxiliary diesel engine

The auxiliary engines can be operated optionally with heavy oil or diesel oil. Fig. 4 shows the piping and instrumentation plan of the fuel supply system of the auxiliary engines.

There is only one valve and one filter between the gravity tank and the auxiliary engines. According to the RI plan the emergency system is separated from the normal system operated at a higher pressure through a non-return stop valve.

possible in the pipe section between the stop valves and the check valve at the filter when the check valve is closed and one of the three stop valves fails.

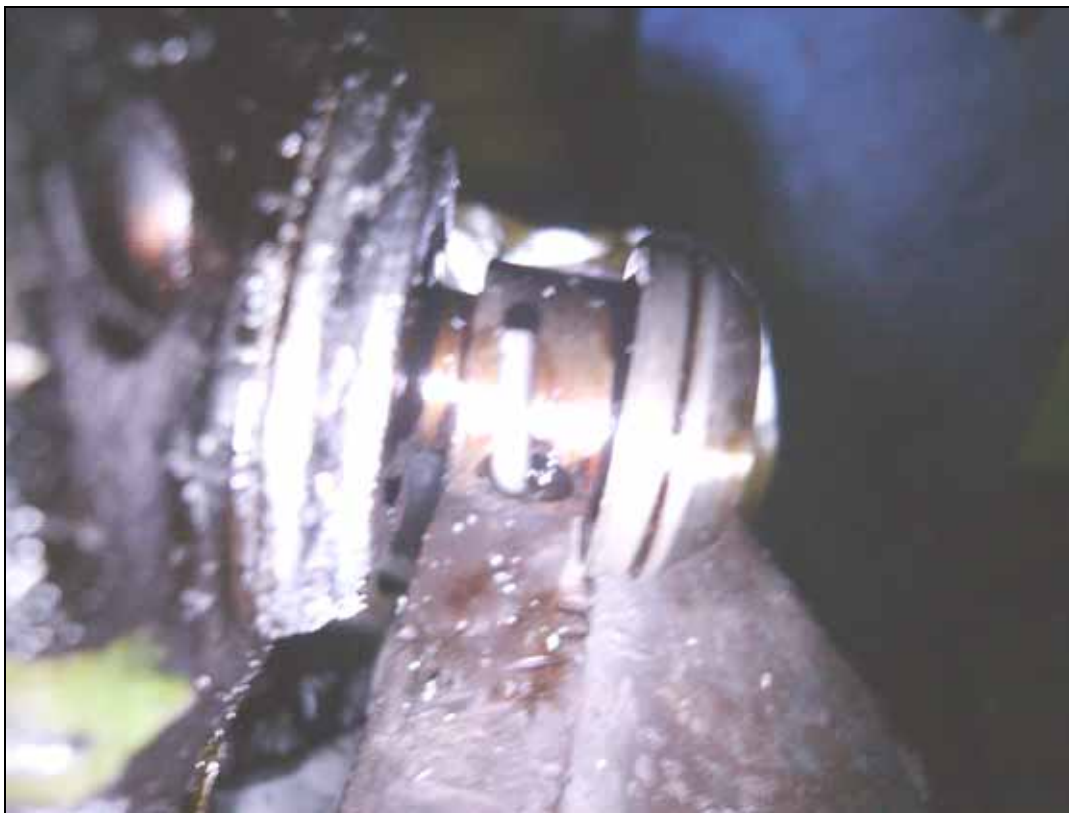
The components of the emergency starting system (the stop valves with non-return function and the filter) were removed and dismantled. It was ascertained that the cones on the spindles of all the subject stop valves were secured with a wire and that the cone was thus strongly restricted in its movability (see Fig. 5 and 6). There was no spring on the spindle. Evidently there was no non-return function as the valve cone was carried with the spindle and raised from its seat when the valve was opened. Thus all the stop valves at the separating point from the normal system to the emergency system did not correspond to the specification of the piping plan. The crew had been unaware of this circumstance.

The investigators had the impression that the securing of the cones with wire on the spindle had not been carried out by the original manufacturer. The crew were unable to provide any information in this respect.

Figure 5: Cone secured with wire

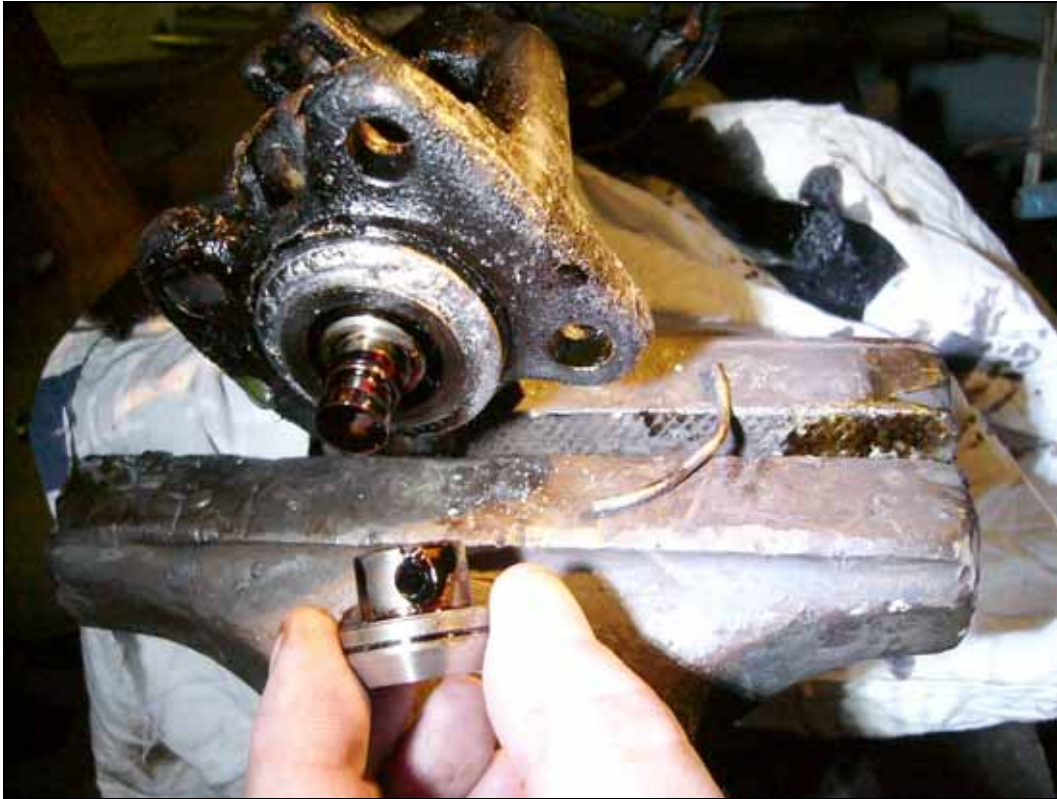
Figure 6: Wire removed and cone drawn off

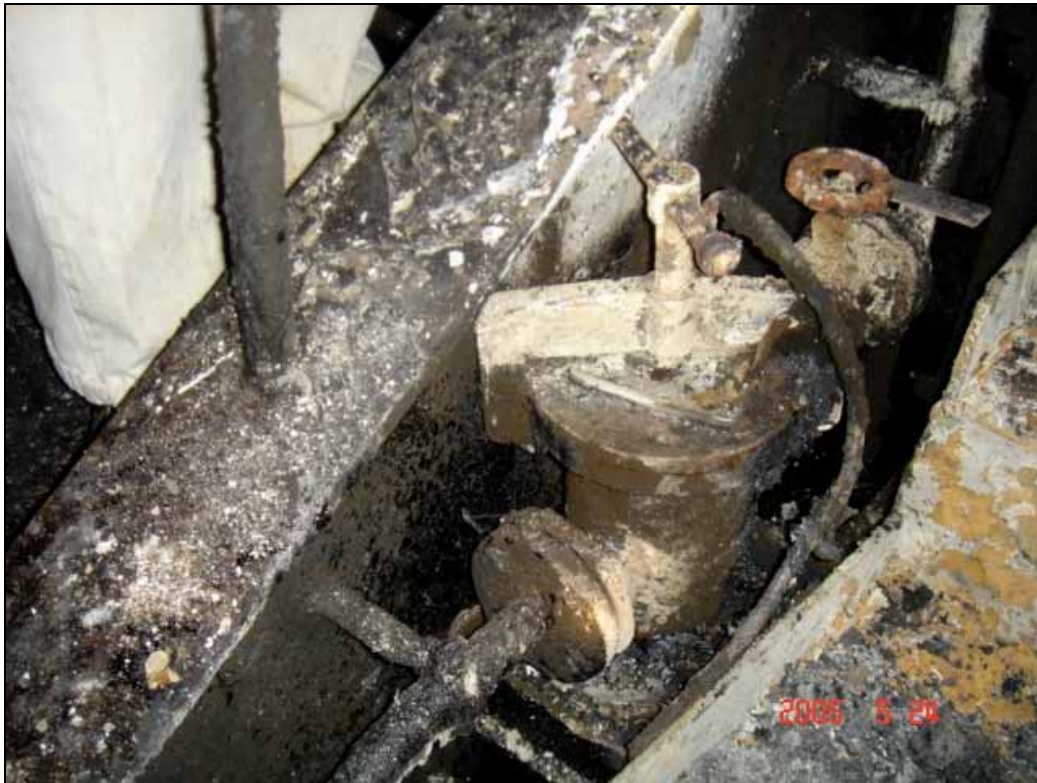
After dismantling of the diesel oil filter it was diagnosed that the seal was completely burnt out. Two other filters of the same type were opened for purposes of comparison. It was ascertained that a T-shaped rubber material had been used for the seal. The filters were designed for contact with diesel oil, a temperature of 35 to 40°C, and a pressure of 0.4 MPA.

Figure 7: Diesel oil filter in the emergency system

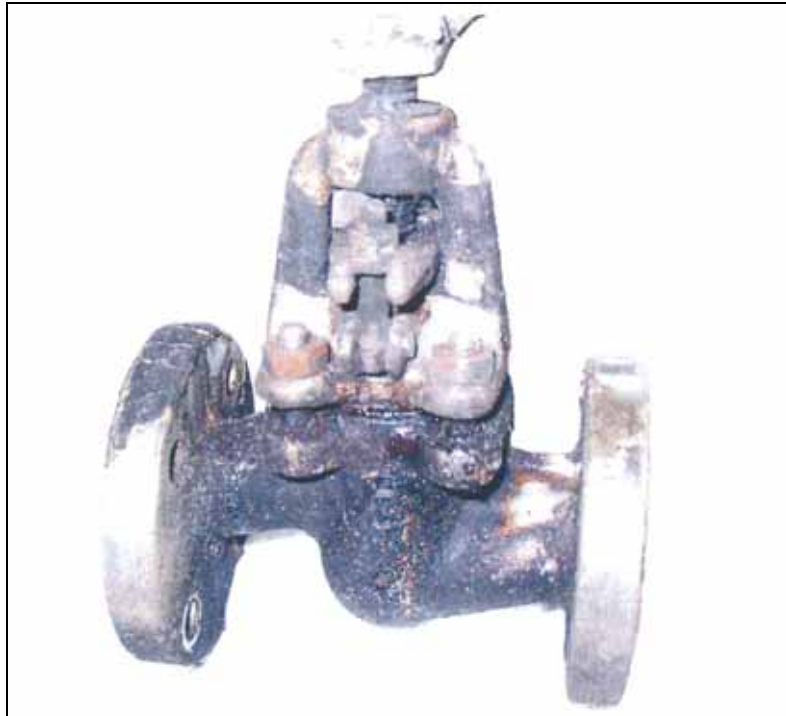
Figure 8: Valve in the condition on delivery

Photo 2 (Fig. 8) shows the valve in the condition on delivery. The valve was dismantled and all parts were cleaned with a cleaning agent. The coats of paint on the housing were removed mechanically in order to make any marks visible. Photo 3 (Fig. 9) shows the valve after dismantling and cleaning.

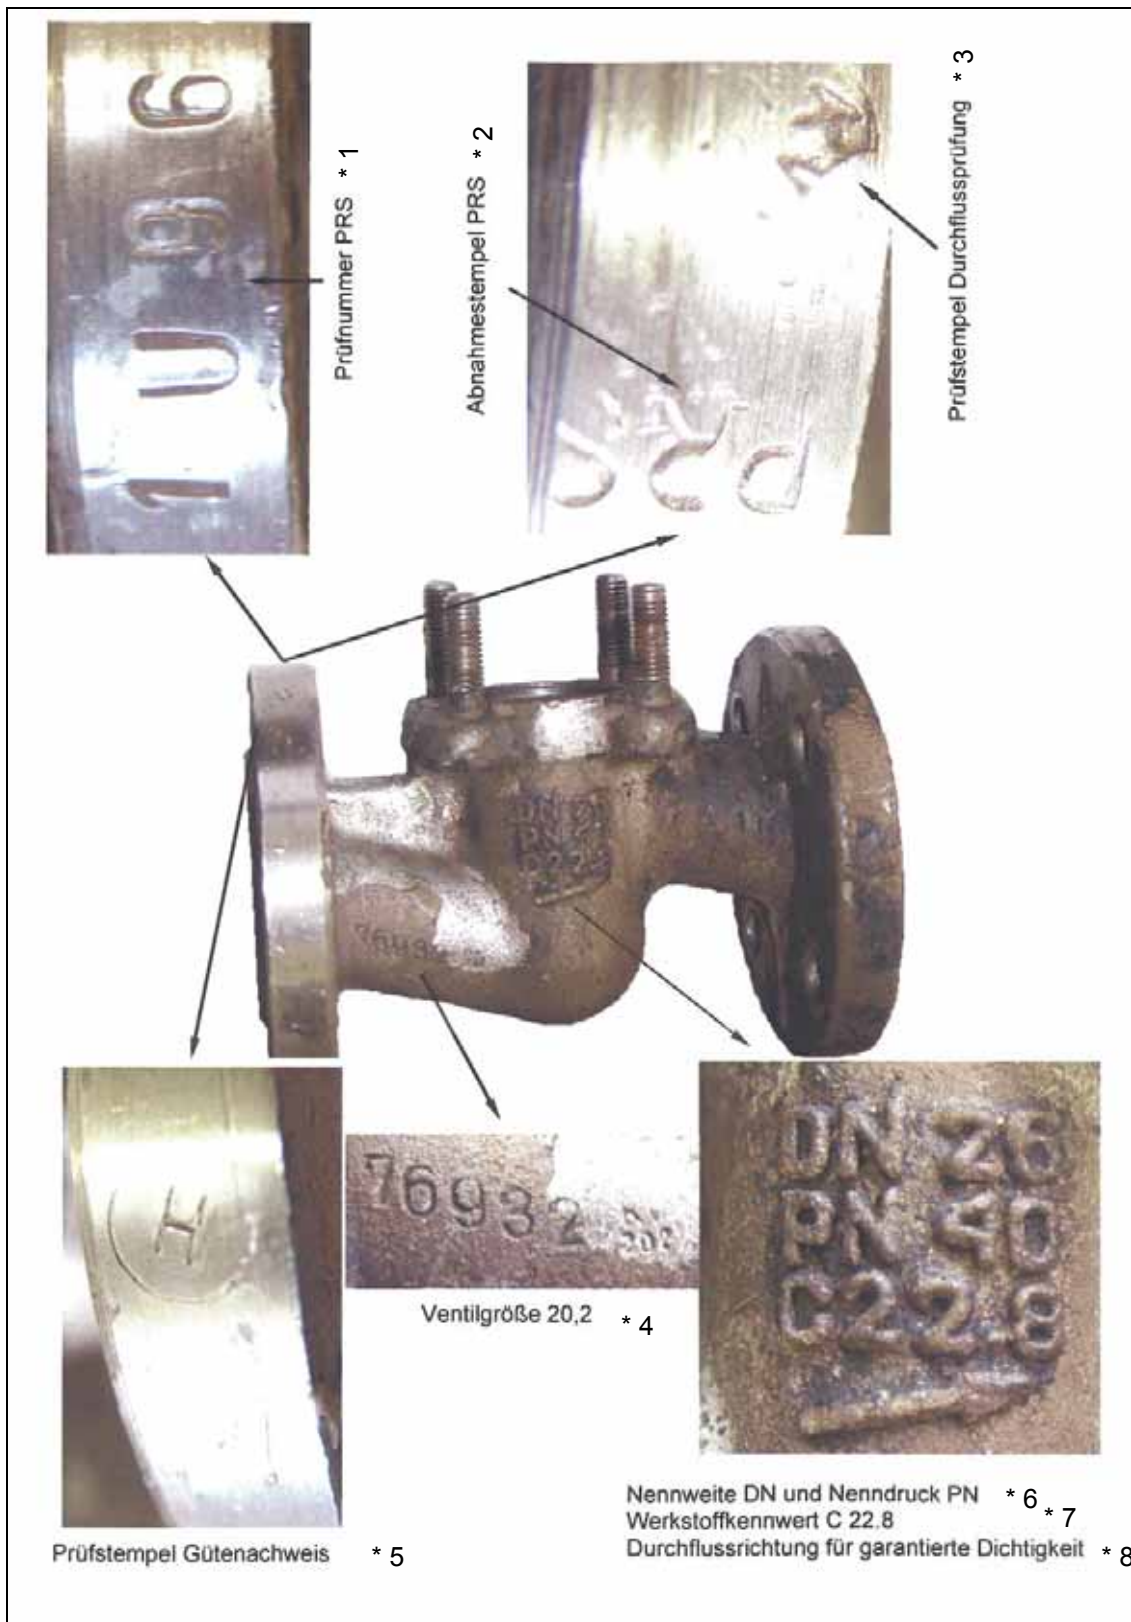
Figure 10: Markings on the valve

The cast and mechanically applied marks ascertained after completion of cleaning of the valve body are shown in Photo 4 (Fig. 10).

- *It is evident from the marking on the housing - see Photo 4 (Fig. 10) that the valve with nominal width ND 25 is made of cast steel and in accordance with DIN 2401, Part 2, is licensed for a nominal pressure NP 40 (40 bar).*

- *Judging by the thickness of the coat of paint that had to be removed on cleaning of the valve in order to make the marks visible, it is to be assumed that the valve was installed already when the vessel was built.*

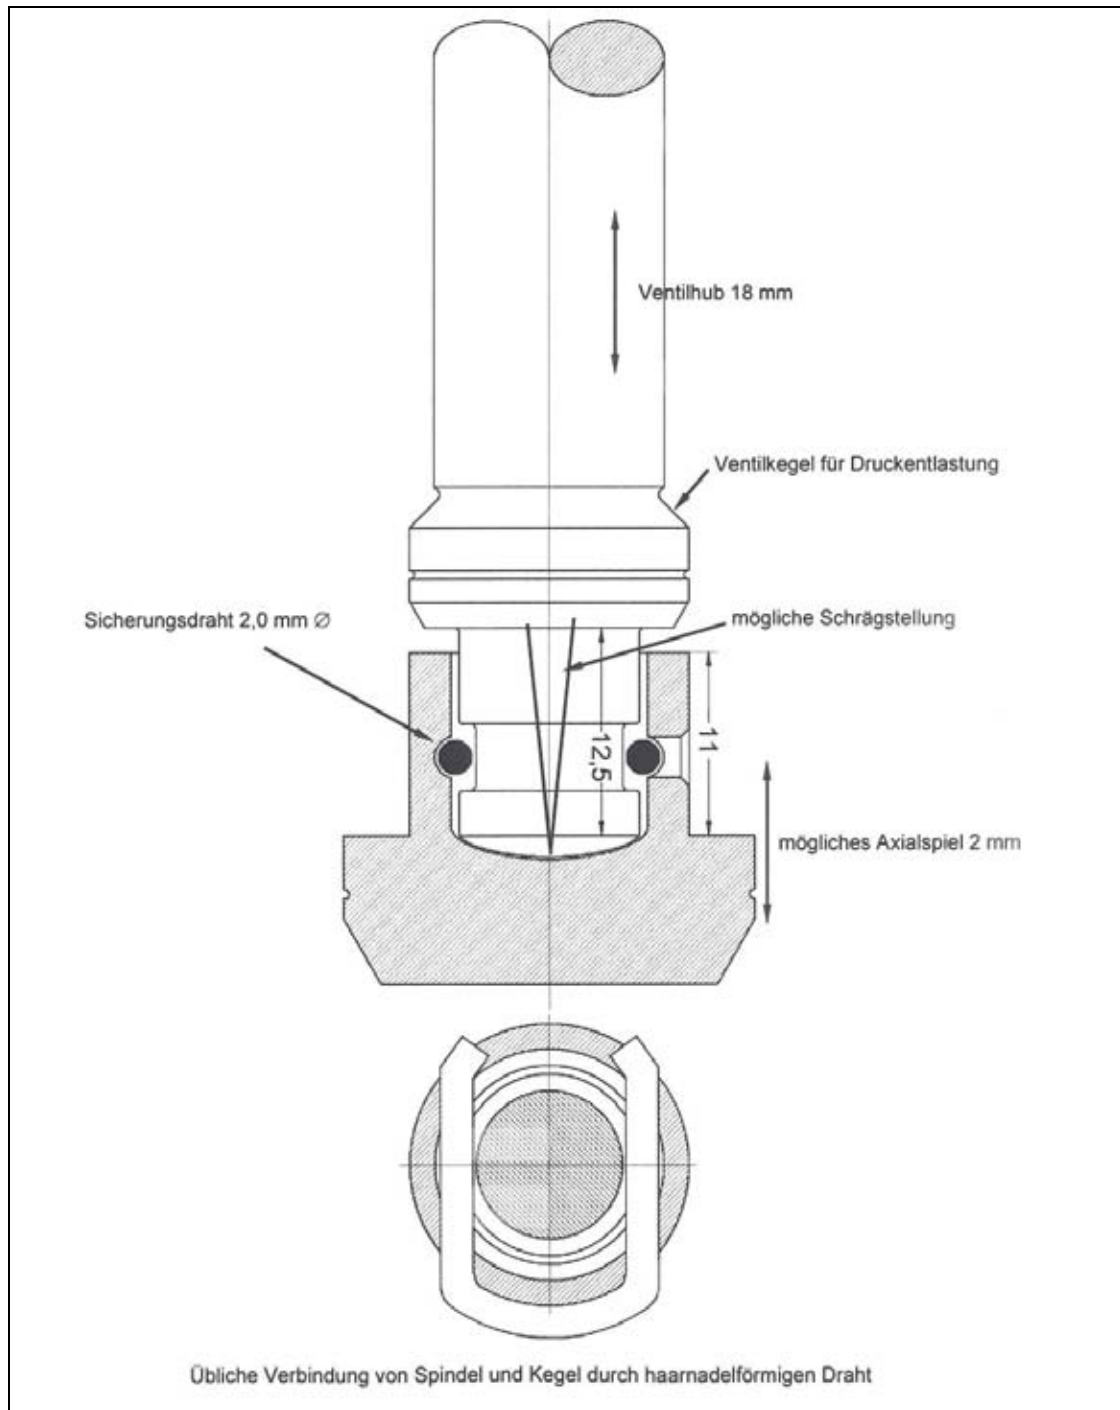
Figure 11: Dimensions on the valve

A maximum axial play of 2 mm and a maximum possible inclination of $\pm 3^\circ$ was ascertained on the cone fixed on the spindle by steel wire with a diameter of 2 mm.

After the securing wire had been removed, the spindle and the bore of the valve cone were measured. The measuring results are listed in Figure 5 (Fig. 11).

- *In valves of this kind fixing the cone with steel wire is certainly customary, but generally a hairpin-shaped wire is used for this purpose (see Fig. 11). With the pressed-in wire made of heat-resistant material the valve cone was fixed securely.*
