MAIB SAFETY BULLETIN 1/2009

Catastrophic Failure of High Pressure
Hydraulic Anchor Windlasses

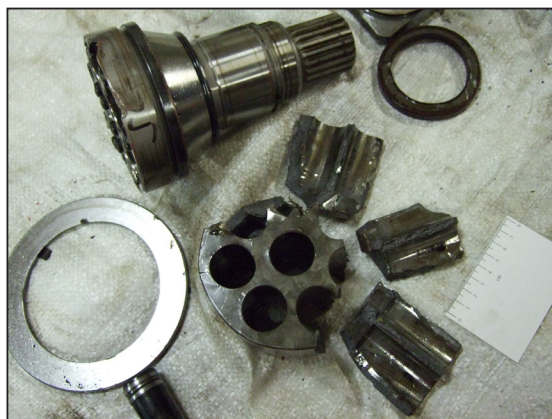
- On 23 March 2009, the hydraulic motor of the TTS Kocks high pressure windlass on board the Bahamas registered crude oil tanker *Stellar Voyager* exploded as the vessel attempted to weigh anchor in Tees Bay, UK. With the wind gusting up to 30 knots and a 2m swell, the anchor chain was under considerable tension. The windlass motor was in the 'heave' position but the anchor chain had started to render or pay out. When the windlass motor casing shattered, the windlass operator was seriously injured by debris, some of which was thrown as far as 40m. This accident is being investigated by the MAIB and the Bahamas Maritime Authority.

Preliminary findings of metallurgical examination of the failed components recovered from *Stellar Voyager* have identified:

- There is no evidence of damage caused by fatigue, metallurgical defects or impact.
- The toughened steel cylinder and pistons of the axial piston displacement motor had been subjected to extremely high internal pressures.
- Signs that the outer cast iron casing had fractured under extreme internal pressure and on impact with broken components of the hydraulic motor.

2009/140S Identify the technical reasons for the catastrophic failures of its windlass motors and determine engineering and design solutions to prevent similar accidents on board vessels fitted with its equipment.
