# Bundesstelle für Seeunfalluntersuchung Federal Bureau of Maritime Casualty Investigation

## **Safety Recommendation with respect to wooden masts**

## **Fatal accident on board the sail passenger vessel AMICITIA off the port of Harlingen/Netherlands on 21 August 2016**

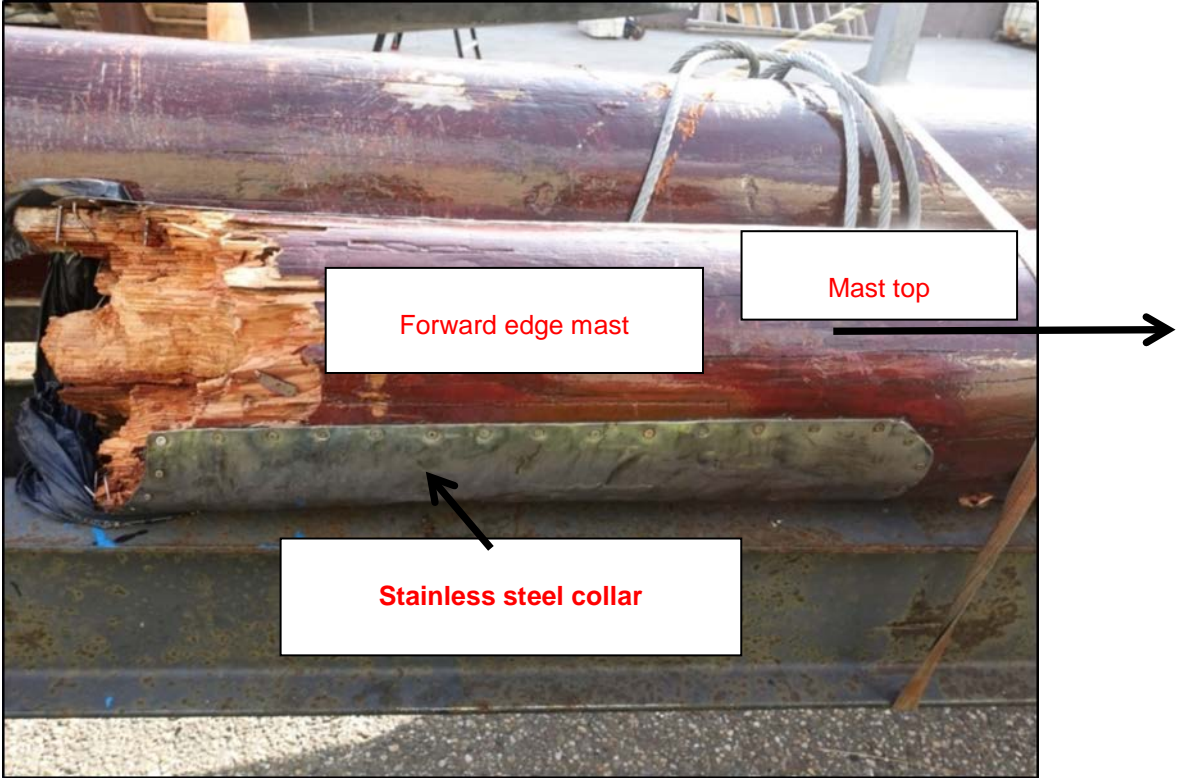
The wooden fore mast had a total length of about 19.50 m. The breaking point was about 12.55 m far from the pivot point of the Mastkoker-bolts. At the breaking point, the mast had a circumference of 96 cm and a diameter of 30 cm, respectively. The breaking point of the mast is located at the lower edge of a non-circulating, bolted stainless steel collar.

Upper part of the mast fallen down

This accident could as well have occurred on a German ship or in German territorial waters. For this reason, the BSU calls upon the ships owners and operators of ships equipped with wooden masts. These masts should be checked with respect to their strength, particularly on ships with a gaff rigging.

Chapter 15 a – Special Provisions for sail passenger vessels – according to the Directive 2006/87/EG – should be adhered to as minimum standard for the masts, the rigging and their inspection.

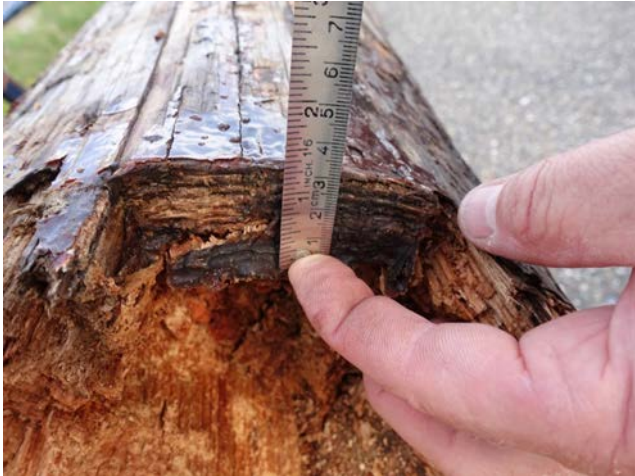
Unprofessional repairs, that were invisible, were obviously carried out at the mas below the stainless steel collar. Altogether, at least 4 wooden wedges were found in this part. There were apparently used to repair foul and abraded parts, respectively.

Wooden wedges

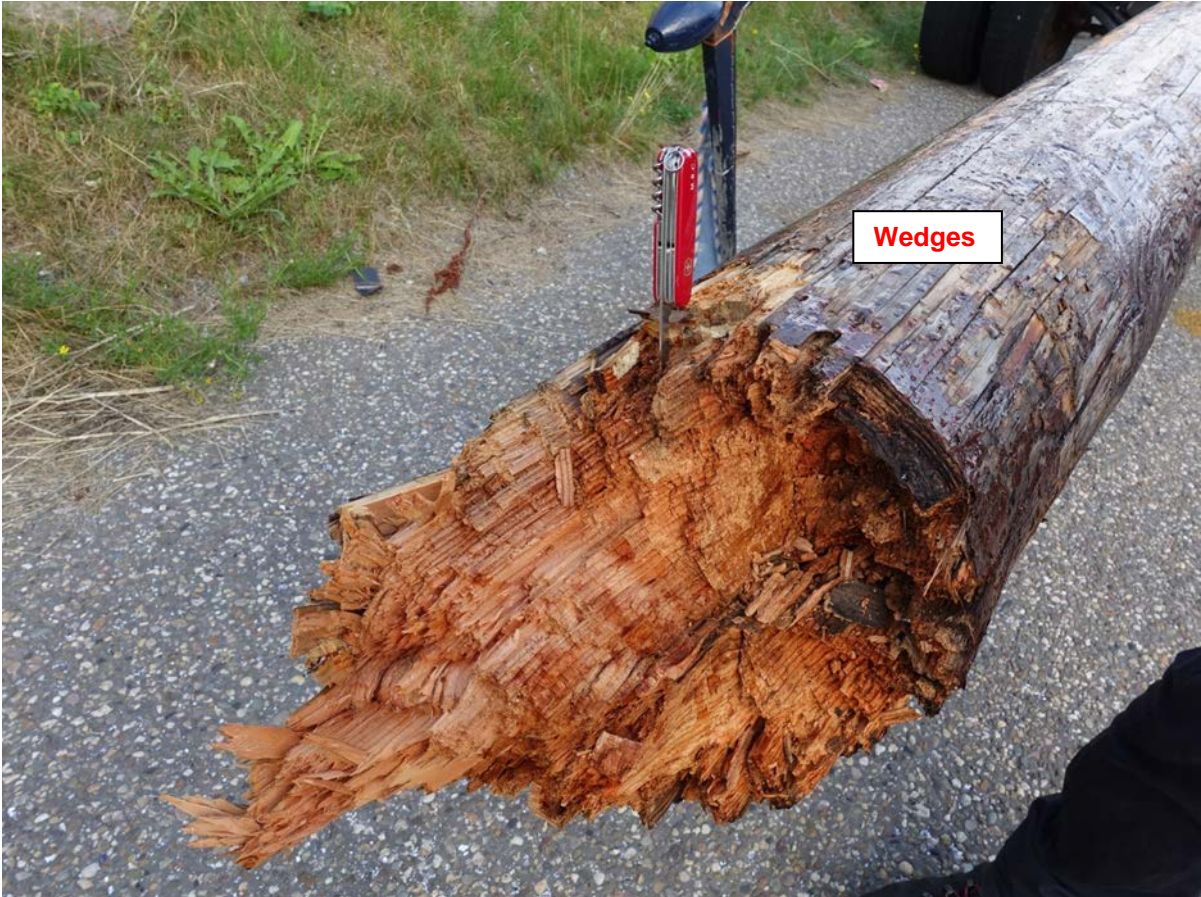
Additionally, water could accumulate below the stainless steel collar, leading to the core getting foul. In all likelihood, these repairs and the water ingress resulted in the fact that only 25% of the original mast cross section was available for the strength.

Breaking point on the remaining part of the mast.

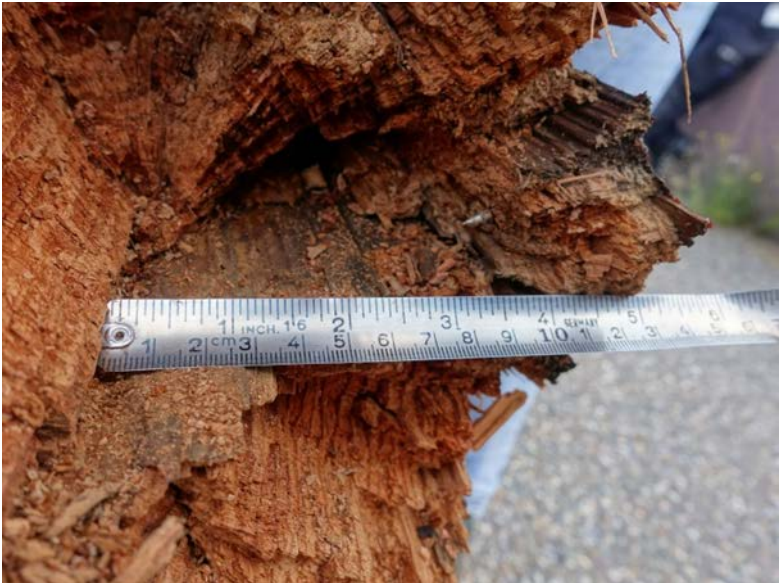
Moisture beyond the core

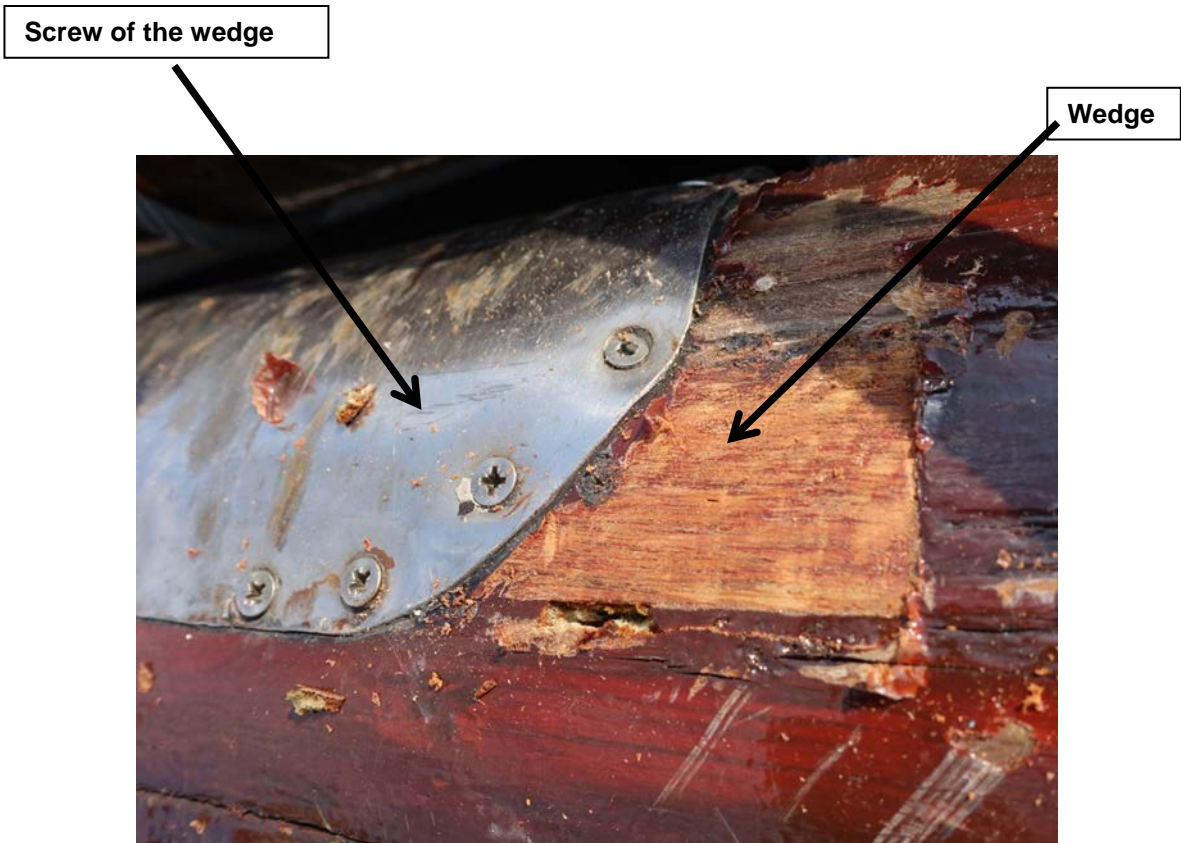
Mast mended with wedges
