SAFETY CAMPAIGN

2019

PILOT LADDER SAFETY SURVEY 2019

IMPA Safety Survey 2019

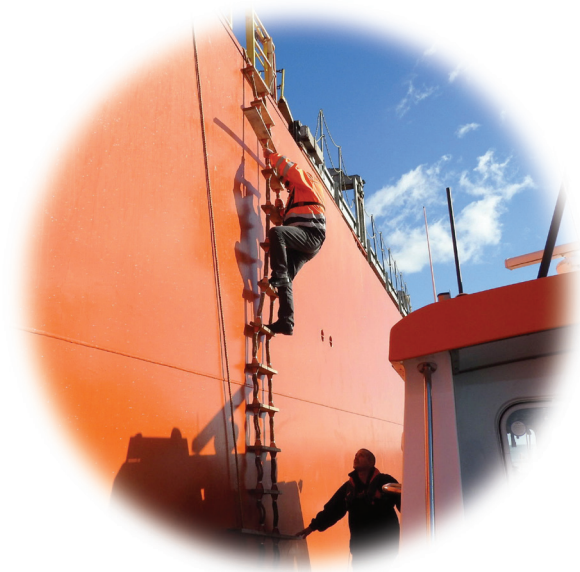
COMPLIANCE BY REGION

The chart below shows 4,225 returns from participating IMPA members which have been grouped into 6 geographical areas. The total non-compliance is shown as a percentage of total returns from each region and as a total.

COUNTRY	TOTAL RETURNS	COMPLIANT	NON COMPLIANT	NON COMPLIANT AS %
Africa	43	31	12	27.91
Asia / Oceania	886	769	117	13.21
Europe	1743	1466	277	15.89
Middle East	4	2	2	50.00
North America	209	173	36	17.22
South America	1340	1241	99	7.39
TOTAL	4225	3682	543	12.85

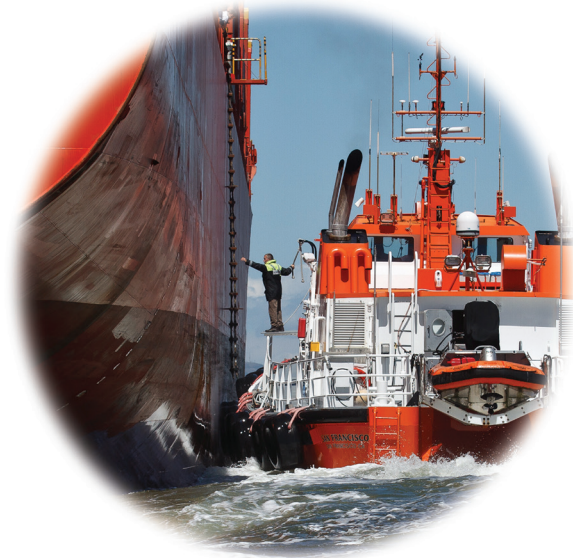
COMPLIANCE BY VESSEL TYPE

The following chart shows a break down of all returns by vessel type. Both the number and the percentage of non-compliant vessels by type are shown.

VESSEL TYPE	TOTAL NUMBER OF VESSELS	COMPLIANT	NON COMPLIANT	NON COMPLIANT AS %
General Cargo	667	584	83	12.44
Oil Tanker	595	511	84	14.12
Ro/Ro	146	127	19	13.01
Passenger	178	168	10	5.62
Container	1106	991	115	10.40
Gas Tanker	194	172	22	11.34
Reefer	21	18	3	14.29
Fishing	19	12	7	36.84
Bulkcarrier	707	594	113	15.98
Chemical Tanker	276	246	30	10.87
Car Carrier	95	85	10	10.53
Rig Supply Vessel	71	59	12	16.90
Other (E.G. Navy)	206	169	37	17.96

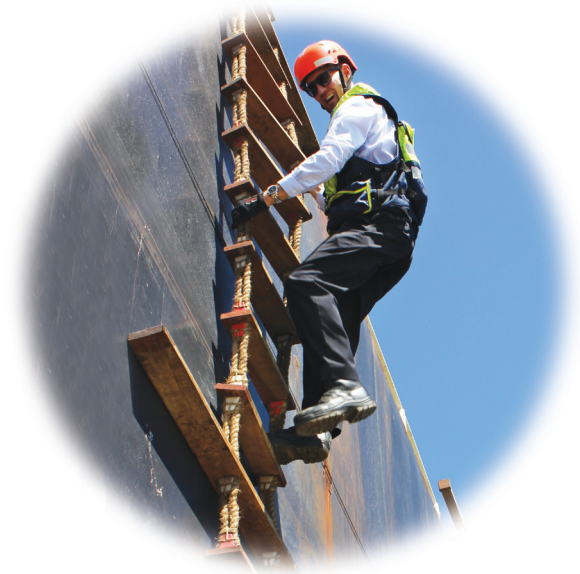
COMPLIANCE BY MEANS OF TRANSFER

The following chart shows a breakdown of all returns by means of transfer. Both the number and the percentage of non-compliant means of transfer by type are shown.

MEANS OF TRANSFER	TOTAL NUMBER	COMPLIANT	NON COMPLIANT	NON COMPLIANT AS %
Pilot Ladder	2764	2410	354	12.81
Combination	885	753	132	14.92
Side Door and Pilot Ladder	361	318	43	11.91
Gangway	43	43	0	0.00
Helicopter	113	112	1	0.88
Deck to Deck	124	109	15	12.10
TOTAL	4290	3745	545

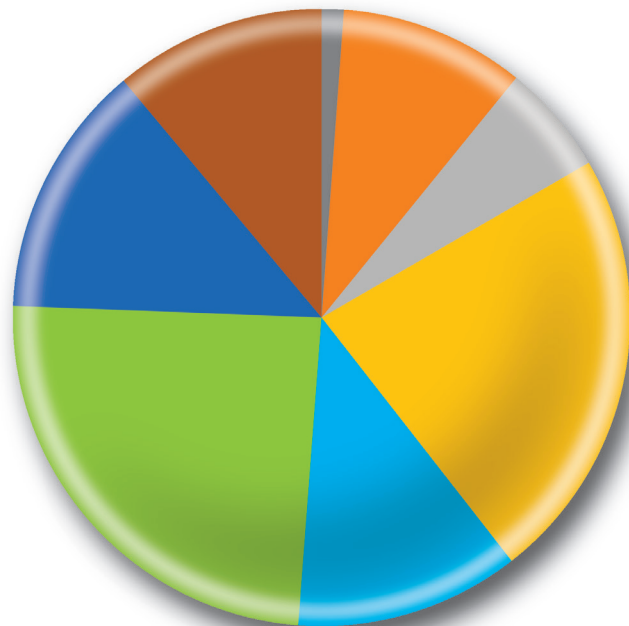
COMBINATION DEFECTS	TOTAL	AS %
Accommodation Ladder not leading aft	2	1.29
Lower platform stanchions / rail incorrect rigged	15	9.68
Accommodation ladder too steep (>45 degrees)	9	5.81
Pilot Ladder not attached 1-5m above Accommodation Ladder	35	22.58
Lower platform not horizontal	18	11.61
Ladder(s) not secured to ship's side	38	24.52
Lower platform less than 5 metres above the sea	21	13.55
Other	17	10.97
TOTAL	155
