Bundesstelle für Seeunfalluntersuchung
Federal Bureau of Maritime Casualty Investigation

Annual Report

June 2023

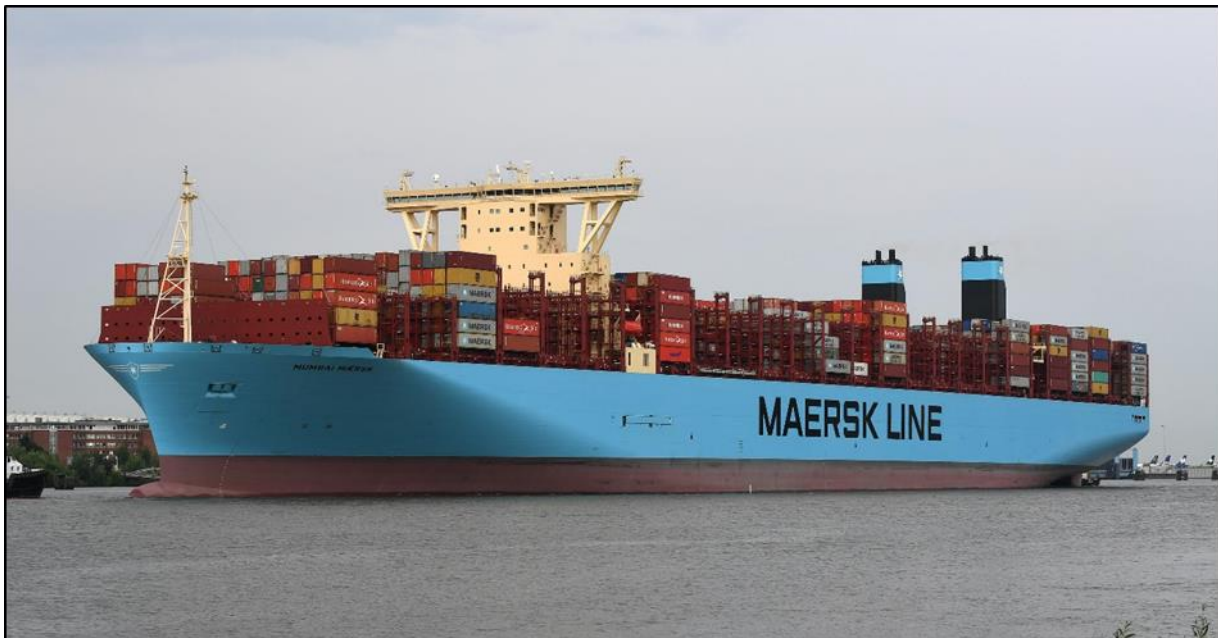
Figure 2: The MUMBAI MAERSK⁹

The first accident concerns an ultra-large container ship (ULCS¹⁰). On 2 February 2022, the 400 m long MUMBAI MAERSK was en route from Rotterdam to Bremerhaven. The ship had chosen the offshore deep water route. During the approach to the narrow fairway section of the Neue Weser, the MUMBAI MAERSK, which had a draught of 12.80 m and was dependent on the tide, was advised by radio that her berth would reportedly remain occupied for longer than planned but that it would soon be vacant. To begin with, the vessel traffic service permitted the ship, which was approaching at 6-7 kts, to cross the boundary of the area. However, she was informed shortly after that it was reportedly still not possible to enter the part of the fairway in which neither a turn nor an encounter between two large vessels is possible without any problems. Shortly before entering this section of the fairway, the ship therefore sailed on a reciprocal course.

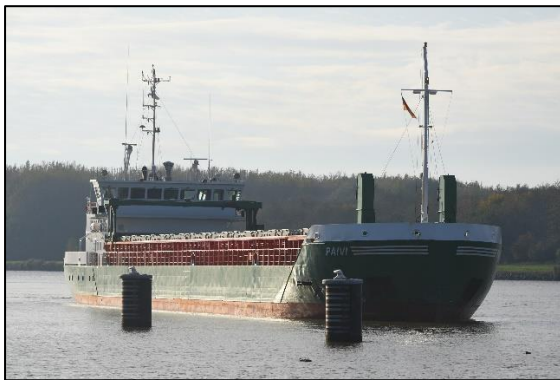
Figure 4: The Cyprus-flagged PAIVI¹²

The collision took place in the area of the bridges at Levensau. The collision occurred because the PAIVI had suddenly left her intended course and turned towards the oncoming BJOERKOE. Due to the close proximity of the vessels, an evasion manoeuvre or effective reduction in speed was no longer possible. Each vessel suffered considerable damage to her fore section during the collision. The bow of the PAIVI was completely deformed. The BJOERKOE's hull was holed above and below the waterline, causing water ingress in the forepeak and bow thruster compartment. Due to the unexpected impact, three of the PAIVI's crew members were injured such that deployed fireboats and ambulances had to transport them to a hospital for the treatment of lacerations and bruises. One of the BJOERKOE's crew members also suffered bruises.

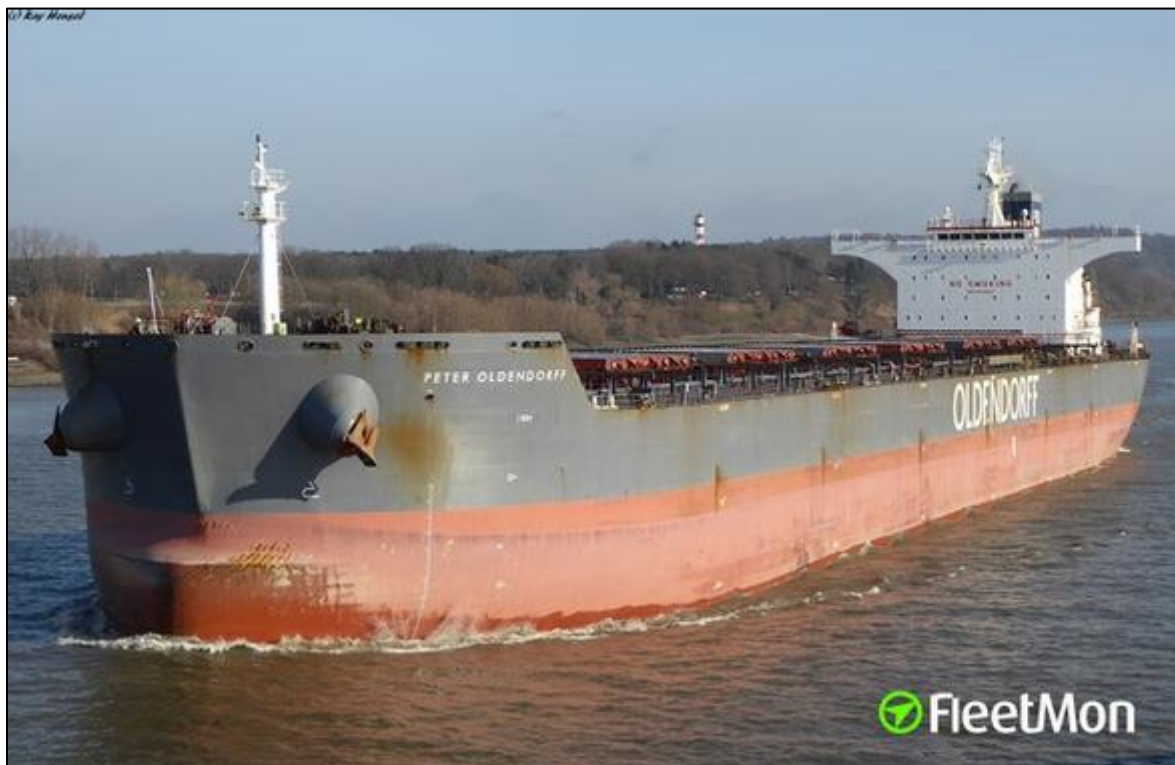
Figure 10: The sailing PETER OLDENDORFF¹⁹

A fatal work accident occurred on August 3 aboard the bulk carrier PETER OLDENDORFF in the ferry port of Mukran while removing a steel plate from a vertically stowed pile. The stack was located in the aft part of the ship's steering gear room. The very heavy plates¹⁸, which cannot be moved by one person, are stored there in order to be able to access raw material for on-board repair work and cut it to size as required.

The crew member involved in the accident, who was working alone in the steering gear room at the time of the accident, had apparently loosened the cross strut that secured the stack to a railing and thus prevented it from tipping over. The stack then tipped to the side. The accident victim was caught by the stack and crushed between it and a shelf mounted on the ship's side at waist level. When the victim was found later, he was already unresponsive. Immediate first aid measures were unsuccessful. The emergency doctor who was called to the scene was only able to diagnose the death of the crew member.

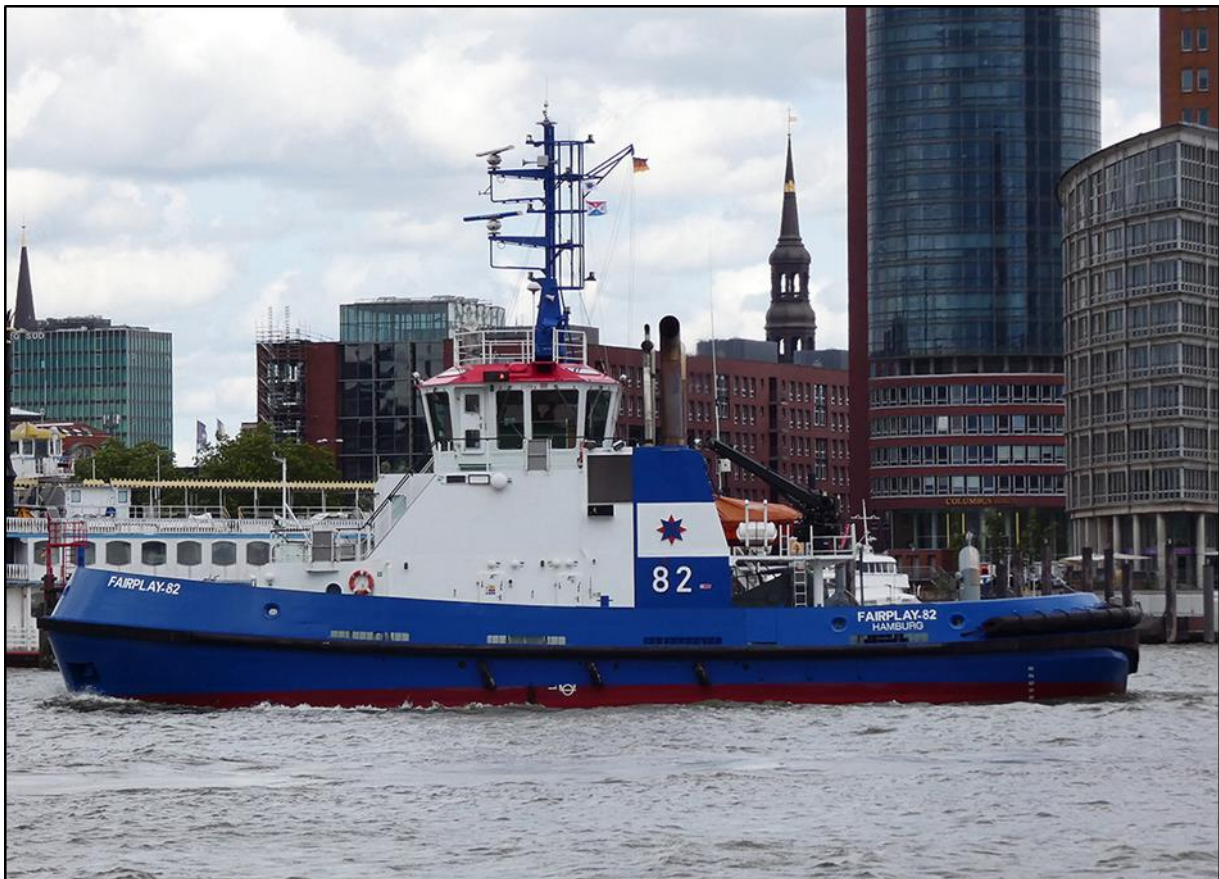
Figure 13: The FAIRPLAY 82 in operation before the accident²²

On the day in question, the seagoing vessel TANG LAND was shifting in the port of Hamburg from the Norderelbpfähle [northern Elbe pilerow] to the Moorburg power station. The tug FAIRPLAY 82 as well as the FAIRPLAY 9 and BUGSIER 9 provided assistance. At about 1730, the towed convoy passed the two open Kattwyk bridges in a south-easterly direction. After this passage, the lift bridges were lowered again to enable rail and road traffic to pass.

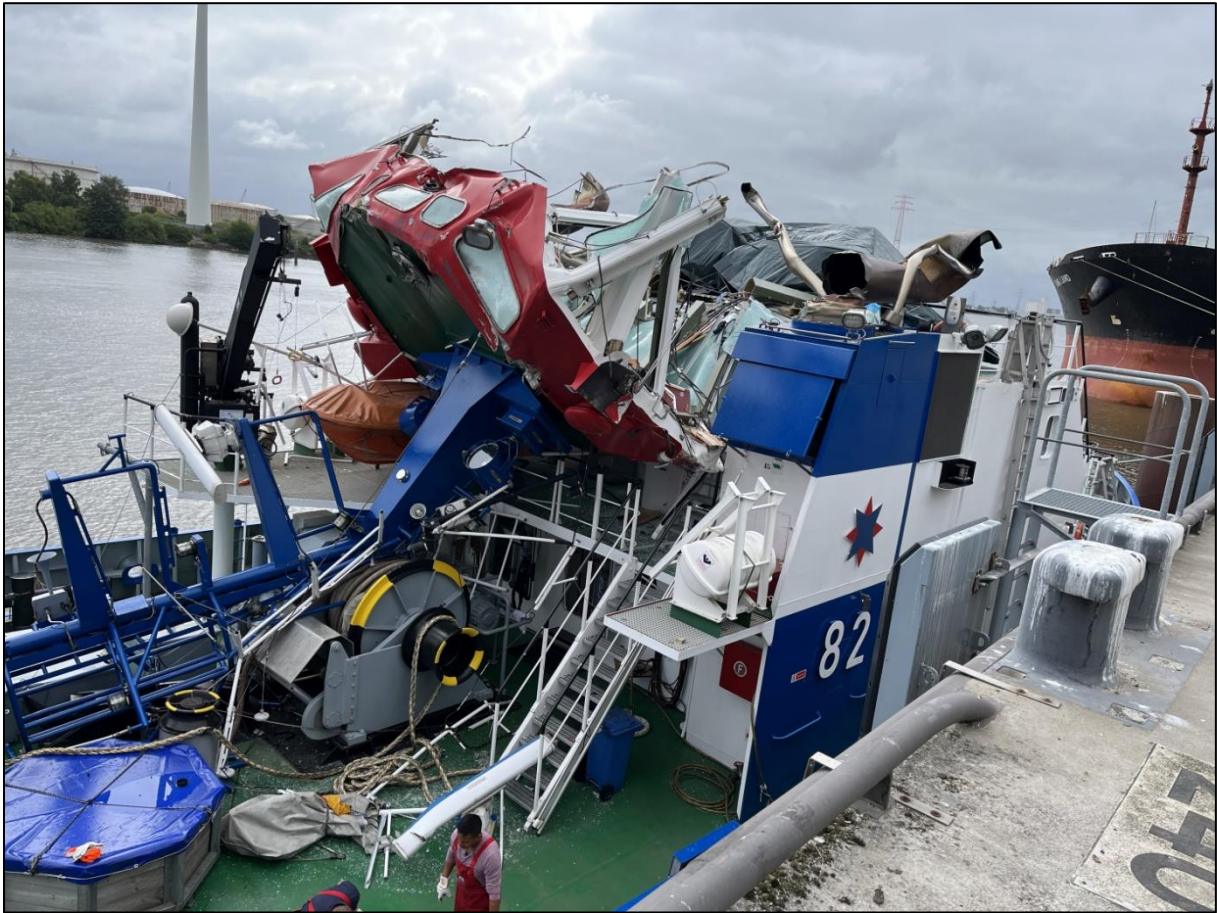
Figure 15: The heavily damaged FAIRPLAY 82 after the collision²⁴

The ship struck the bridge centrally level with the wheelhouse and was pushed underneath. The wheelhouse was literally torn off at waist height and completely destroyed. The people there – the master and his chief engineer – were able to protect themselves by kneeling just low enough to be only slightly injured. The third crew member, a ship mechanic, was in the superstructure and fell down a stairway due to the sudden jolt that went through the ship. During the fall, he also suffered minor injuries.

The BSU assessed the considerable damage on the following day and immediately launched an investigation. It can already be noted that since nobody was seriously harmed, the ship's crew was extremely fortunate, however.

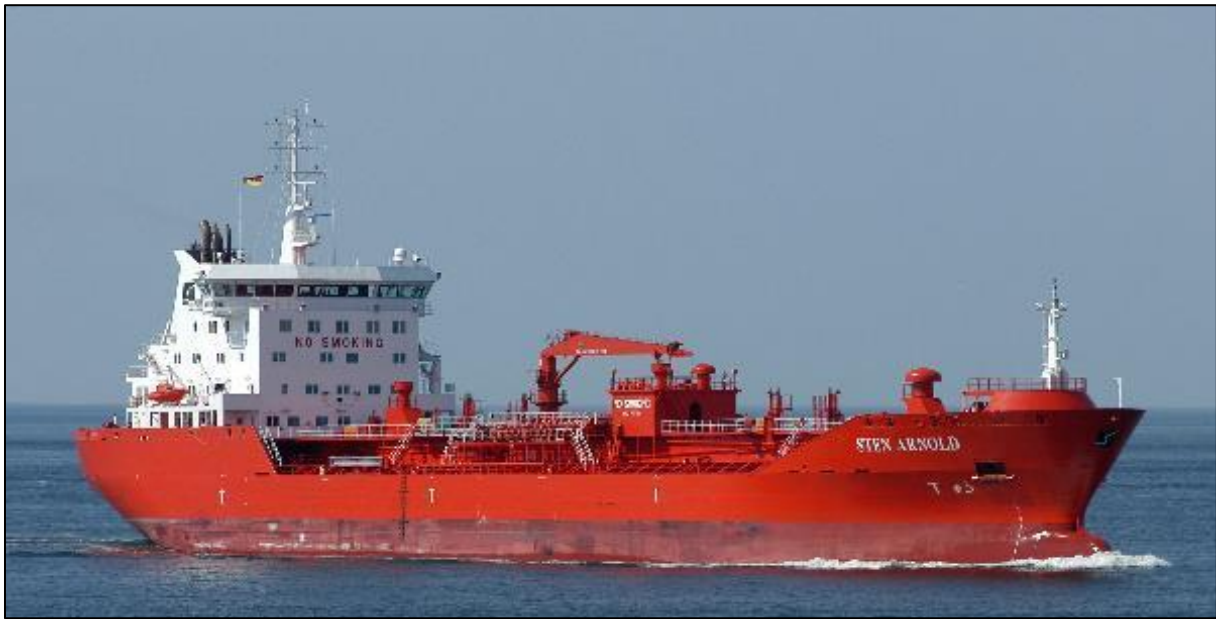
Figure 16: The chemicals and product tanker STEN ARNOLD²⁵

On the day of the accident, the 144 m long tanker, flying the UK-Gibraltar flag and manned by a pilot, was sailing upstream on the River Elbe towards Hamburg in receding water with a draught of 8.5 m. The vessel was sailing on the right-hand side of the fairway in accordance with regulations when she suddenly ran aground level with buoy 63 at a disposal site there. According to the chart and most recent sounding, the water depth at this point should have been more than 12 m. Information about a shoal was neither plotted on the navigational chart, nor was it known about beforehand.

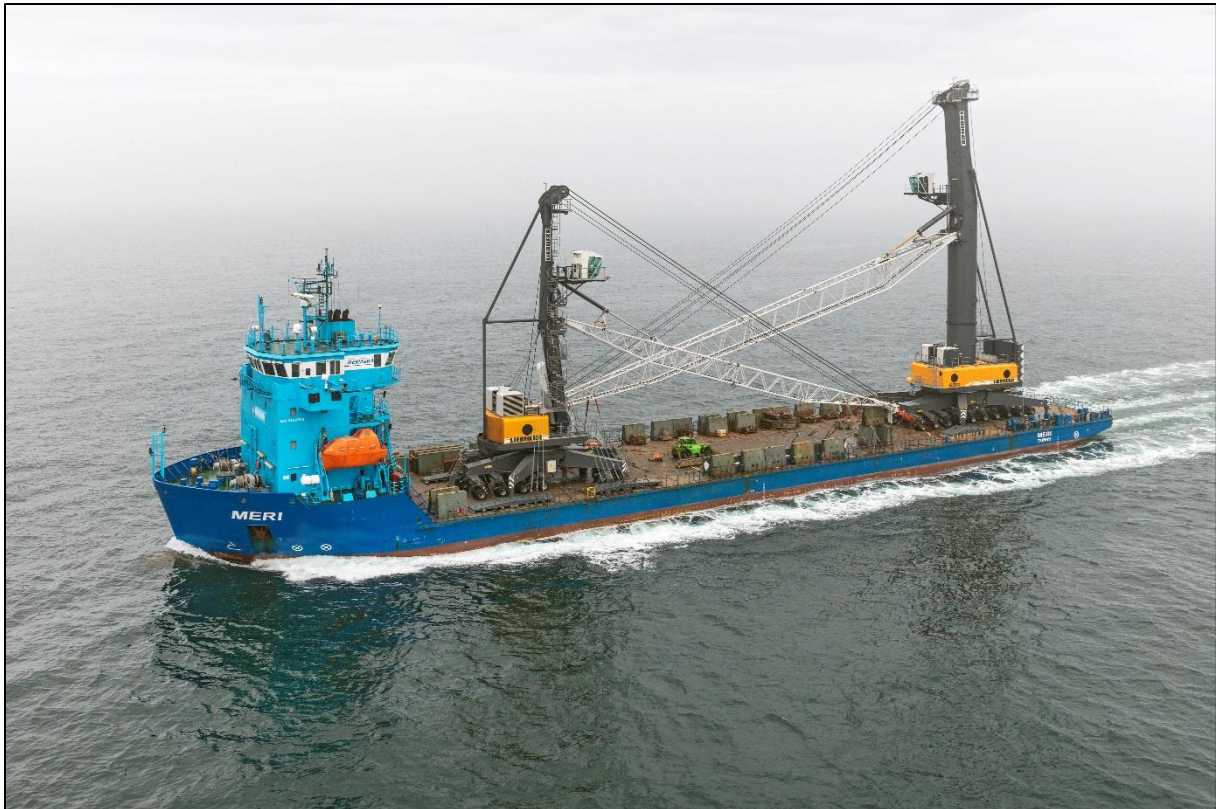
Figure 18: The MERI loaded with two cranes²⁷

The MERI, a heavy-lift vessel flying the flag of Finland, set off from Rostock on 29 November for Esbjerg on the Danish North Sea coast. The cargo was a mobile harbour crane from a crane builder in Rostock, which was destined for the port there. According to the documents available, the height of the ship and cargo was such that she could have transited the NOK safely.

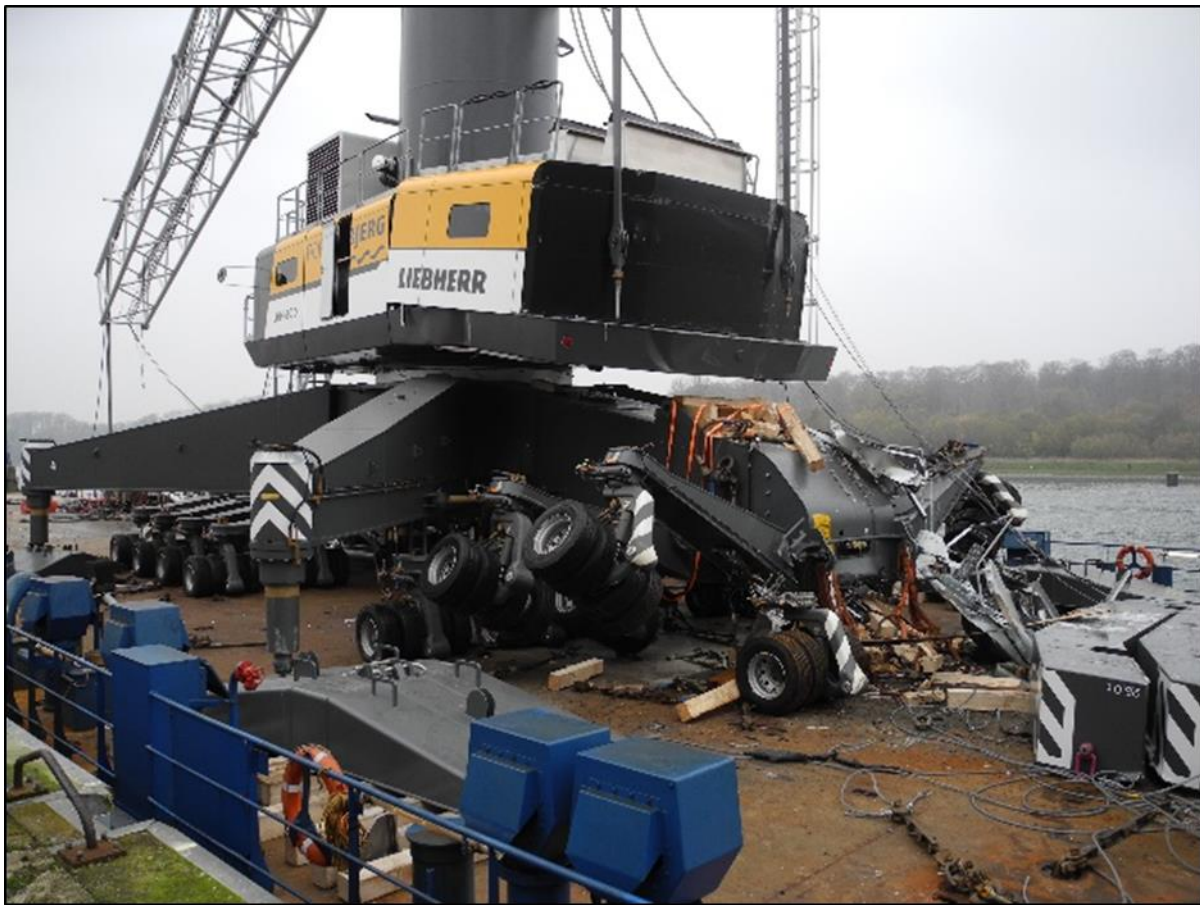
Figure 19: The damaged crane²⁸

While passing the bridges at Holtenau, the top of the tower struck the hollow boxes of both lanes of the bridges. The crane was torn out of its lashing and moved due to the force of the impact. The running gear was destroyed in the process. Also damaged, the MERI's deck was deformed and torn open in places. Three counterweights, each weighing 25 t, went overboard and fell into the NOK. The bridge also sustained considerable damage. The bridge and the NOK were closed temporarily.

The BSU decided to investigate the accident immediately after it happened. Although the primary cause appears to be clear, and even trite, i.e. the ship and loaded crane were higher than stated, the BSU is faced with the question as to how this could have happened and, more importantly, why it was not noticed at any point earlier. The investigation is still ongoing.
