**Bundesstelle für Seeunfalluntersuchung**  
Federal Bureau of Maritime Casualty Investigation

## **2019 Annual Report**

**June 2020**

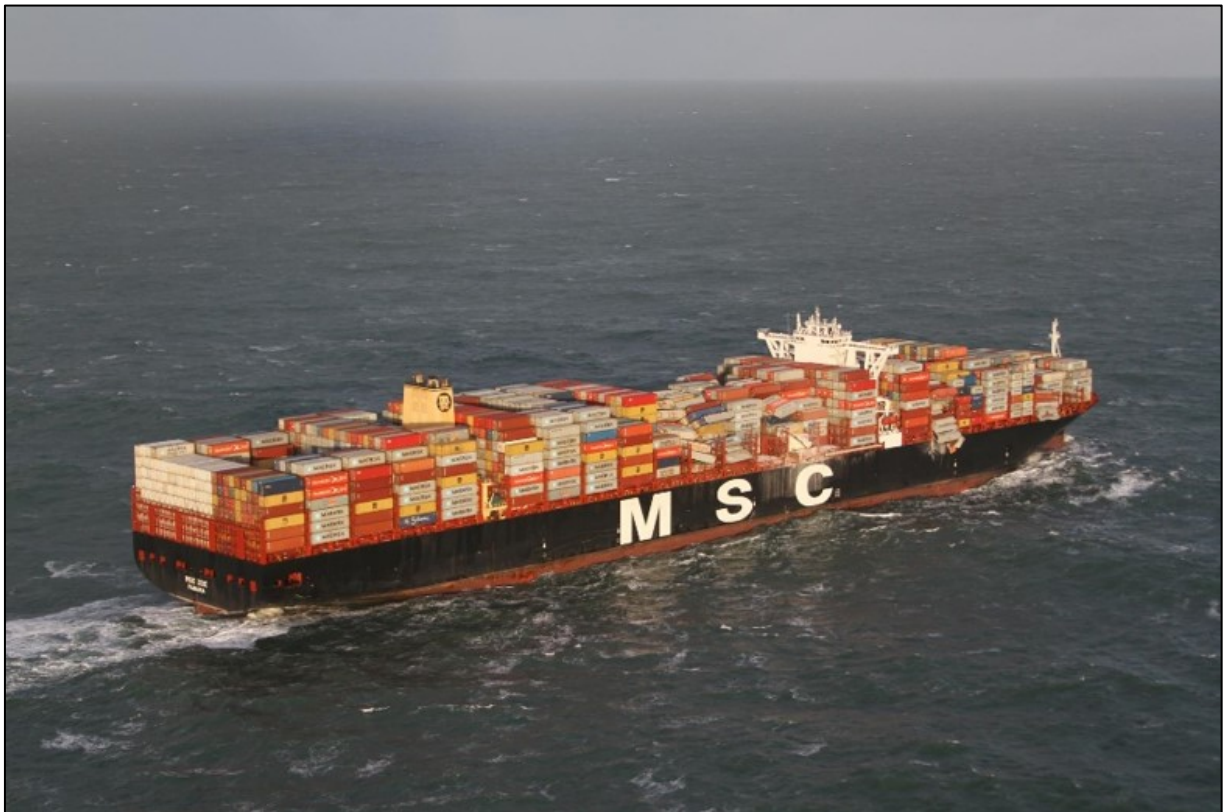
Figure above: The MSC ZOE sailing for Bremerhaven. The damage is clearly visible. (Source: CCME)

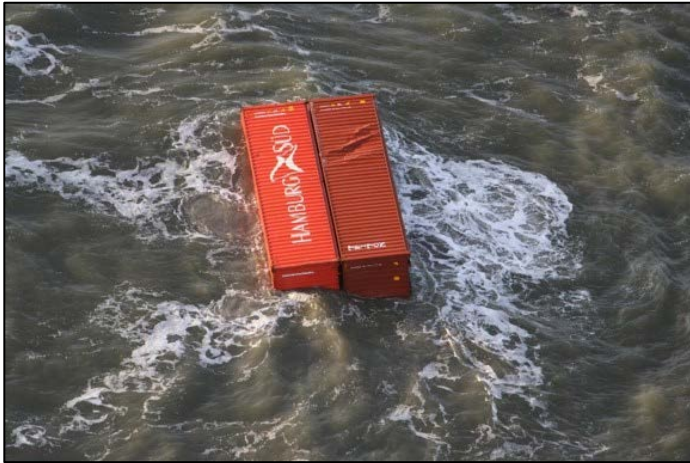
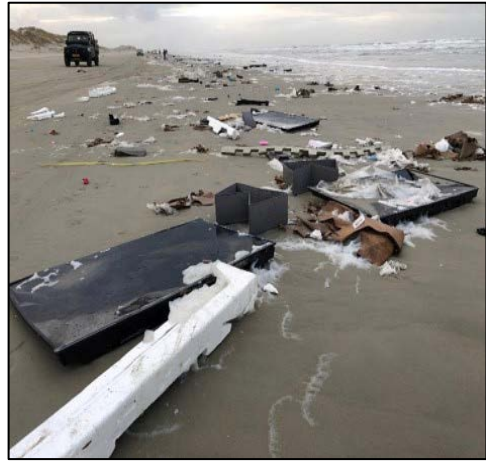
Most of the containers burst open when they struck the water and their contents were washed into the sea or sank there and then. The majority was washed up on the beach in the Netherlands and a smaller part on the German North Sea island of Borkum, causing considerable pollution there.

Figure above left: Containers floating in the North Sea (Source: CCME)

Figure above right: Beach at Ameland in the Netherlands after the accident (Source: DSB)

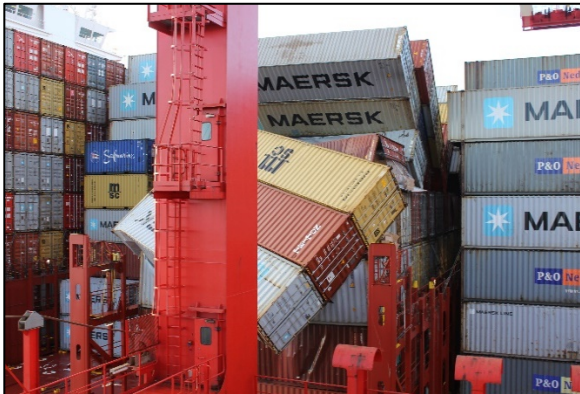
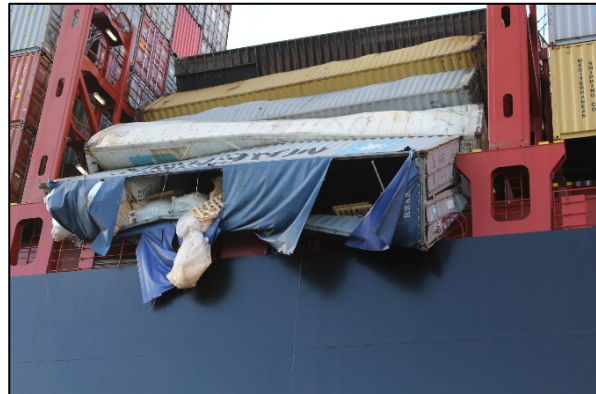
The MSC ZOE sailed into Bremerhaven that same night. Investigators from the BSU were on board soon after together with their Dutch and Panamanian colleagues and carried out an initial assessment. The damage was considerable. Entire stacks had been torn from their anchorage, toppled over, slipped or wedged into one another. Many more containers could have gone overboard.

Figure above: Damage on board the MSC ZOE (Source: CCME and BSU)

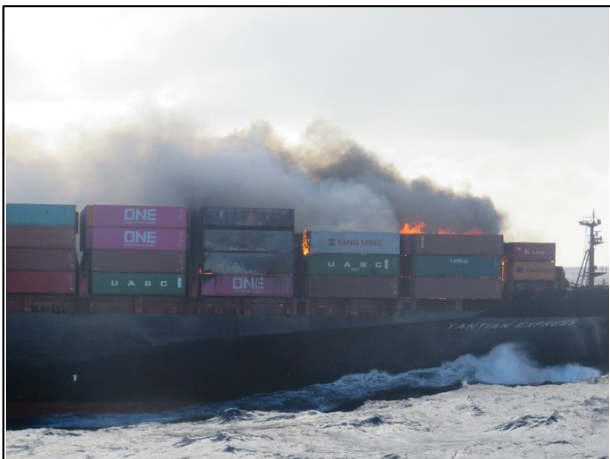
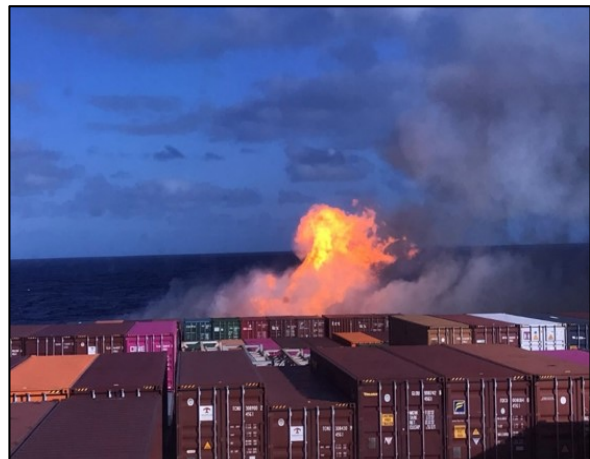
Another drama was unfolding in the middle of the Atlantic at almost the same time. The YANTIAN EXPRESS, a container ship of 320 m in length with 22 crew members on board, was sailing from Colombo in Sri Lanka to Halifax in Canada when a fire in the containers was discovered in the forward section of the ship during the night of 2-3 January 2019. The fire spread rapidly and the crew struggled in vain for more than 24 hours to contain it before being forced to discontinue active firefighting due to exhaustion and a lack of options. Despite the fact that the ship was more than 1,000 nm from the nearest coast, rescue workers were at the scene as early as the following evening and began to fight the fire from a distance using water cannons. However, by that time fire had taken hold on much of the ship's fore section and spread to a large number of containers on and below deck. Accordingly, containing it from a distance was virtually impossible. Added to this was a strong wind which repeatedly fanned and whipped up the fire, posing a risk of flying sparks and heat generation setting other containers on fire. For that reason the master constantly steered the ship with the wind blowing from astern to prevent the fire from spreading forward toward the superstructure.

Figures above left and right: Fire on board (Source: SMIT Salvage (left) and Hapag-Lloyd (right))

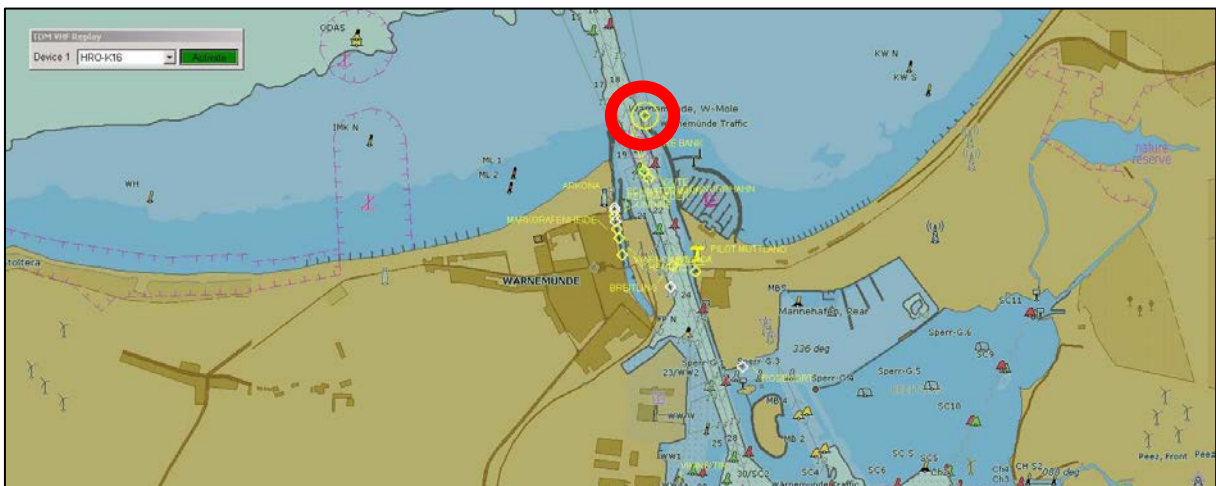
The Finnish-flagged ro-ro ship BORE BANK was sailing from Kotka in Finland to Rostock on 17 January 2019. The pilot found that the ship was no longer under command when they started to sail into the port in the early hours of the morning. Switching to manual steering proved unsuccessful, too. Only the use of the tiller brought the steering gear back under control. However, the ship was already so close to the breakwater by then that countersteering was no longer possible. The previous emergency manoeuvre was therefore continued and the ship sailed onto soft ground in a controlled manner so as not to hit the breakwater. The ship was towed free shortly afterwards and able to enter Rostock.

Figure above: The scene of the accident (circled in red) just off the Rostock-Warnemünde port entrance (Source: WSP)

The BSU has therefore used this accident as an opportunity to recall a safety recommendation issued in 2016 in connection with the grounding of the CSCL INDIAN OCEAN that international efforts be made to supplement steering gear with internal error logging.

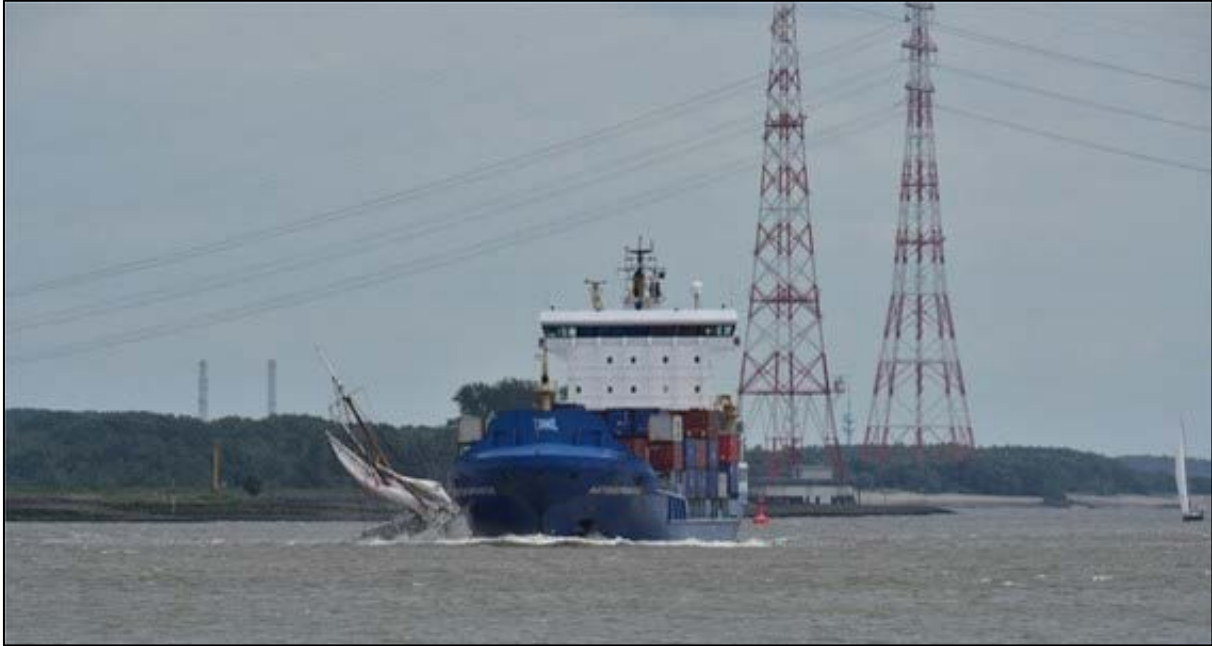
Figure above: The moment of the collision – the N° 5 ELBE is pushed to the side (Source: Daniel Beneke, Stader Tageblatt)

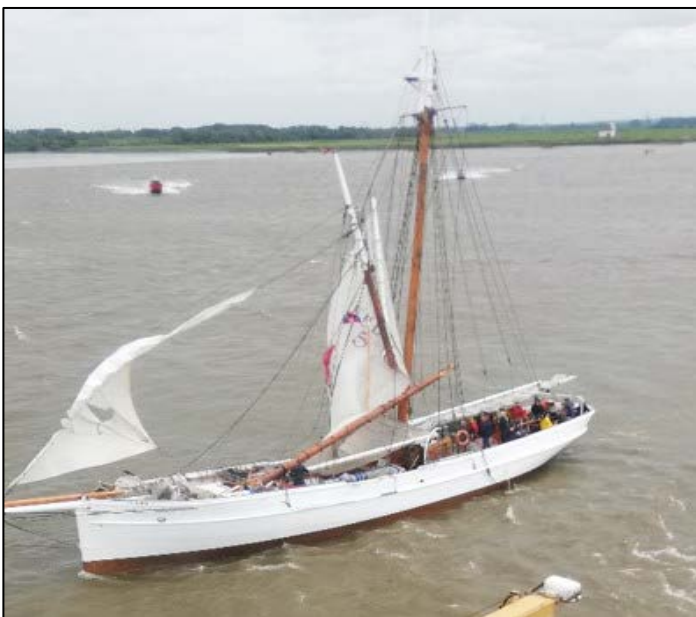
The N° 5 ELBE was struck in the forward section of the hull. The shrouds of the foremast cushioned most of the impact but the mast broke in the process. The running and standing rigging landed on deck and the pilot schooner was holed. There were eight casualties on board. Coincidentally, boats from the Stader Voluntary Fire Brigade and the German Life Saving Association (DLRG) were nearby. They were just finishing another emergency response when they observed the collision and immediately went to assist. Using her own engine and towed by a DLRG boat, the schooner was able to save herself in the mouth of the River Schwinge and put her passengers and crew members ashore there, despite the water ingress. However, she foundered directly at the pier.

The above figure shows the damaged N° 5 ELBE as seen from the deck of the ASTROSPRINTER shortly after the collision. Boats from the fire service and the DLRG hurrying to assist are visible in the background (Source: ASTROSPRINTER's crew)

In the opinion of the fire service, everyone involved had an extremely lucky escape. Firstly, nobody went overboard during the collision. If you look at the above photograph, this in itself is almost miraculous. Secondly, the N° 5 ELBE would probably have either broken up or been pushed under water had she been struck more amidships. In both cases it is highly likely that 43 people, among them several children, would have gone overboard and drifted in the River Elbe fairway, most of them without lifejackets – a horrible thought.

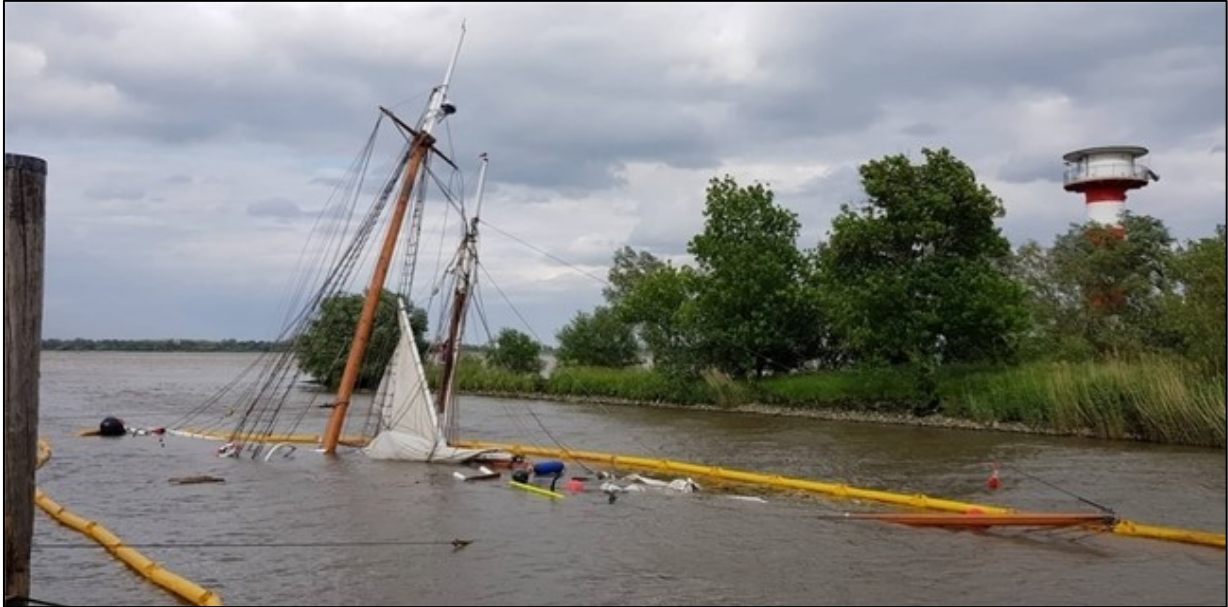
Figure above: The foundered N° 5 ELBE (Source: DLRG)

A specialist company from Portugal raised the ship a few days later and she is being repaired in a Danish shipyard. She is to be put back into operation.

The BSU published a preliminary safety recommendation in this case for the below reasons. The pilot schooner N° 5 ELBE was originally built with a continuous hull, which is not divided by bulkheads. There is no collision bulkhead. The hull has not been fitted with watertight bulkheads – not even in the course of extensive and substantial conversions and renovations. Accordingly, it was unavoidable that damage would result in the flooding of the entire hull and inevitable foundering. Moreover, there will not always be other ships in the immediate vicinity that can initiate a rescue operation without delay. The BSU has therefore advised the competent authorities to adapt the legal situation so that traditional ships carrying more than 12 passengers are subdivided by watertight bulkheads. The operator was advised to act accordingly and install watertight bulkheads during the forthcoming repairs.

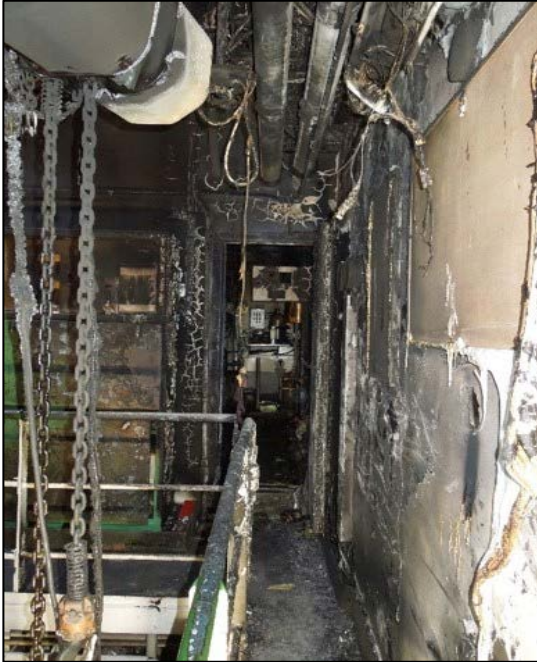
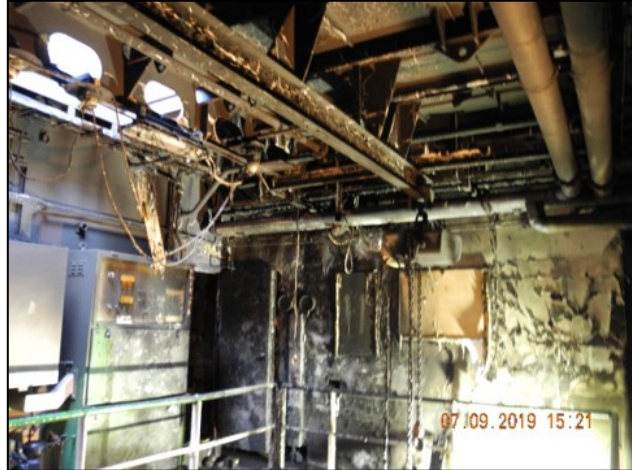
By that time the crew had managed to fully extinguish the fire by discharging CO<sub>2</sub>. The ship's engine was no longer operational and she anchored. The damaged ship was towed to Brunsbüttel. The BSU started the investigation and surveyed the ship immediately after the accident. The investigators found a picture of devastation. It is always horrifying to see the violence with which a fire can rage and the consequences of this, as illustrated by the following photographs.

Figures left and above: Consequences of the fire in the engine room and adjacent spaces – the heavy destruction is clear to see (Source: BSU)

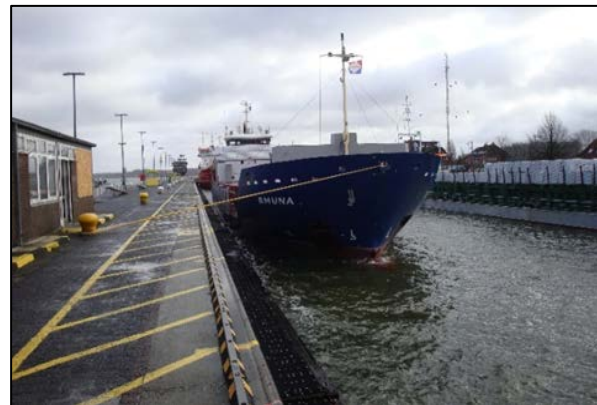
Figure to the right: Similar ship made fast in the lock with the linesmen's cabin on the left-hand side (Source: WSP)

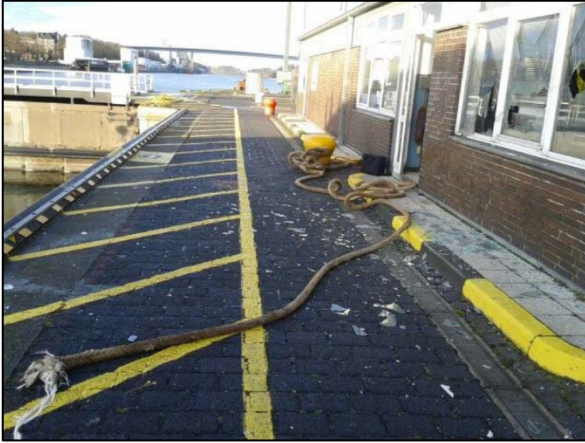
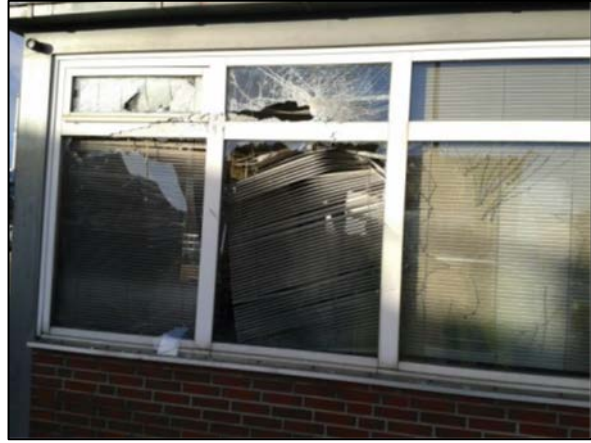
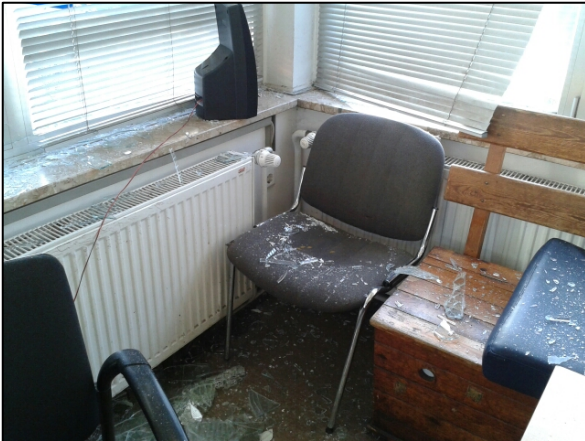
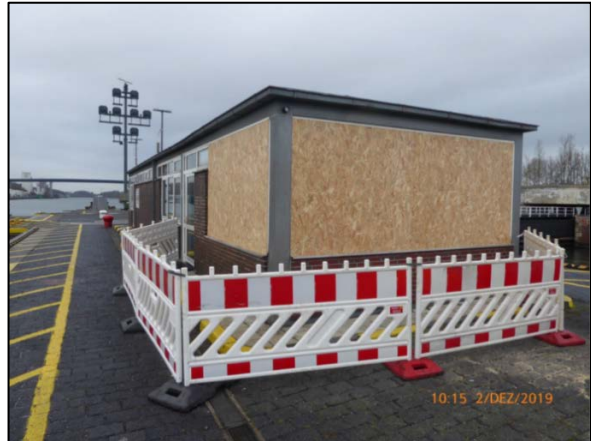
The THEMSESTERN was moored with four lines in the southern chamber of the lock at Kiel-Holtenau on 30 November 2019. As the lock gate was opening a tug set off first to sail out of the lock into the Kiel Canal. Shortly before the THEMSESTERN began to cast off, her head line parted without warning level with the hawse, rapidly rebounded back to the pier and struck the linesmen's recreation cabin, which was located in the immediate vicinity. Some of the windows facing the southern lock chamber and the glazing at the front of the building were destroyed and a person standing in the doorway suffered injuries to his leg.

Figures above and below left: Damage caused by the rebounding line (Source: WSP)  
Figure below right: Linesmen's cabin provisionally sealed (Source: WSP)
