Investigation Report 40/03

Serious Marine Casualty:

Collision
MV "GINA-R. – FC "LIEBE"

on 14 February 2003 off Fehmarn

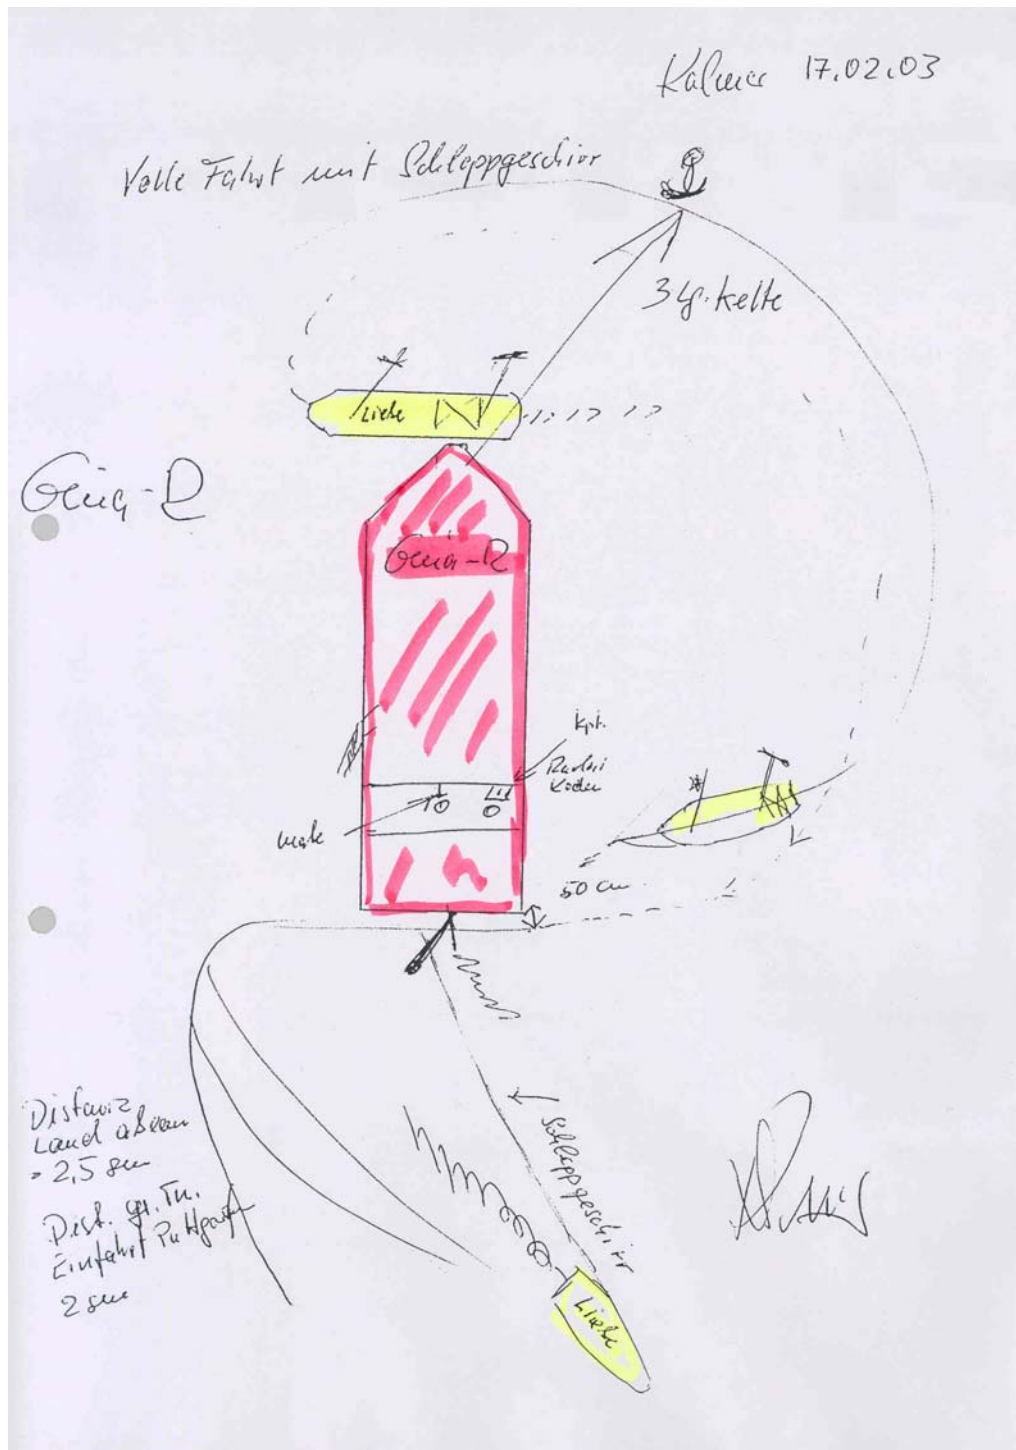
4.7 Sketch of the accident from on board MV "Gina-R."

Full speed with towing gear
3 chain lengths
Master Radar set Koden
Towing gear
Distance land ... 2.5 sm
Distance entrance Puttgarden 2 sm

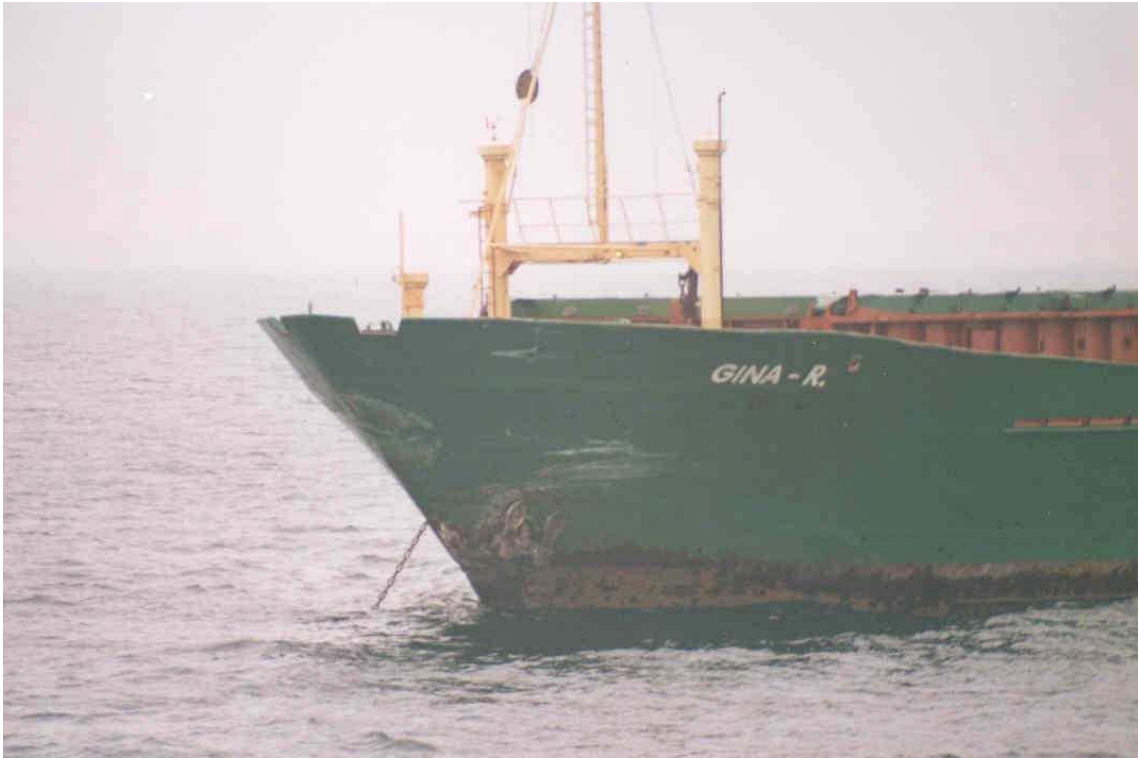
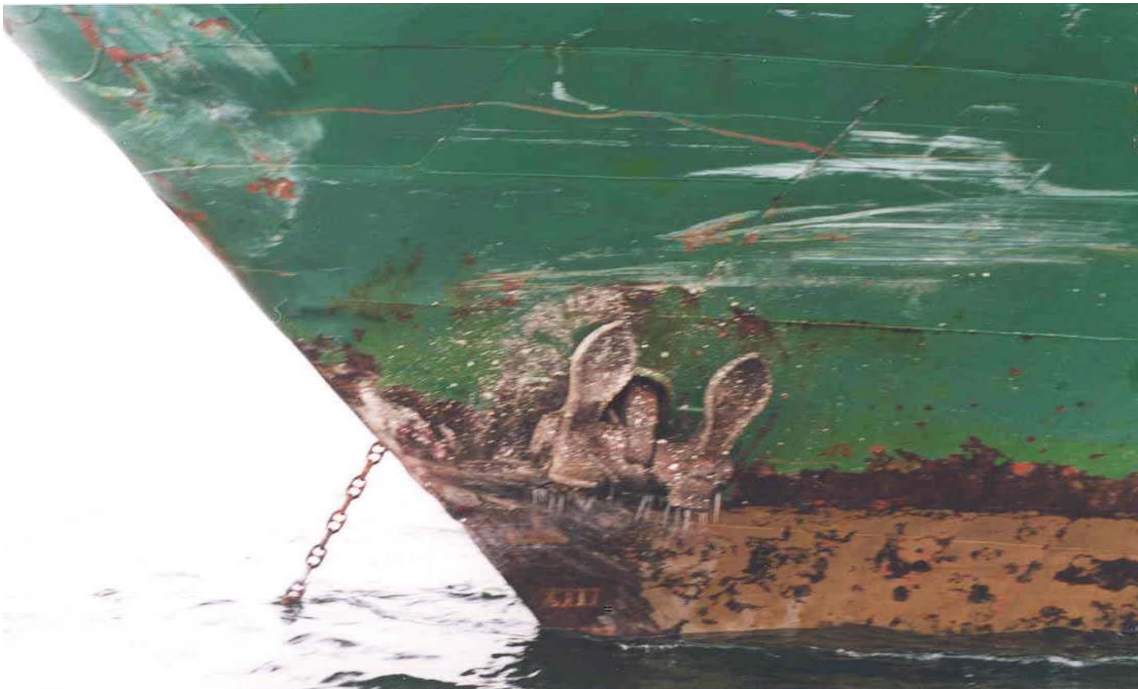
The damage to the Motor Coaster "GINA-R." comprises three small dents and paint abrasion at the stem.

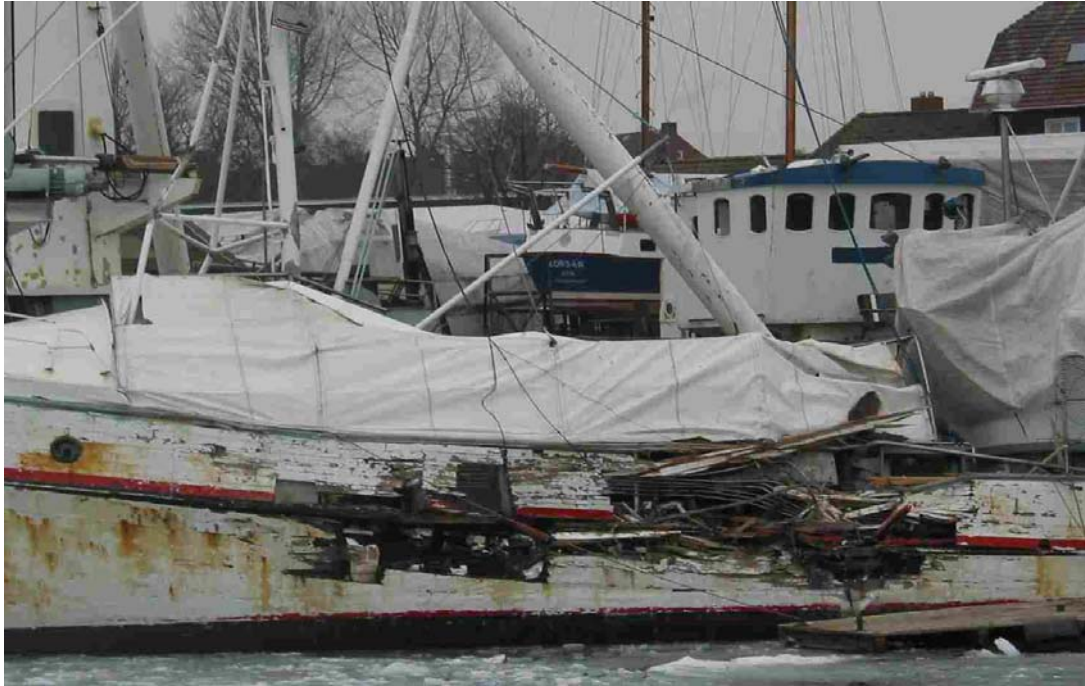
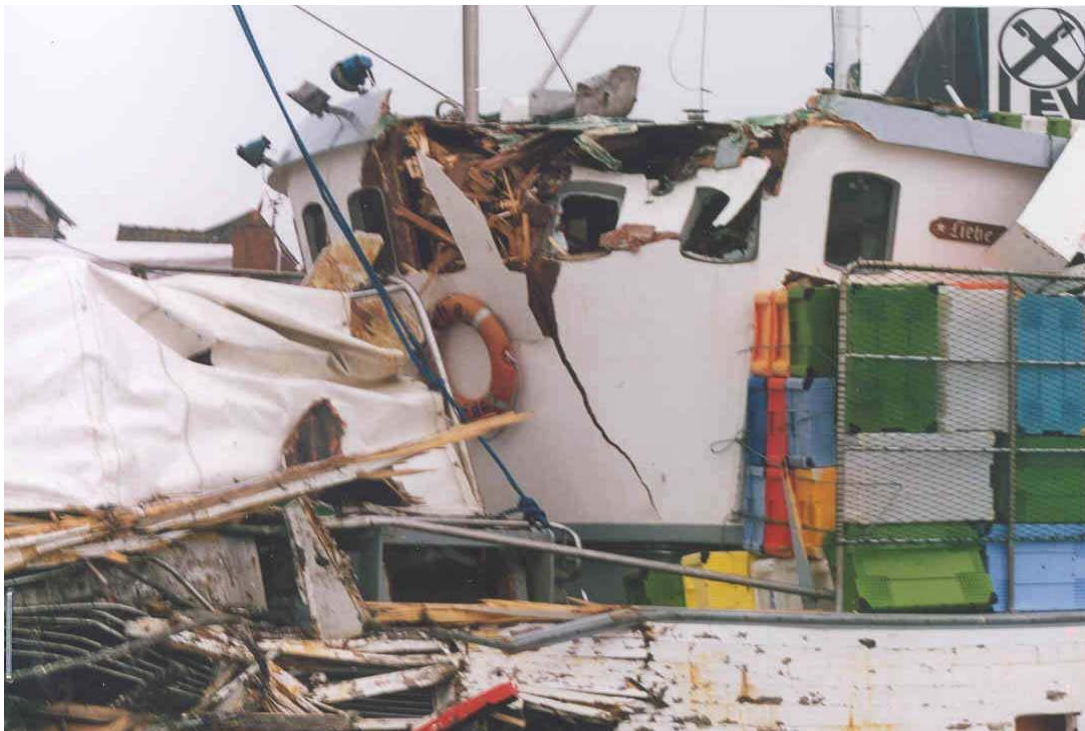
Damaged port side

The Fishing Cutter "LIEBE" was heavily damaged on the port side, at the stem and the wheelhouse, so that a relatively log stay in the yard became necessary.
