Investigation Report 45/04

**Very Serious Marine Casualty**

**Collision between  
CMV COSCO HAMBURG  
and  
CMV P&O NEDLLOYD FINLAND  
on 01 March 2004  
on the Lower Elbe/off Buoy 91  
with the Death of one Seaman**

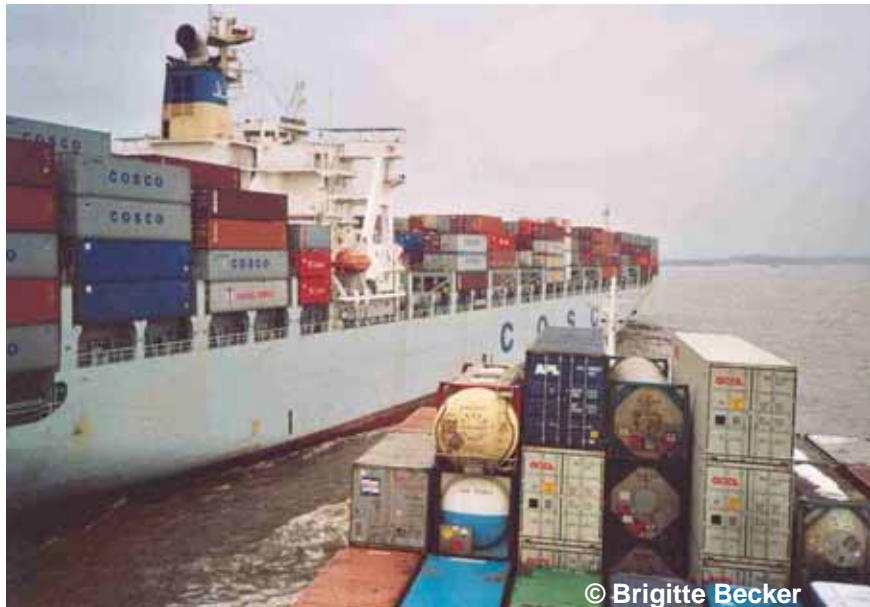
**Figure 4: Positions of the vessels in relation to each other shortly before the collision**

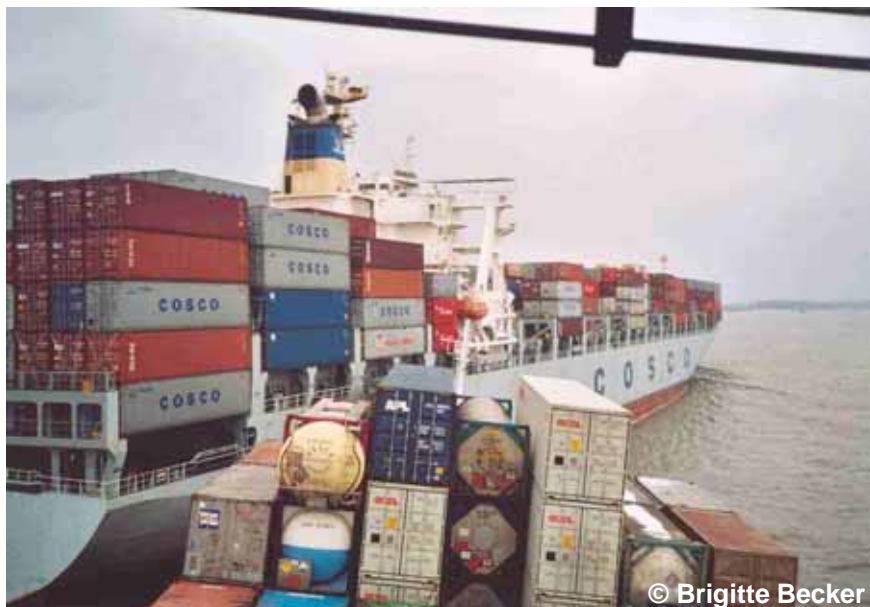
**Figure 5: First contact of the vessels**

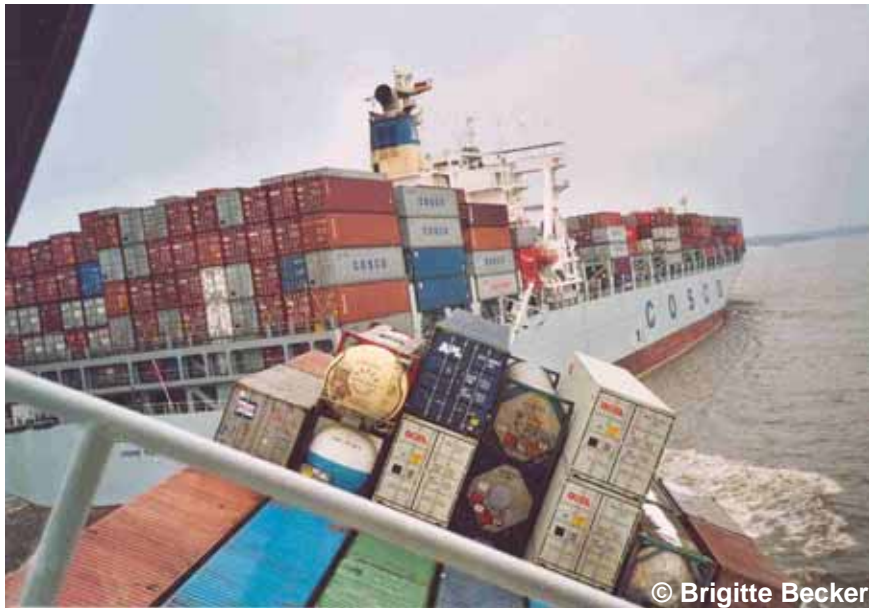
**Figure 6: Last phase of the collision**

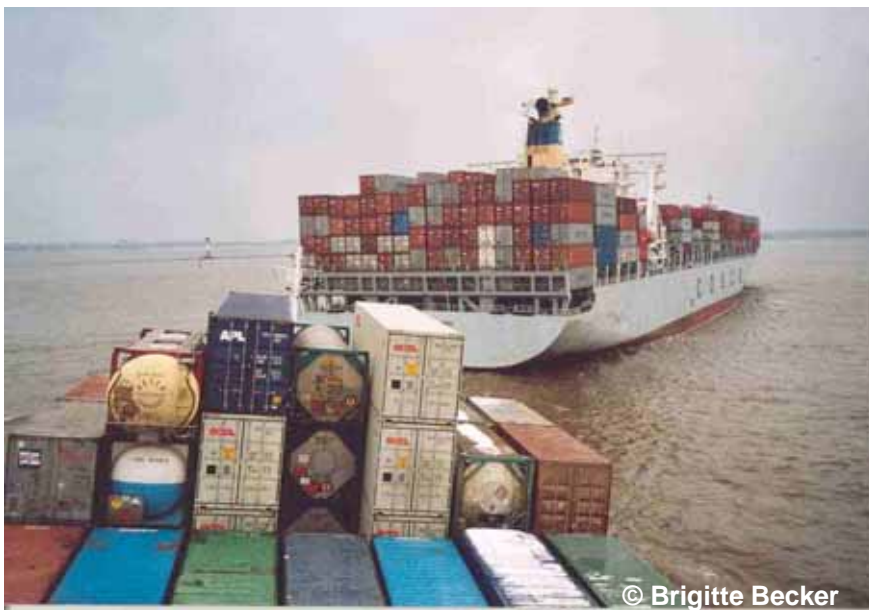
**Figure 7: Position of the vessels in relation to each other shortly after the collision**

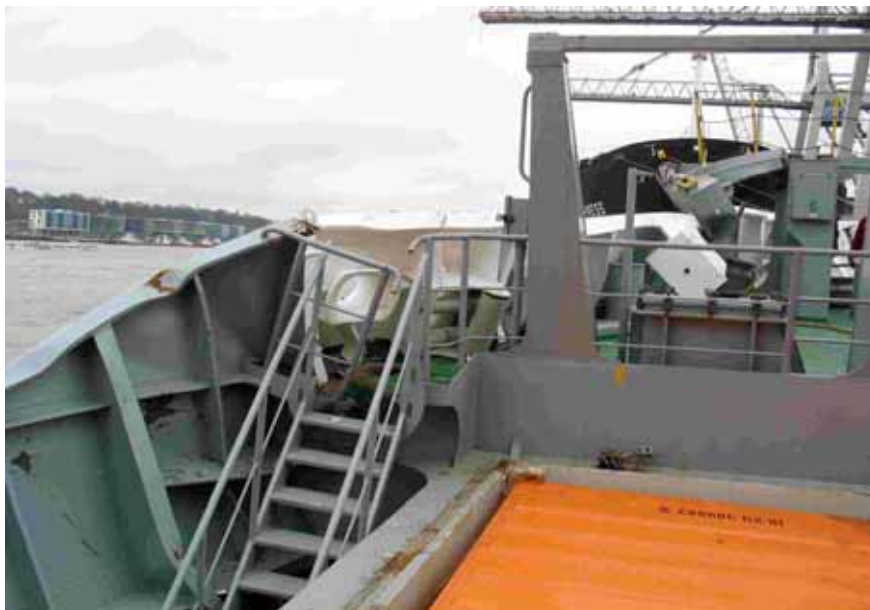
By contrast with this tragic death, the damage to the two vessels participating was relatively slight. NEDLLOYD FINLAND was deformed above the water line in the port fore ship area (known as the shoulder) between frames 124 and 135 over a length of approx. 10 metres as a result of the impact. In addition the container foundation Bay 1 on the port side was destroyed (see Fig. 9). As a consequence of the collision, four containers stowed in the foremost bays on deck were damaged. One 40-foot container that did not, however, contain any dangerous cargo went over board. There was no water ingress or any other impairment of floatability.

**Figure 8: Damage to NEDLLOYD FINLAND (1)**

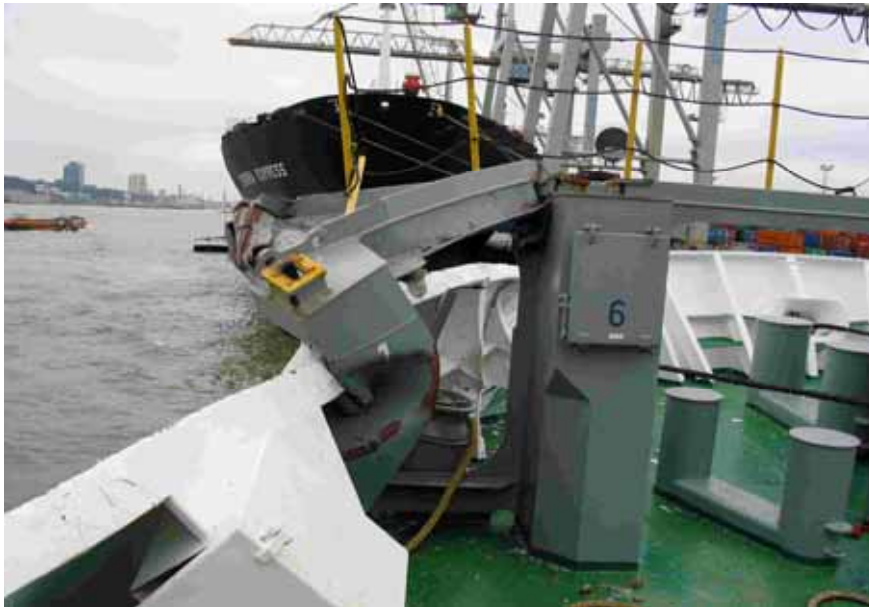
**Figure 9: Damage to NEDLLOYD FINLAND (2)**

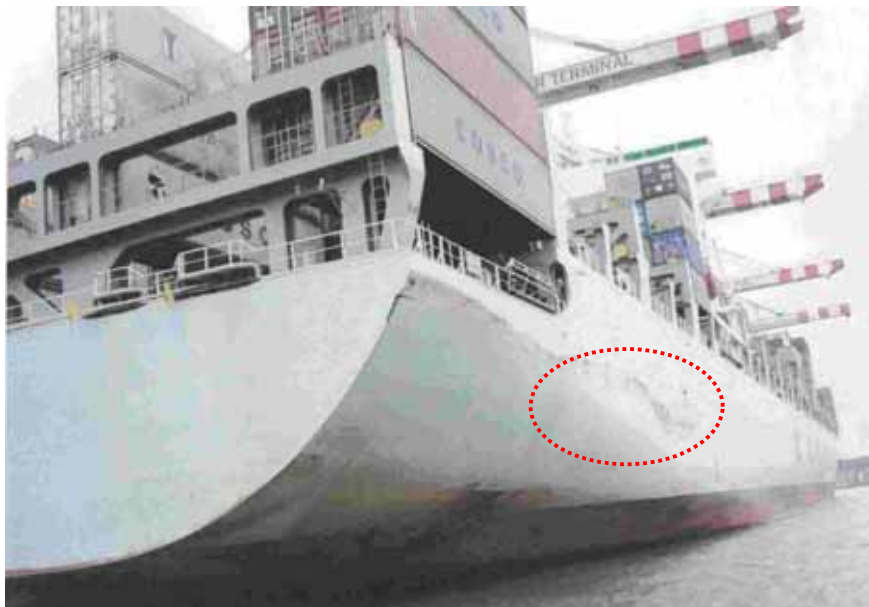
The shell plating of COSCO HAMBURG was dent in at the stern on the starboard side (frames 8 to 14) above the water line (cf. marked area in Fig. 10) as a result of the contact with NEDLLOYD FINLAND, but the vessel remained otherwise undamaged and also unrestrictedly floatable.

**Figure 10: Damage to COSCO HAMBURG**

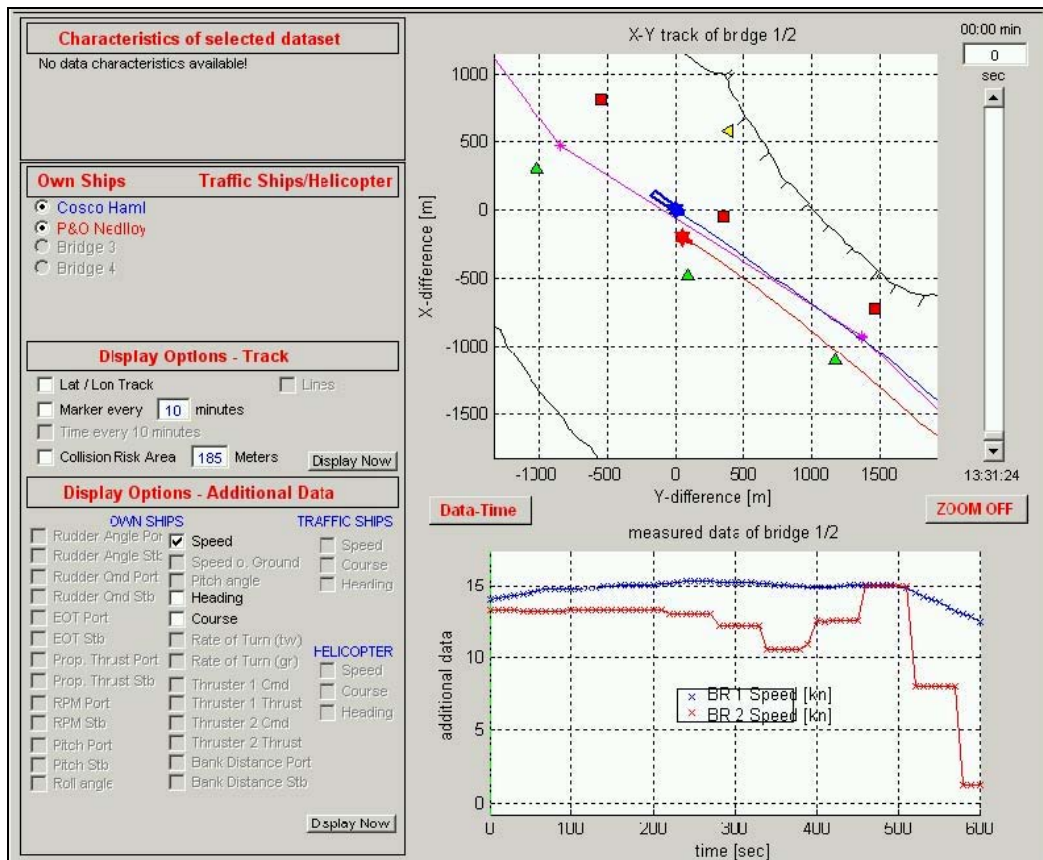
**Figure 11: Example of evaluation of the situation analysis of the overtaking manoeuvre**

In the bottom diagram the speed tracks of the "speed over ground" values recorded for the two vessels are displayed over the entire analysis period observed. The green bars shown marks the time belonging to the situation set out above (here  $t = t_0 = 0$  seconds).

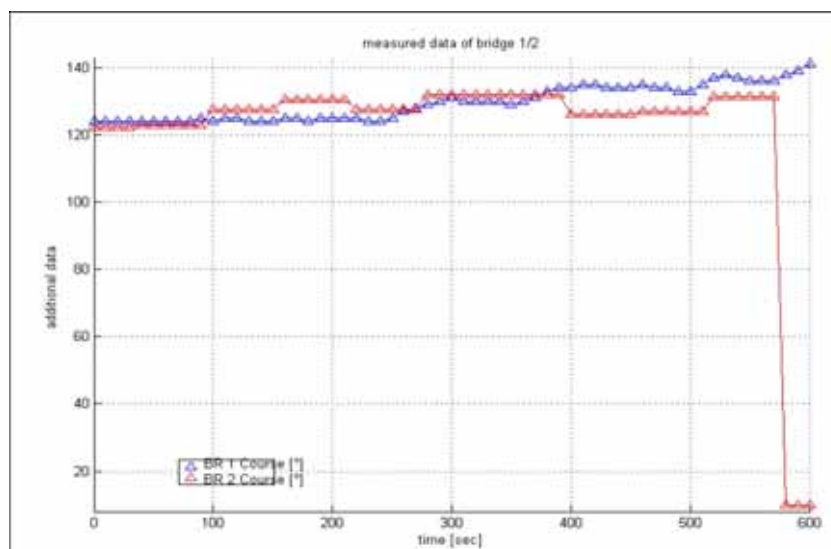
In the following two figures the course tracks recorded through the water (Fig. 14 - heading) and over ground (Fig. 15) are shown. The heading of NEDLLOYD FINLAND is suddenly reduced shortly after  $t = 500$  s from  $130^\circ$  to almost  $90^\circ$  and finally to  $60^\circ$ . At this time the vessel was lying almost crossways in the navigation channel.

**Figure 15: Tracks of courses over ground**  
(blue COSCO HAMBURG, red NEDLLOYD FINLAND)

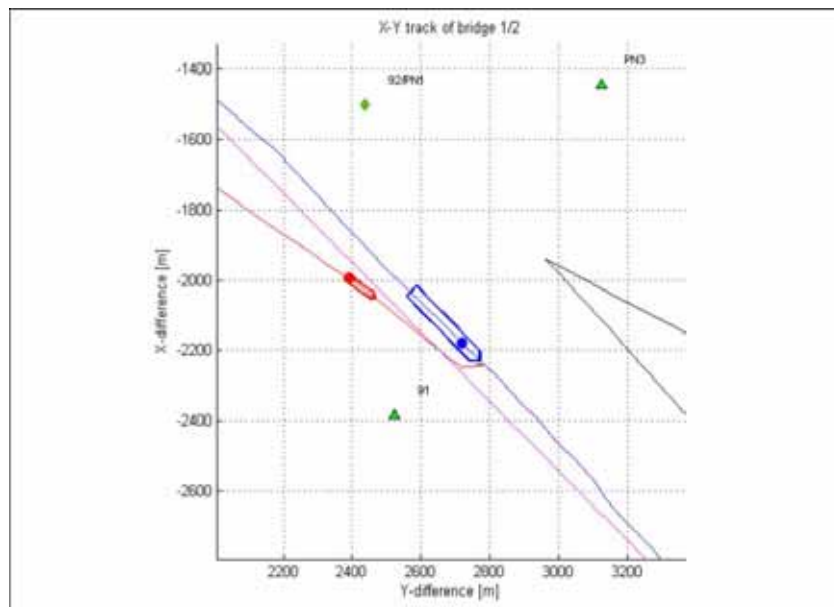
The diagrams in Fig. 18 and 19 show the tracks of the last evaluation segment from directly before to after the contact between the vessels. The positions marked by the ship's contours are faded in for the time of the second closest approximation.

**Figure 18: Snapshot of the overtaking operation shortly before the collision (Gauß-Krüger Coordinates)**

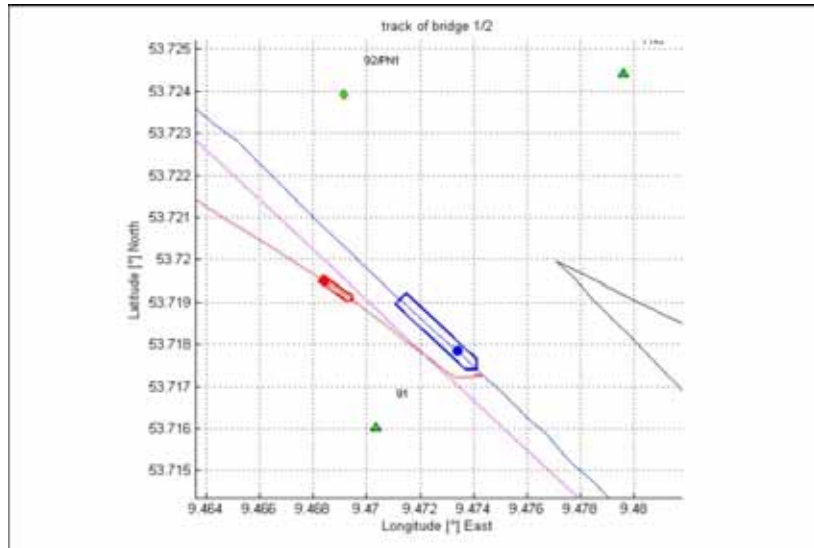
**Figure 19: Snapshot of the overtaking operation shortly before the collision (geographical coordinates)**

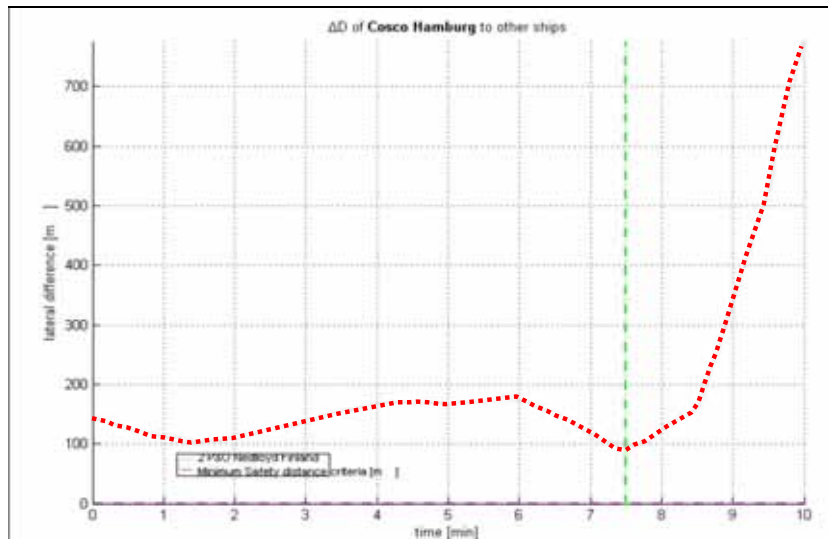
**Figure 20: Closest distances between the vessel hulls of the vessels involved (minimal distance from ship's wall to ship's wall)**

By comparison with the distance developments determined from the data recorded (cf. Fig. 20; minimum value approx. 100 metres!), considering the distance from ship's wall to ship's wall after the time synchronisation results in a minimum value of approximately 0 m at the time of the assumed collision.

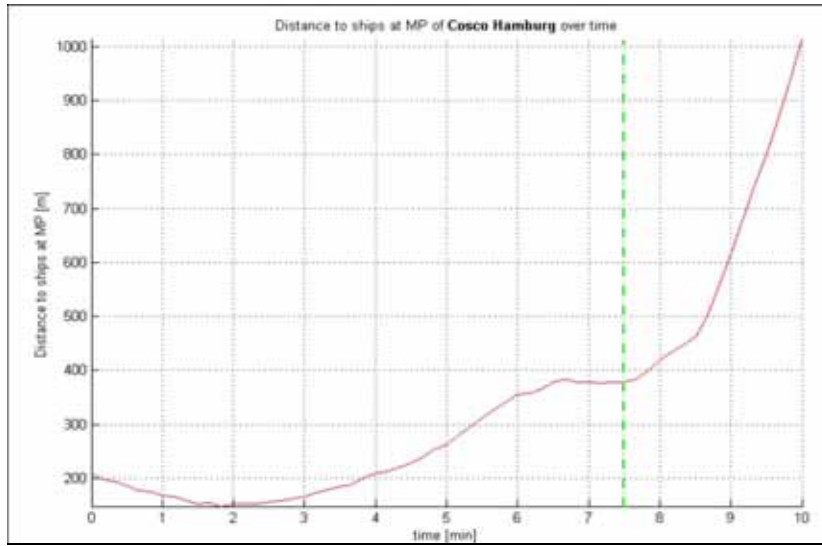
**Figure 21: Closest distances between the sensor positions (System position COSCO HAMBURG vs. GPS aerial NEDLLOYD FINLAND)**

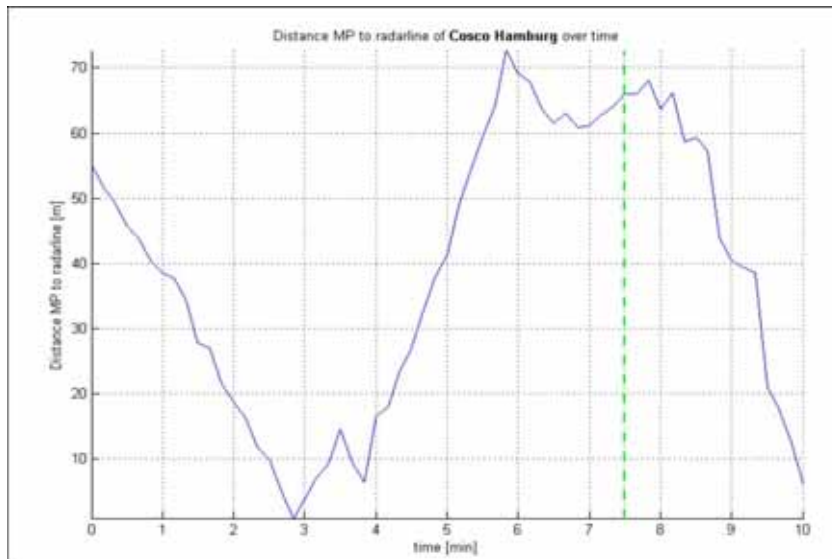
**Figure 22: Absolute distances of the sensor position of COSCO HAMBURG to the radar line**

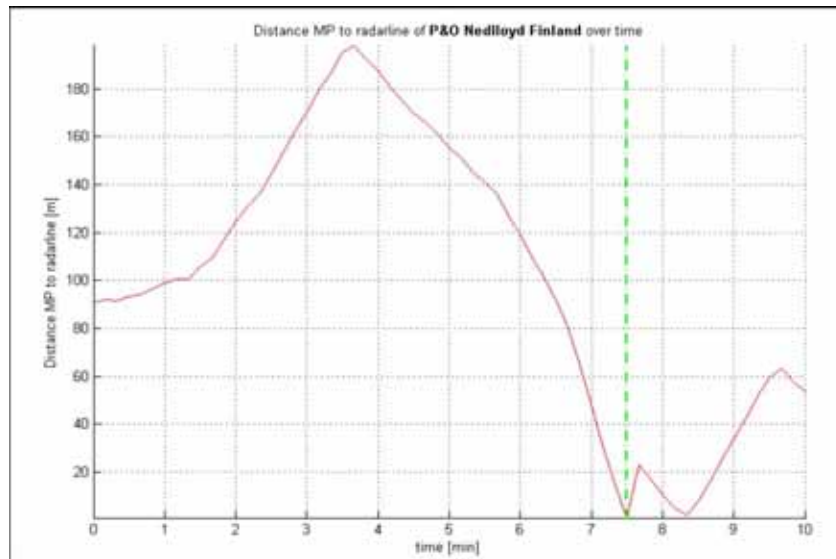
**Figure 23: Absolute distances of the sensor position of NEDLLOYD FINLAND to the radar line**

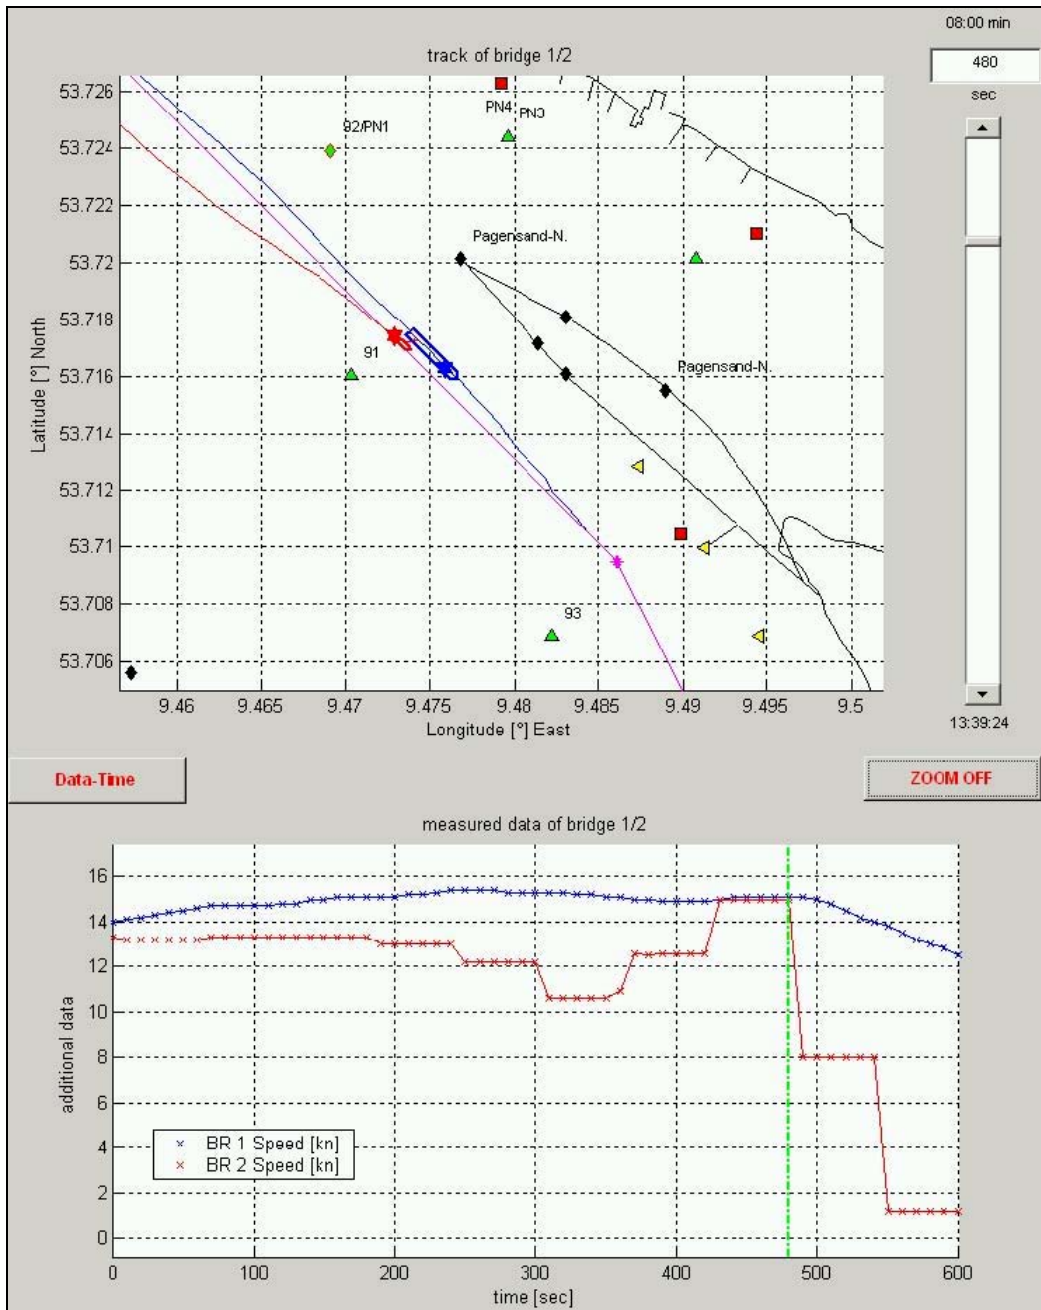
In order to be able to consider the probable course of the situation, Department of Maritime Navigation carried out synchronisation of the data sets on the basis of the photo series available. Figure 24 below shows a resulting snapshot shortly before the assumed time of the accident.

**Figure 24: Presentation of the probable situation shortly before the occurrence of the accident (time-synchronised data sets)**

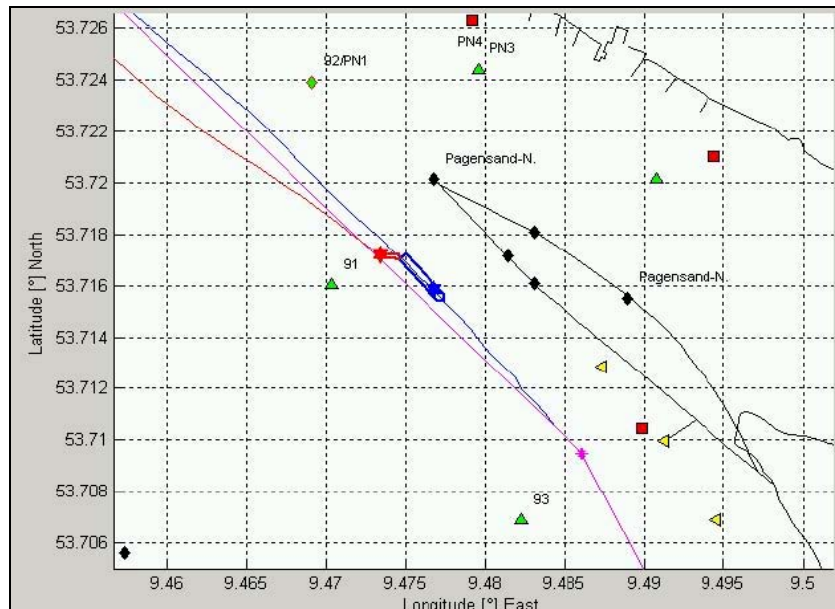
**Figure 25: Final phase of the contact between the vessels involved at approx. 14:39:34 h (time-synchronised data sets)**

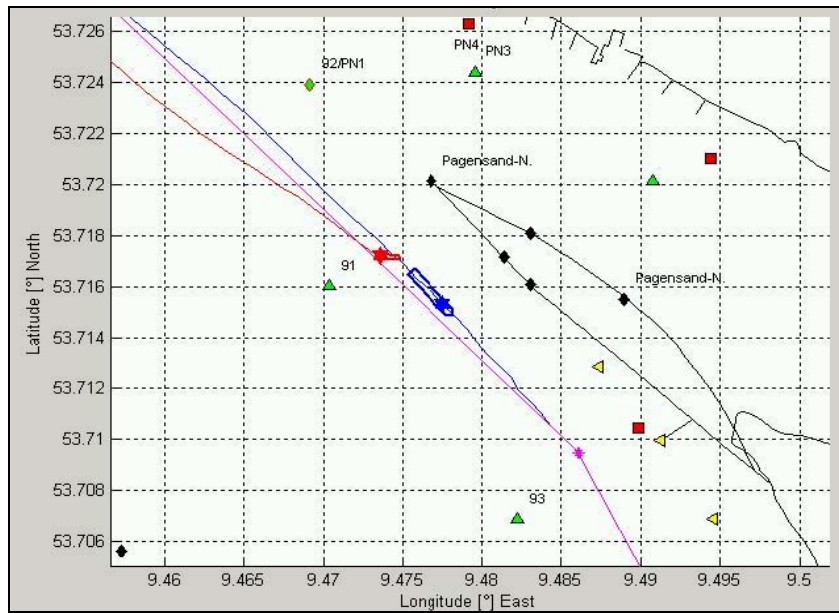
**Figure 26: Situation shortly after the collision (14:39:44) (time-synchronised data sets); NEDLLOYD FINLAND crossways in the navigation channel, navigation mark on the port side almost dead ahead)**

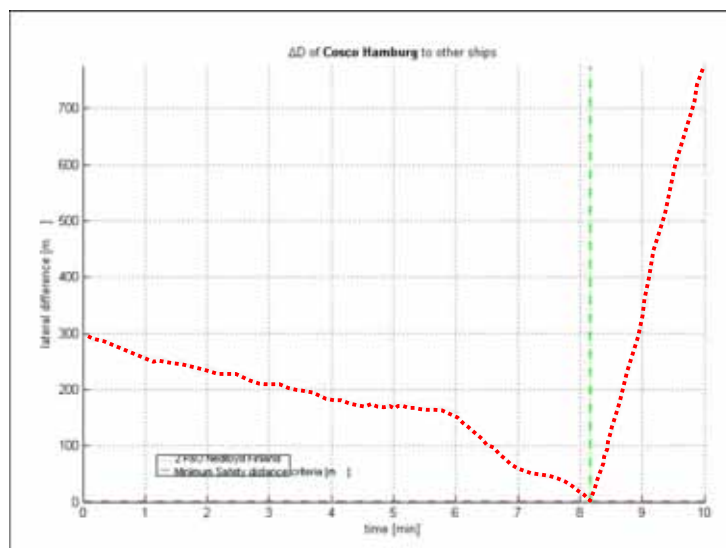
**Figure 27: Closest distances from ship's wall to ship's wall (time-synchronised data sets)**

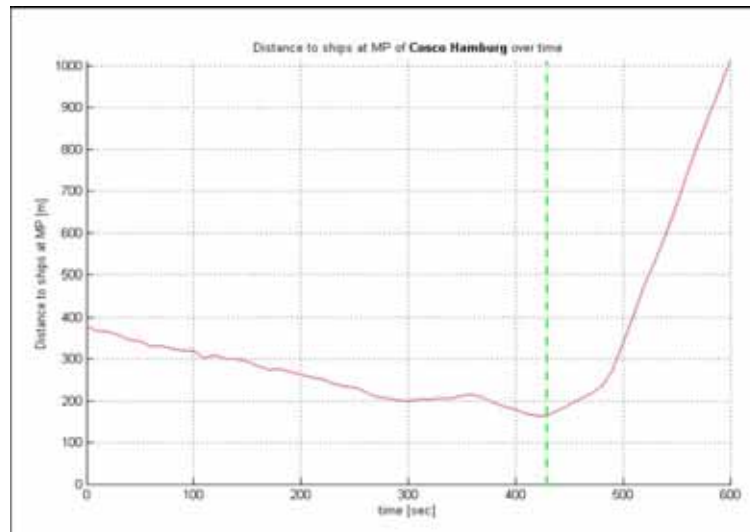
**Figure 28: Shortest distances between the sensor positions (System position COSCO HAMBURG vs. GPS aerial NEDLLOYD FINLAND) time-synchronised data sets**

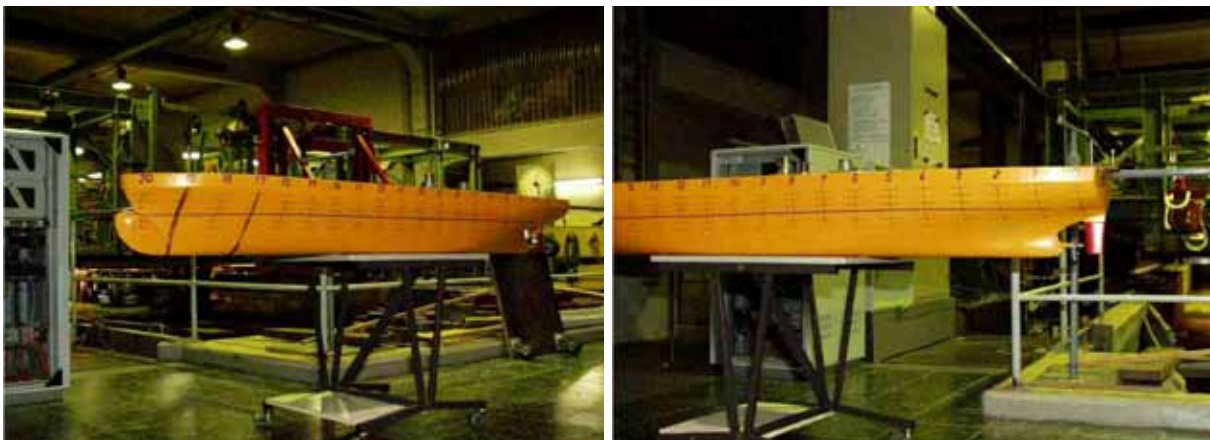
The lines drawings of the smaller vessel were available so that it could be reconstructed precisely (also to scale 1:50). The model has its own propulsion and an adjustable rudder.

**Figure 46: Model NEDLLOYD FINLAND**

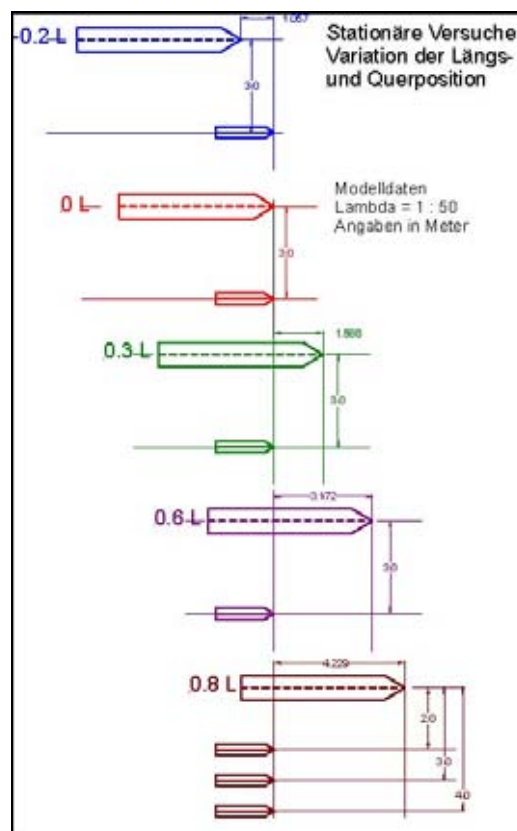
The arrangement of the models in the stationary experiments (both models guided by the large towing carriage) is shown schematically below. Here COSCO HAMBURG was displaced lengthways and NEDLLOYD FINLAND crossways under the towing carriage.

**Figure 49: Variation of the model arrangement (stationary experiments)**

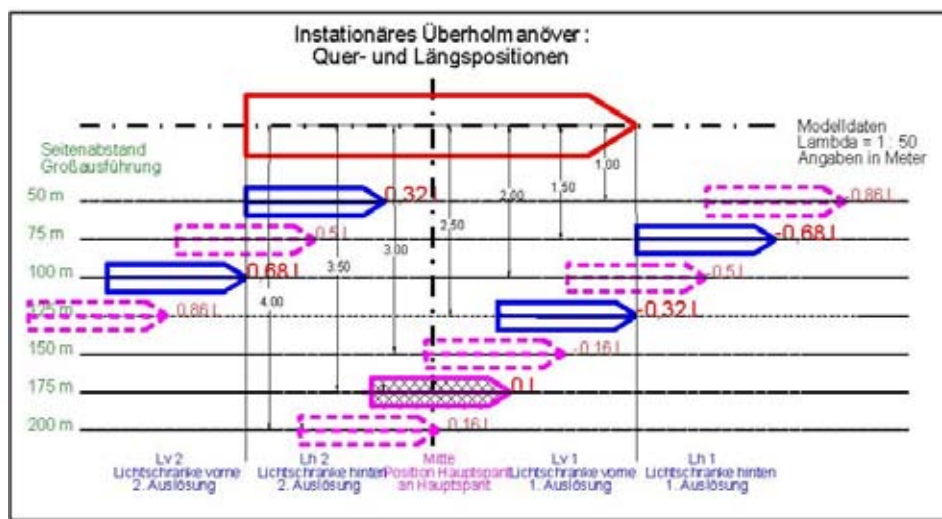
However, it should be pointed out once again that related to the diagram shown, a different "zero position" was used in the non-stationary experiments (cf. remarks above under Section 6.3.3.3.2)

**Figure 50: Variation of the model arrangement (non-stationary experiments)**

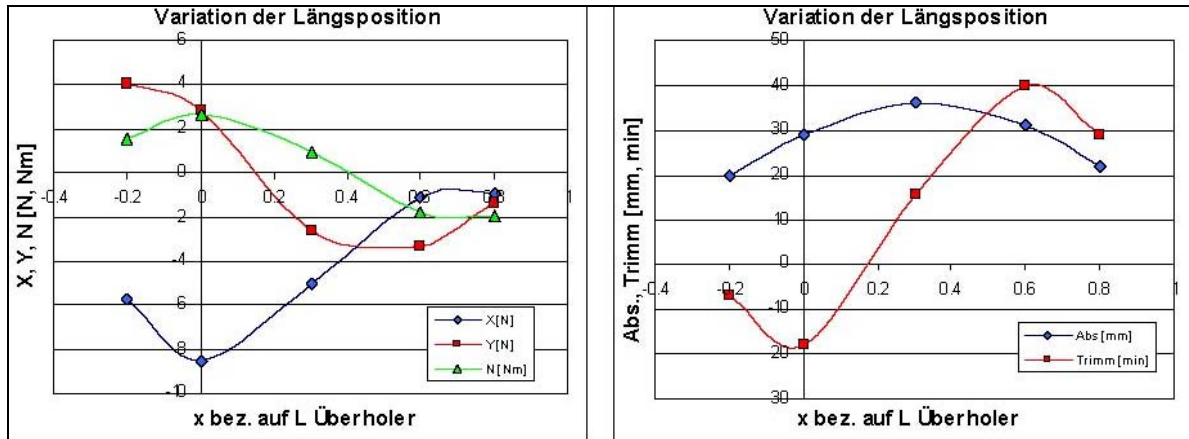
**Figure 58: Forces, moments and positions afloat in the stationary experiment (variation longitudinal position)**

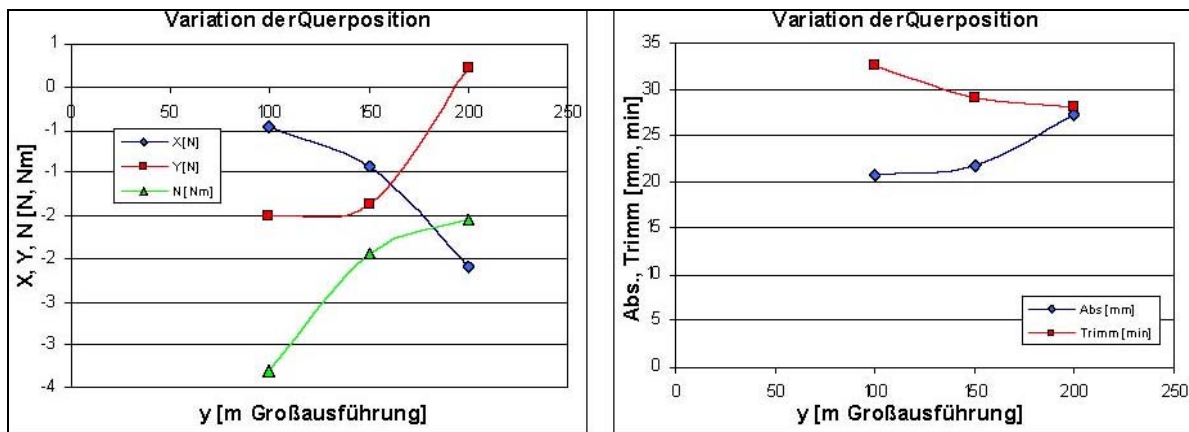
**Figure 59: Forces, moments and positions afloat in the stationary experiment (variation transverse position)**

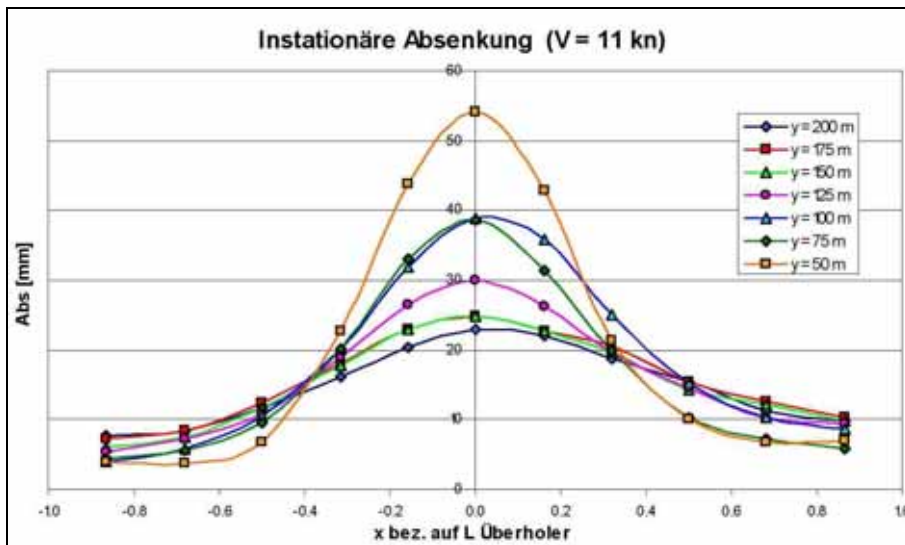
**Figure 71: Lowering at the non-stationary experiments at selected positions**

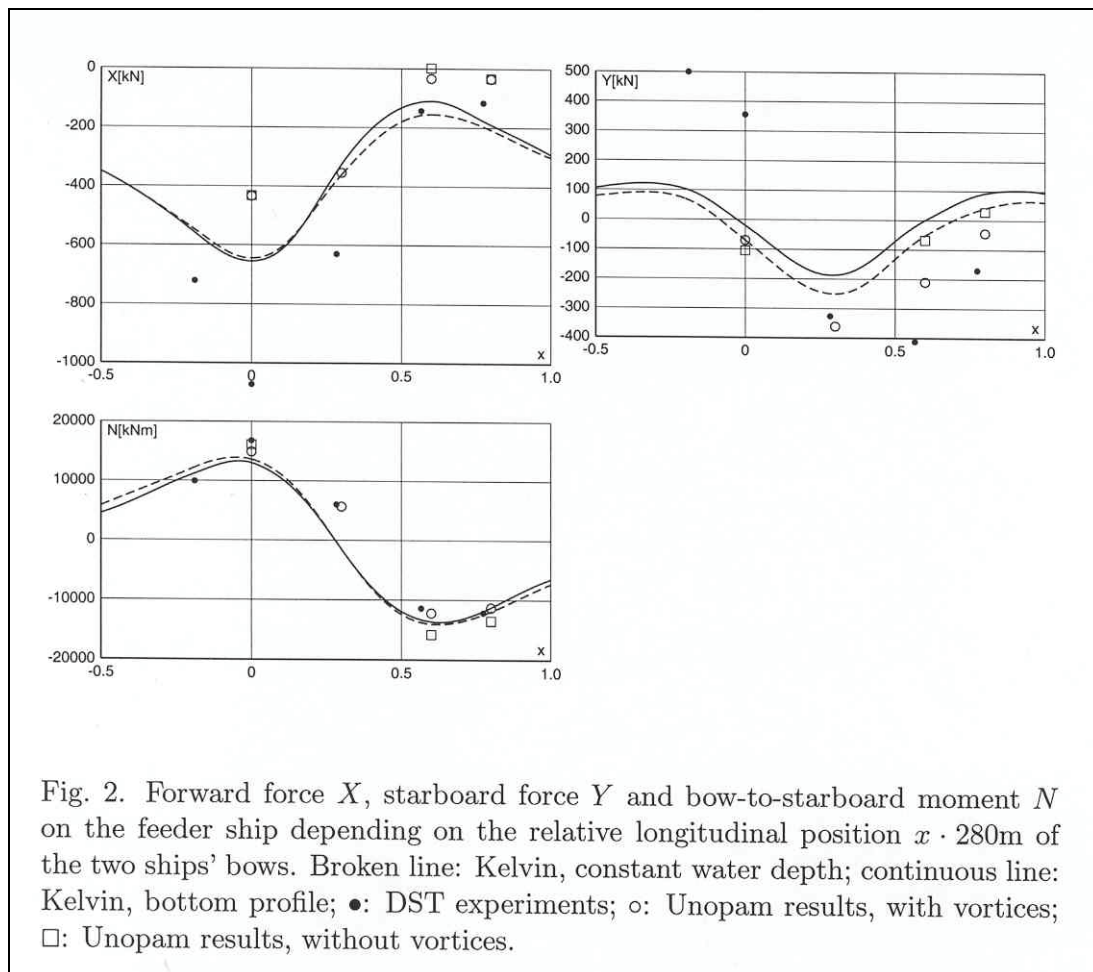
**Figure 75: Comparison of the different calculated and measurement results<sup>54</sup>**
