Investigation Report 293/05

Serious Marine Casualty

Stranding of the Traditional Vessel
"ATLANTIC"
on 3 August 2005
in the Peenestrom at Buoy KR 11

15 May 2006

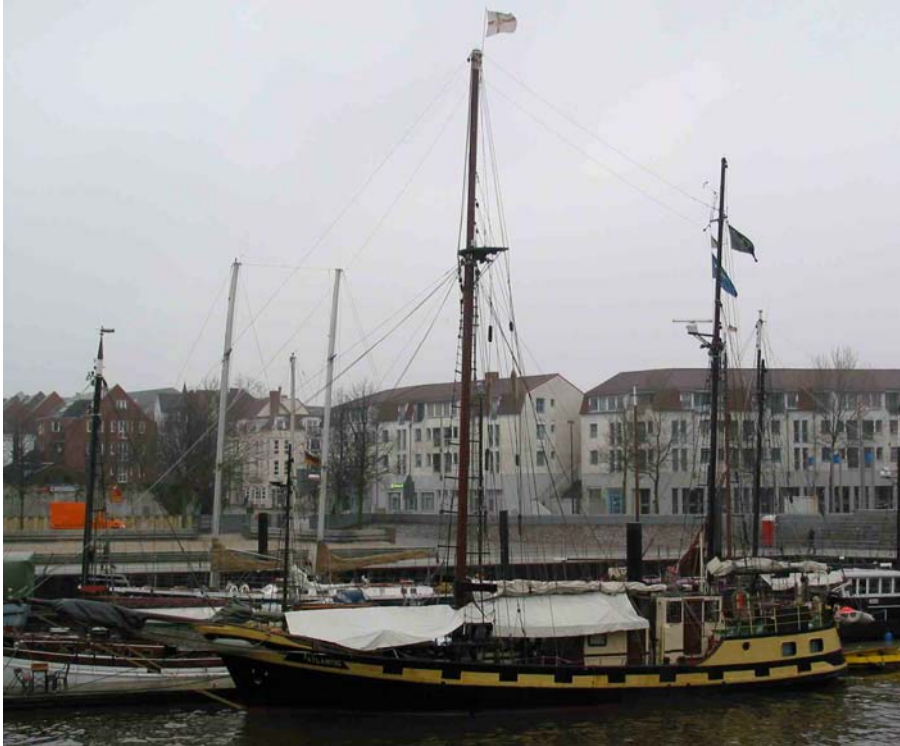
Figure 2: Photo of vessel

Name of vessel:	ATLANTIC
Type of vessel:	Traditional Vessel
Nationality/Flag:	German
Port of Registry:	Bremen
Call sign:	DJRN
Year built:	1871
Building yard/location:	Norddeutsche Schiffbau AG, Kiel
Licence:	GSHW / See-BG
Length over all:	29.00 m
Hull length according to Safety Certificate:	21.22 m
Width over all:	5.05 m
GRT:	57.44 GRT
Draft at the time of the accident:	3.20 m
Engine rating:	160 hp
Main engine:	Deutz
Speed:	10.5 kn
Sail area:	245 m ²
Hull material:	Transverse framing construction, riveted steel
Number of crew:	3

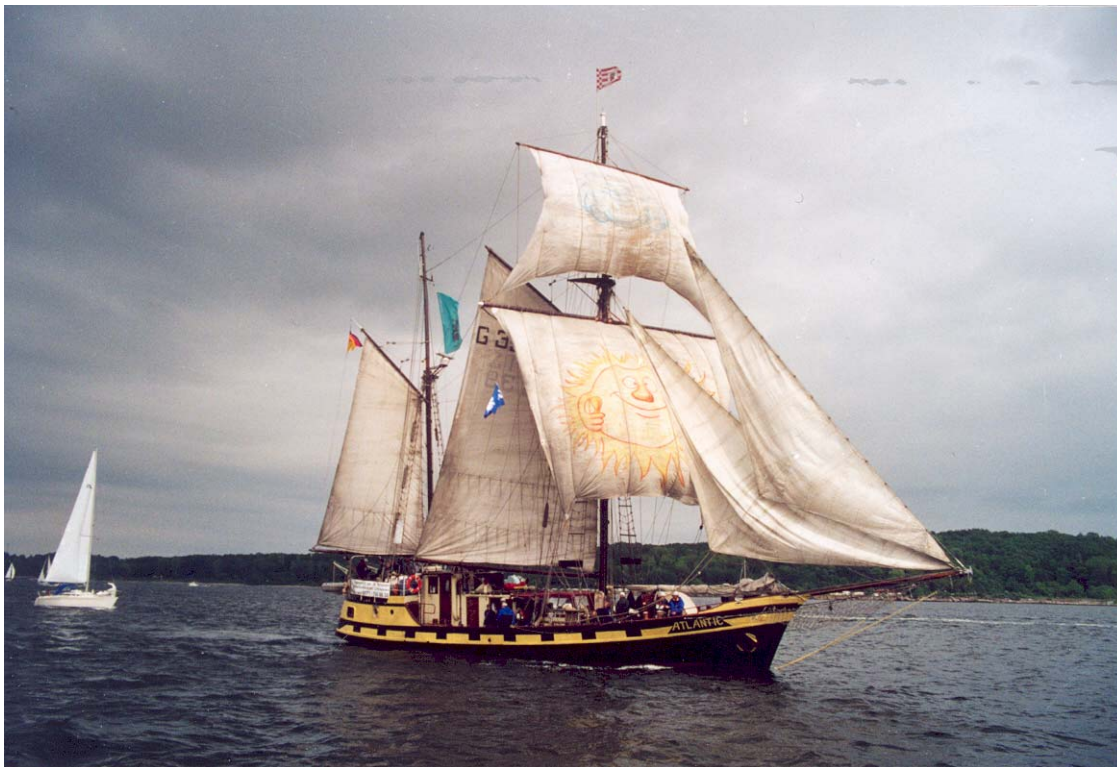
Figure 5: ATLANTIC under sail, photo courtesy of owner

The Traditional Vessel ATLANTIC is rigged as a 2-mast gaff ketch. In addition to the main sail and mizzen-sail, the vessel runs 3 fore sails and two square sails. The sails are operated from the main deck and the elevated aft deck.

The vessel can be steered from the wheelhouse and from the elevated aft deck with a manual hydraulic steering system. Both steering-stands are switched parallel and neither of them take precedence. A manual hydraulic steering system can

additionally be run via a hydraulic pump that can be switched in using an auto-pilot or joystick. The visibility from both wheelhouses forward was good.

The 160 hp four-cylinder main engine could only be started from the engine room. The engine is started with compressed air and the starting operation takes some time, as some preliminary works such as opening the sea valves and preliminary pumping of the oil pressure is necessary. For ongoing maintenance it is necessary for the main engine and the attached cooling water pumps to be oiled every 3 hours. One life-raft for 6 persons and one for 25 persons with due maintenance date June 2005 were on board.

In order to be able to ensure safe shipping operation for the Traditional Vessel ATLANTIC, at least five crew members are necessary to operate the engine and the 245 m² sail area. For sailing manoeuvres, for example, in addition to the helmsman another two men are required on the fore ship and two men to operate the main and mizzen sails.
