Investigation Report 45/07

Less Serious Marine Casualty

**Loss overboard of 10 containers
from JRS CANIS
at estuary of Elbe River
on 12 January 2007 at 02:40**

1 October 2008

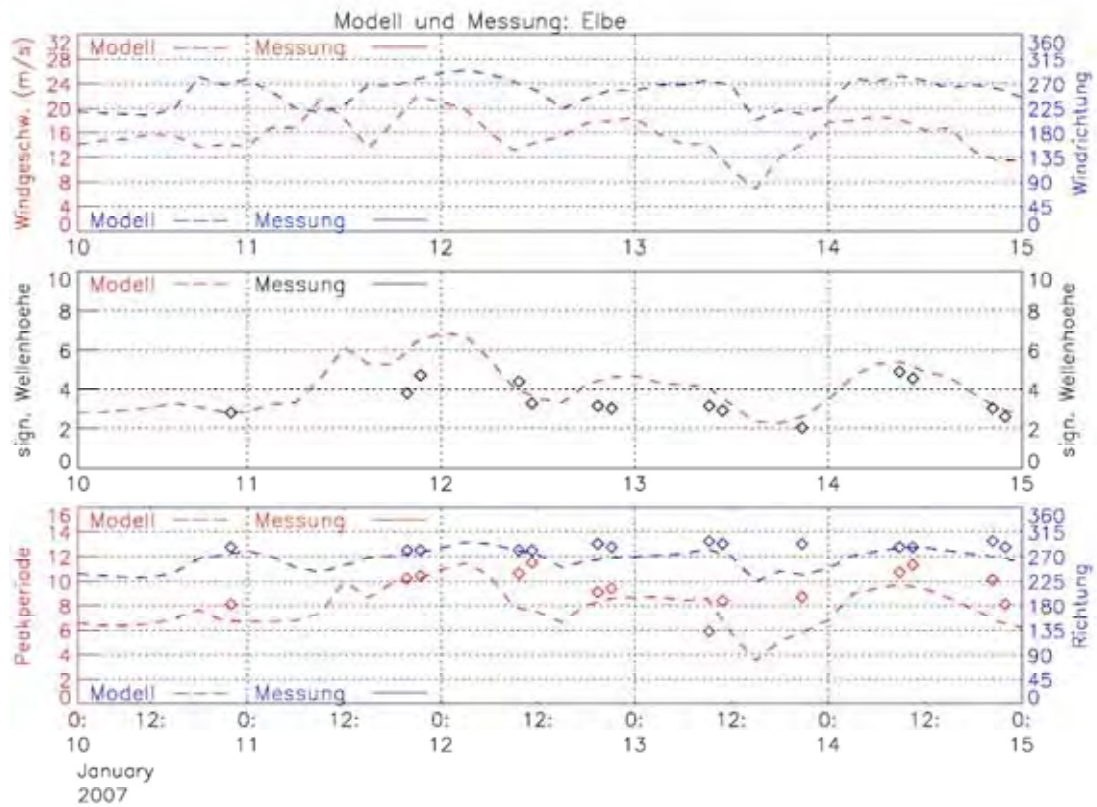
Figure 3: Weather data from the Elbe station

Since measurements were missing for the Elbe station (Fig. 3), we can only assume that the calculated wave heights were too high by roughly the same amount. The time progression at Heligoland and the Elbe station is very similar.

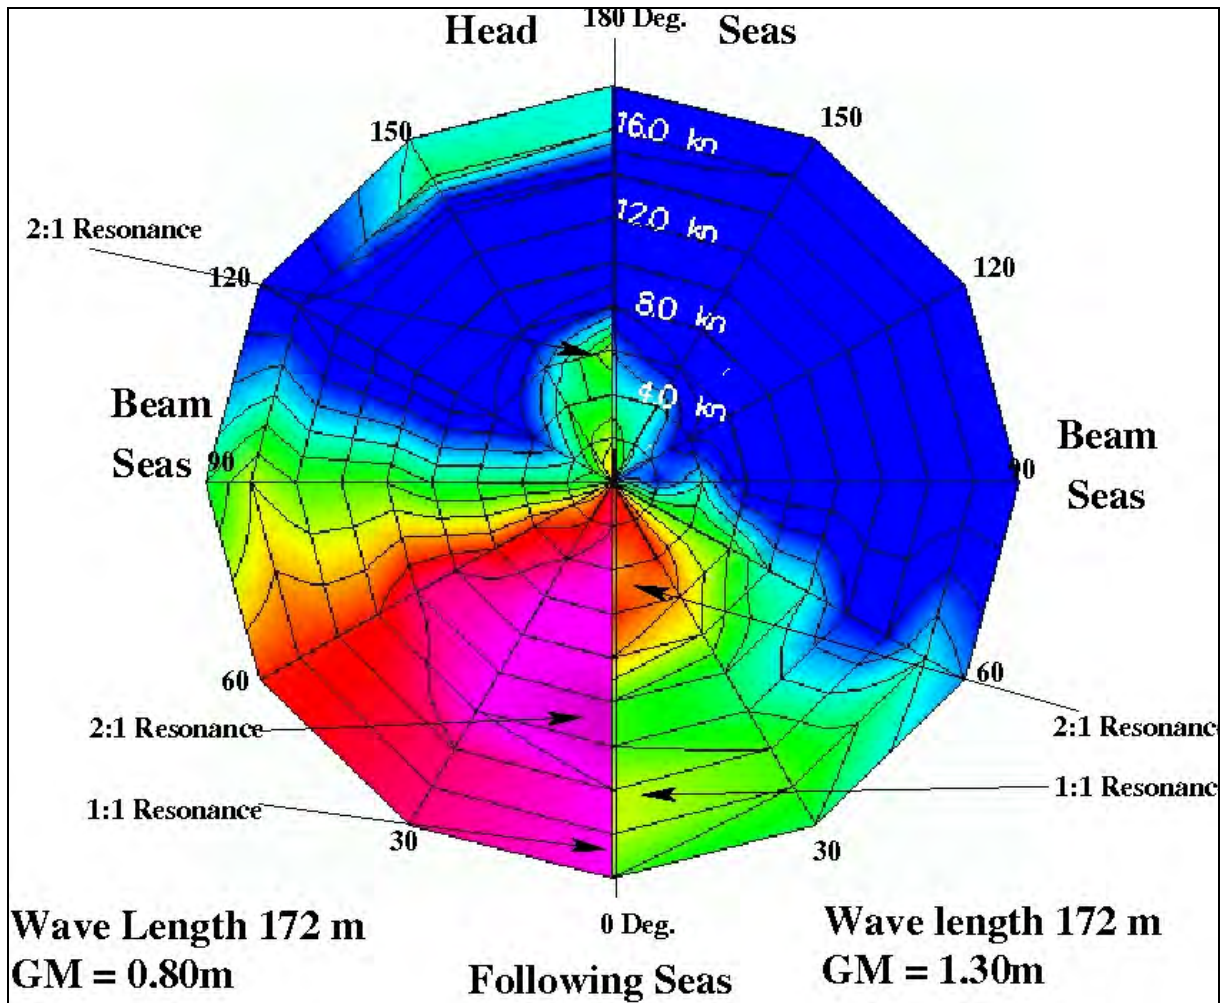
Figure 14: Wave effects for severe rolling

1:1 resonance in stern seas which is at about 20-21 kn for a GM of 1.0 m. Since the roll damping effect is considerable, you need much higher waves to produce a roll angle corresponding to the 2:1 situation. On the right-hand side of the image, you see the same ship but in longer waves with a 170 m significant length. You can clearly see that the critical resonances overall have shifted to lower speeds. Otherwise the image is very similar to the previous one. Even longer waves would shift the critical resonances overall to even lower speeds.

Illustration of the basic wave effects for severe rolling in a natural sea state for a RoRo ship with two different stability conditions. The colours denote at which (significant) wave heights a certain roll angle is exceeded.

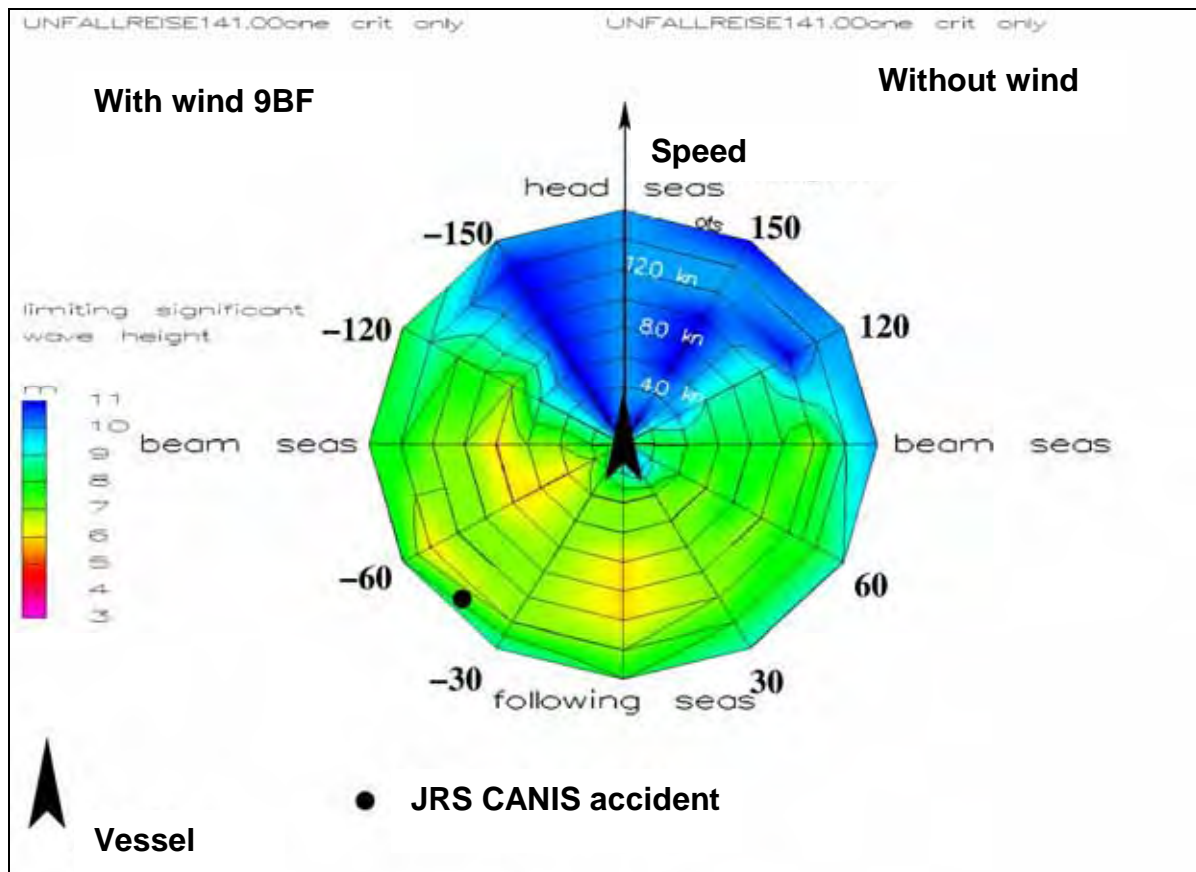
Figure 16: Calculated significant wave heights for generating a roll angle of 20°, **significant period 9.5 s**

Calculated significant wave heights for generating a roll angle of 20°, 99 % quantile (i.e. 99 % of the calculated roll angle is below 20°), significant period 9.5 s. Left side of the polar co-ordinate diagram: Including the influence of a 9 Bft wind, right side: without the influence of wind.

Initially, the results of the calculations generally show that a roll angle of about 15-20° (as observed by the crew) is achieved with a fair degree of probability taking all three situations into account. Accordingly the statements of the crew are realistic. Since the significant period was supposedly between 10.5 and 11.5 s (which would dictate a tendency for the waves to have been on the steeper side than is given in our model due to the formation of ground swell) the occurrence of the specified, repeated roll angle of 15-20° can be viewed as very probable. Due to the very large range of vessel stability, the 2:1 resonance has practically no effect, likewise the 1:1 resonance. This corresponds to the aforementioned expectations, that we cannot fundamentally assume a risk state in a stern sea due to the stability being more than sufficient. Furthermore, calculations show a certain influence by the wind, i.e. that the heeling angle generated is somewhat more pronounced due to the wind. However, the influence is not so major that it can be viewed as the cause of the loss of cargo. An interesting fact is that a risk state when broaching-to at low speeds is indicated for larger wave lengths. As a result the transfer functions of the rolling motion were examined once again and they showed that the linear transfer functions reach their peak roughly in the range of a period of 11-15 s at speeds of between 0 and 8 kn (Nb: The natural roll period of the vessel at the time of the accident was about 13.7 s). However, due to linearisation of the sway, the rolling motion of the vessel is

In summary, the following can be established from an analysis of the situations and conditions that lead to an approx. 20° roll angle: The roll angle observed by the crew of about 15 to 20° approximately matches the roll angles of the simulation which you would expect in a natural sea state with a significant period of around 11 s, especially if the sea would also tend to ground swells.

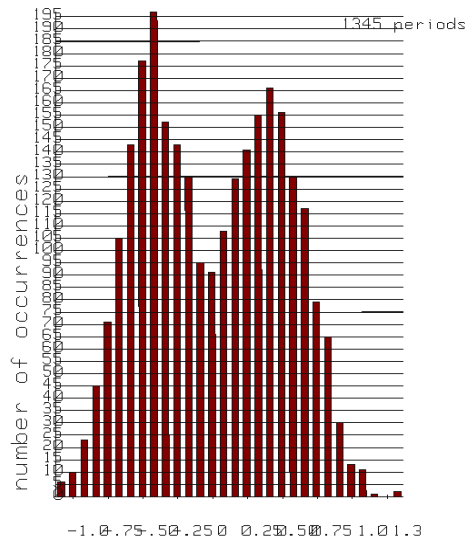
Figure 23: Static distribution of vertical accelerations

$T=11.0s$, $H 1/3= 7.0m$

Heading: 135.0deg, Speed: 8.0knots

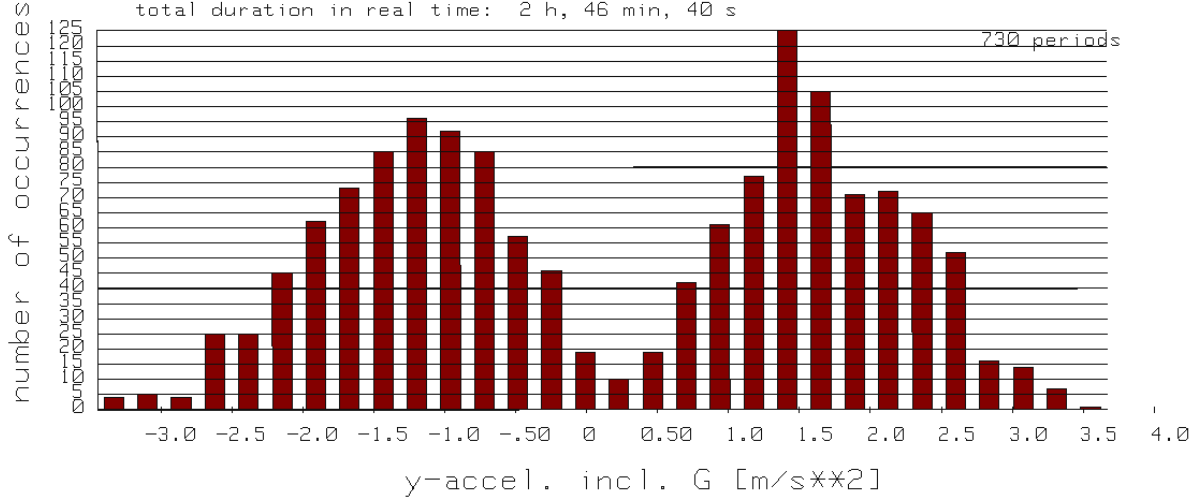
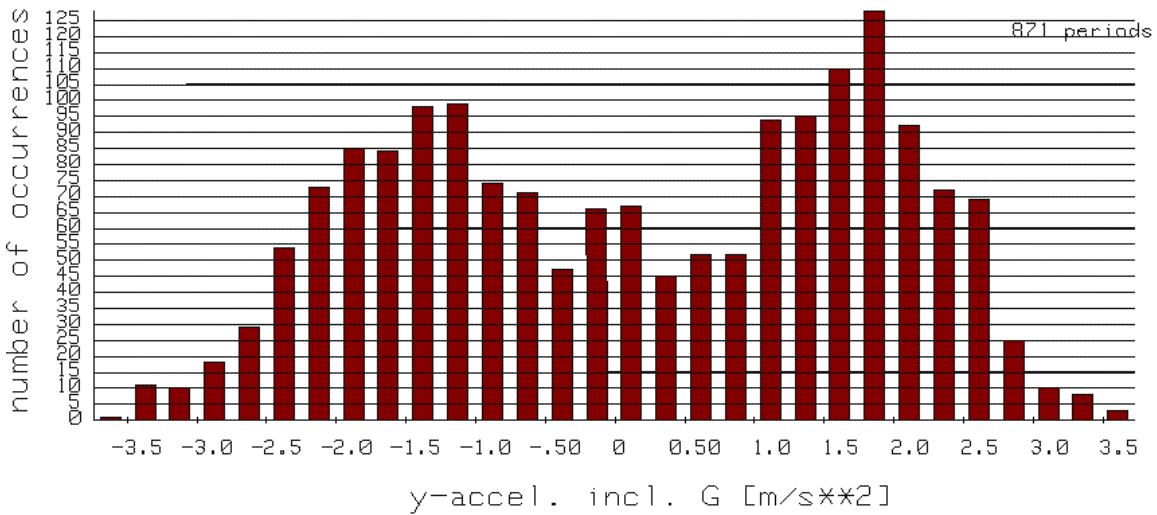
Figure 24: Static distribution of transverse accelerations

T=11.0s, H 1/3= 7.0m
 Heading: 45.0deg, Speed: 16.0knots
 Statistics over time: mean: 0.174901, st.dev.: 1.117138
 of amplit.> mean(time): mean: 1.676676, st.dev.: 0.638510
 of |amplit.|: mean: 1.475505, st.dev.: 0.694696
 signif.: 2.347696
 total duration in real time: 2 h, 46 min, 40 s

T=11.0s, H 1/3= 7.0m
 Heading: 135.0deg, Speed: 8.0knots
 Statistics over time: mean: 0.172486, st.dev.: 1.175716
 of amplit.> mean(time): mean: 1.634460, st.dev.: 0.719667
 of |amplit.|: mean: 1.490510, st.dev.: 0.781097
 signif.: 2.433603
 total duration in real time: 2 h, 46 min, 40 s

It is possible that the lashing experienced a certain range of prior damage which could have then led to a forced break of the lashing later on due to transversal acceleration based on the calculated acceleration values for a course at low speed moving transversely against the sea which theoretically could have led to the loss of cargo.

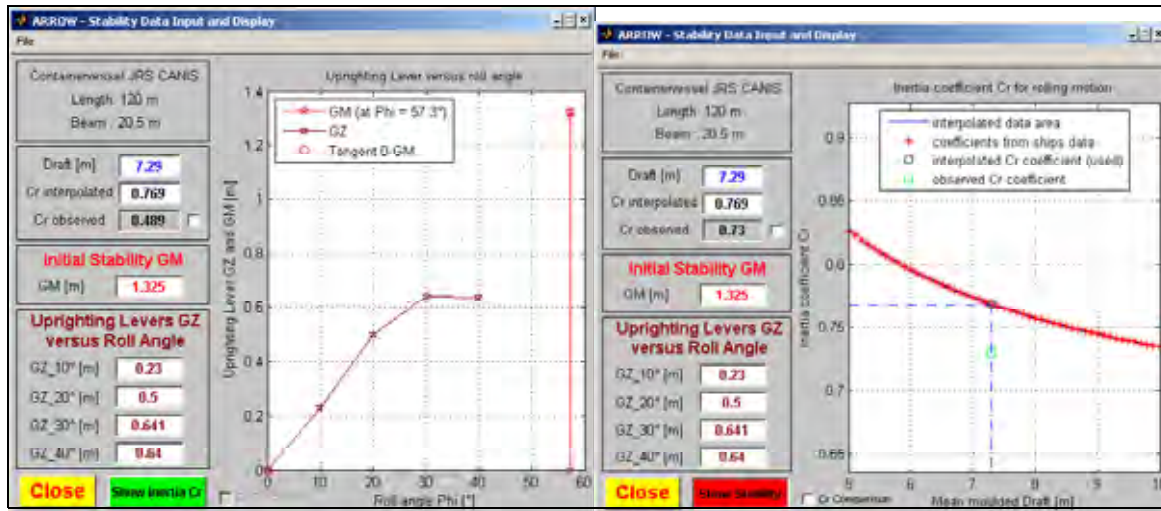
Figure 30: Stability data window – lever arm curve over the roll angle with tangents based on the GM value (left) and inertia coefficient curves CR for rolling over the draught

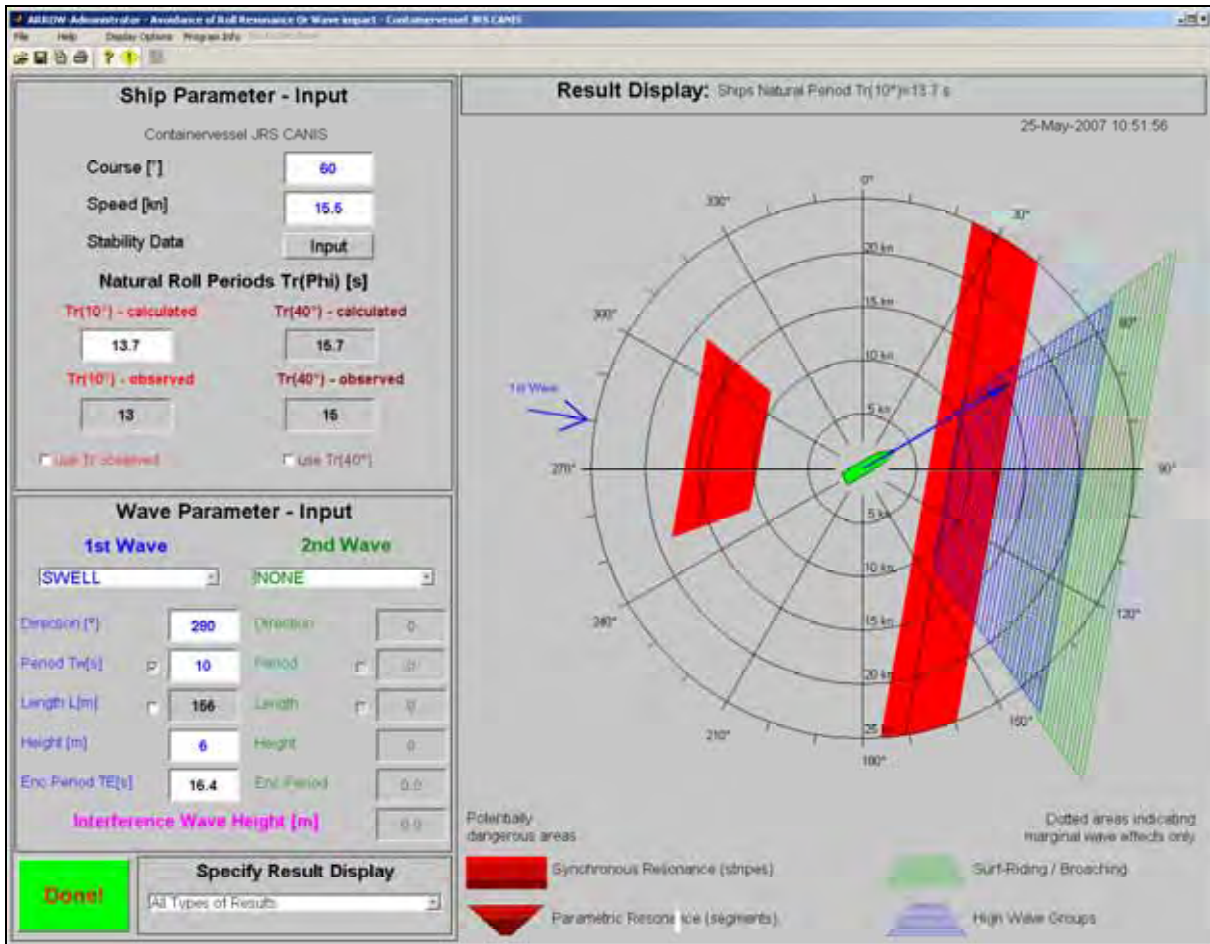
Figure 31: Results from the endangerment assessment for $T_w=10$ s - here without $Tr(40^\circ)$.
(ARROW application for JRS CANIS)

Calculations were also carried out for wave period $T_w = 11$ s (Fig. 32) and wave period $T_w = 12$ s (Fig. 33) in addition to calculations of dangerous areas for the aforementioned period $T_w = 10$ s (Fig. 29 and Fig. 31).

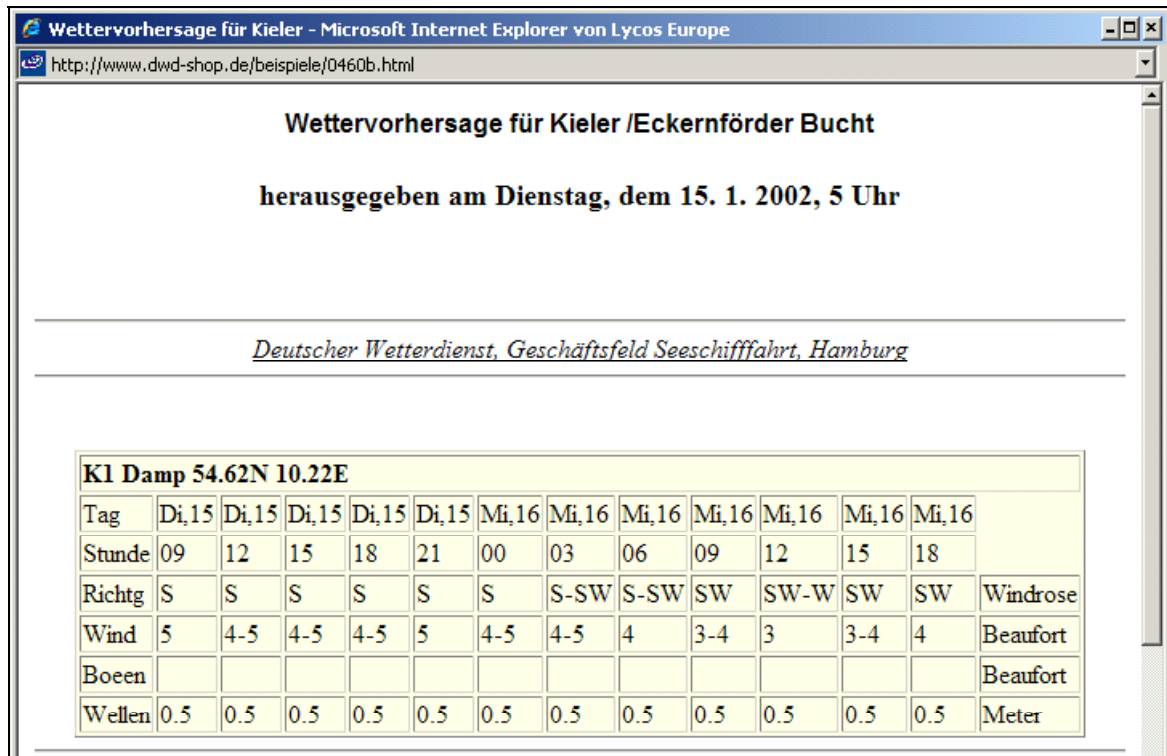
Figure 34: Example of commercial weather information of the DWD from the "Wettershop" - however, this contains no information on wave periods (<http://www.dwd-shop.de/>)

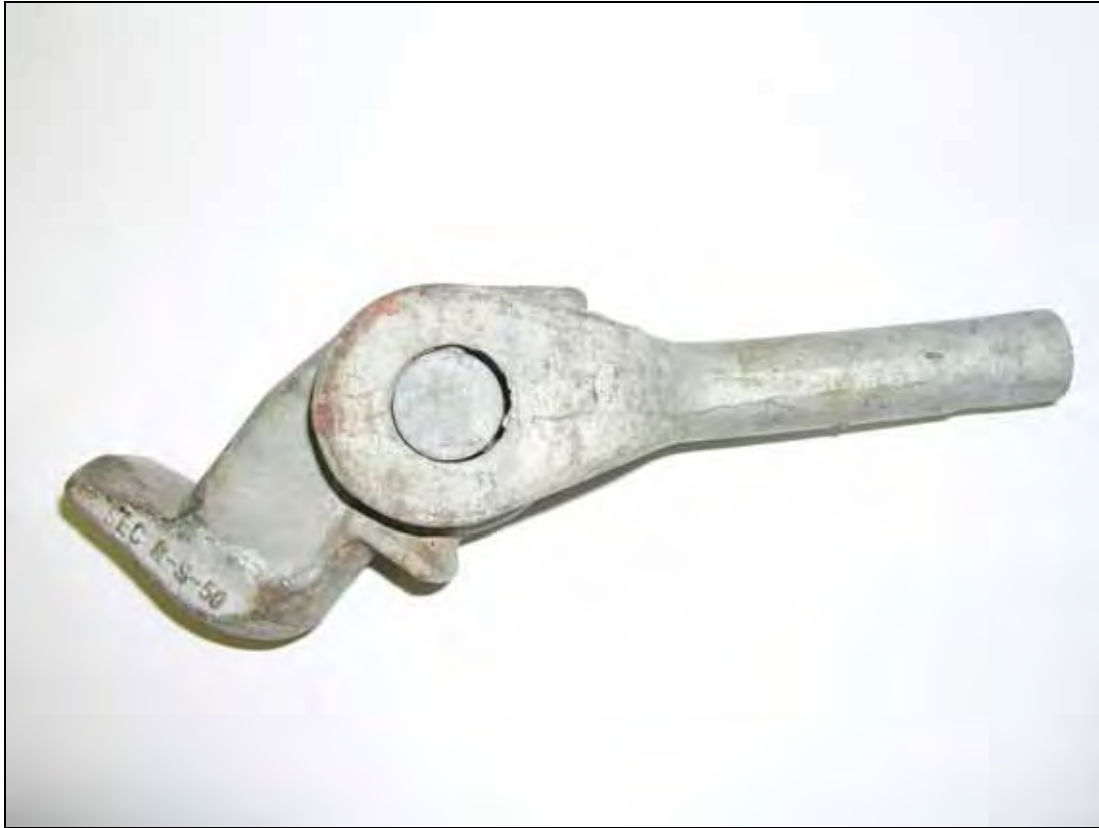
Figure 42: Fragment of a lashing bar

A hardness test from the micro-section showed a hardness of 272 HV 10. This allows us to estimate a tensile strength for the lashing bar of approx. 870 N/mm².

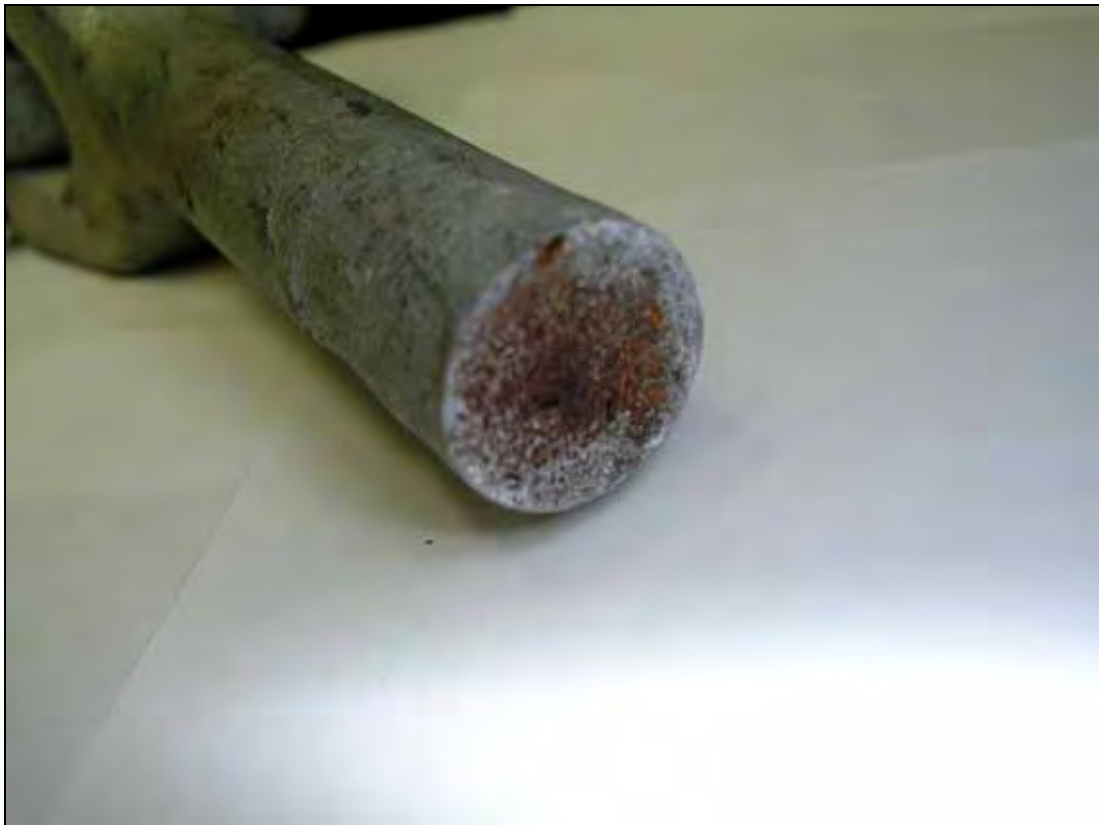
Figure 43: Corroded fracture surface of the lashing bar

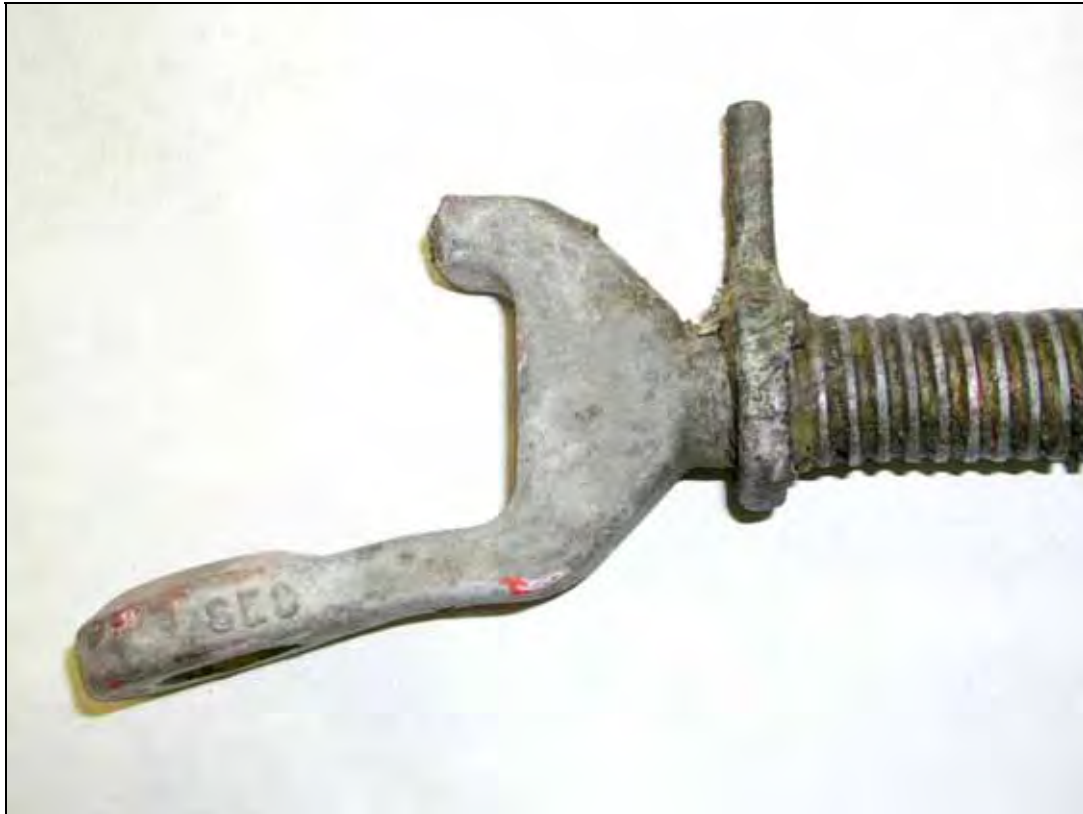
Figure 45: Turnbuckle fork

As shown in Figure 45, the end of the turnbuckle is forked with lugs. The fracture is next to a lug in the side of the fork. The fracture was non-deformed and the fracture area is covered with corrosion products which means that no additional information can be taken from the fracture image (Fig. 46). The micro-section taken from the fracture area shows that the material is cast steel with low micro-porosity. The structure corresponds to a hardened and tempered material (Fig. 45). A hardness test gave an average value from three measurements of 309 HV 10. The subsequently calculated tensile strength is 995 N/mm².

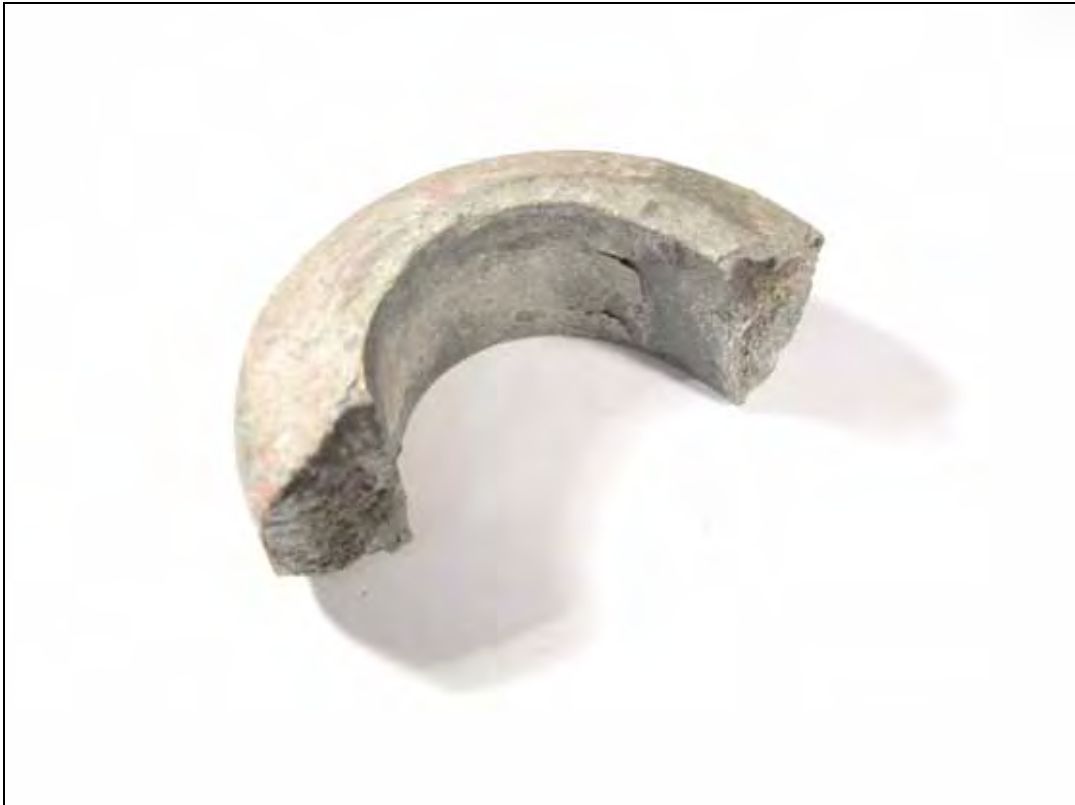
Figure 48: Lug fragment

The hardness test showed an average value from three measurements of 326 HV 10. Accordingly the tensile strength must be estimated as 1040 N/mm².

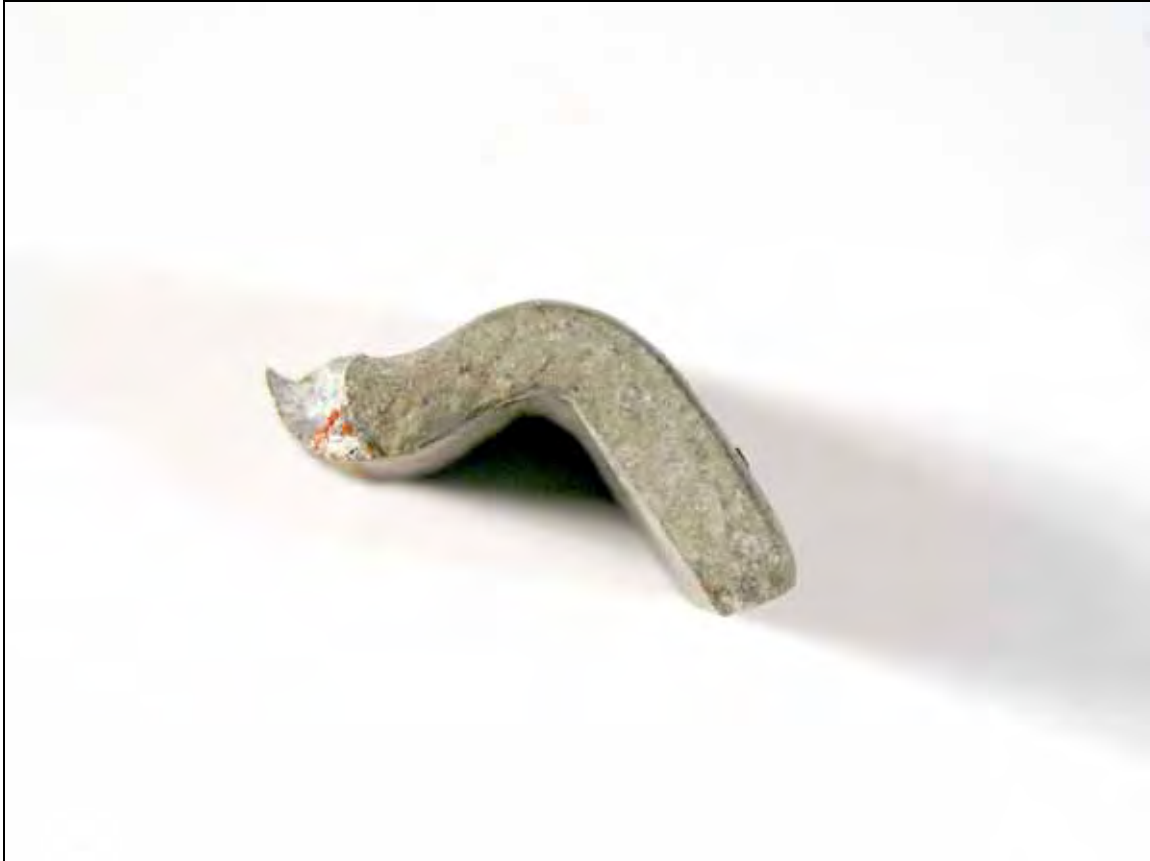
Figure 50: Bolt

The bolt is a narrow strip of material broken with a shear fracture (see Fig. 50). The micro-section showed that the bolt was manufactured from a sheet using cold forming. The material is low-carbon steel with a structure predominantly comprising ferrite (Fig. 51).
