**Bundesstelle für Seeunfalluntersuchung**  
**Federal Bureau of Maritime Casualty Investigation**  
Federal Higher Authority subordinated to the Ministry of Transport,  
Building and Urban Affairs

**Summary**  
**Investigation Report 491/08**

**Danger due to suction and waves**  
**on 14 September 2008**  
**on the Lower Elbe - level with Wittenbergen**  
**caused by the MV WMS GRONINGEN**

**15 June 2009**

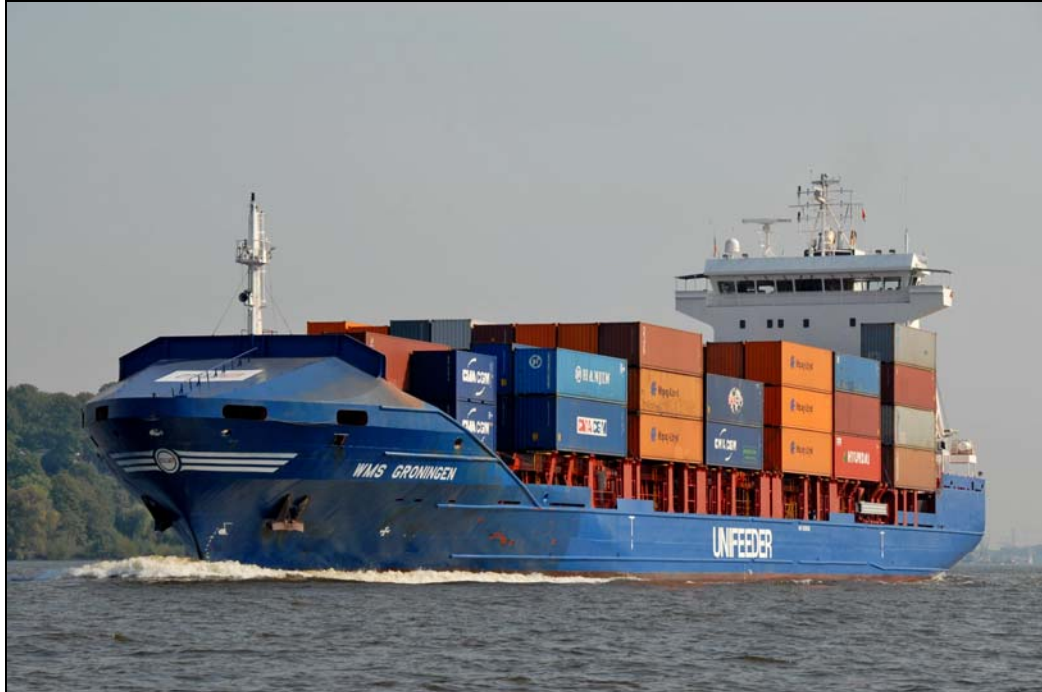
Figure 2: Vessel photo (Hasenpusch)

Name of the vessel:	WMS GRONINGEN
Type of vessel:	Container vessel (container feeder)
Nationality/flag:	Cyprus
Port of registry:	Limassol
IMO number:	9339038
Call sign:	C4NV2
Shipping company:	C.V. Scheepvaartonderneming MV WMS GRONINGEN
Year built:	2006
Shipyard:	Fujian Mawei Shipbuilding Ltd./Fuzhou
Classification society:	GL
Length overall:	129.60 m
Breadth overall:	29.60 m
Gross tonnage:	7,545
Deadweight:	8,173 t
Draught:	Fore = 6.58 m; Midship = 7.37 m; Aft = 8.15 m
Engine rating:	7,200 kW
Main engine:	Caterpillar 8 M 43 C
(Service) speed:	16 kts
Persons on board:	12

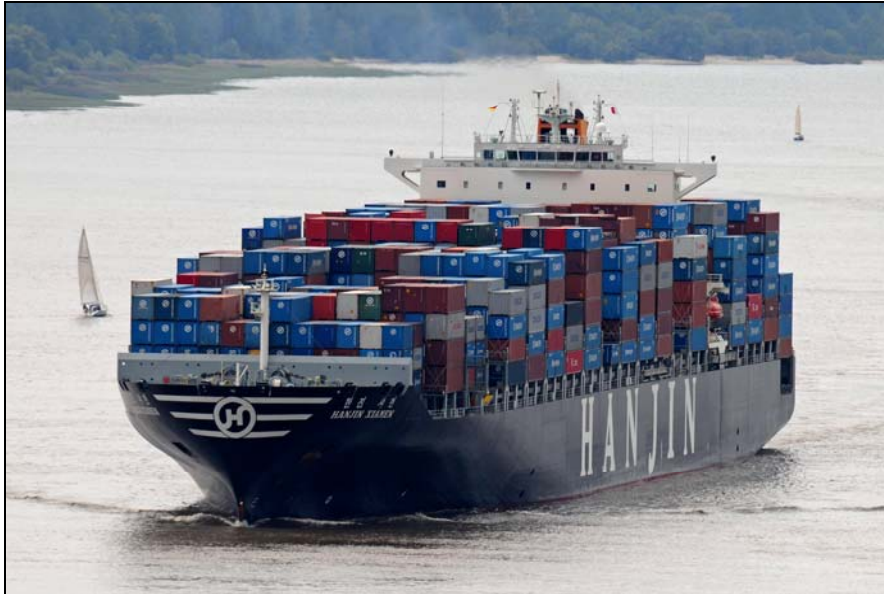
Figure 3: Container vessel HANJIN XIAMEN

At around 1507, between buoys 115 and 117 in the Lühebogen, the WMS GRONINGEN began manoeuvring to overtake the container vessel HANJIN XIAMEN sailing ahead of her. The HANJIN XIAMEN is a container vessel with a length of 304 m and a width of 40 m, sailing under the Panamanian flag.

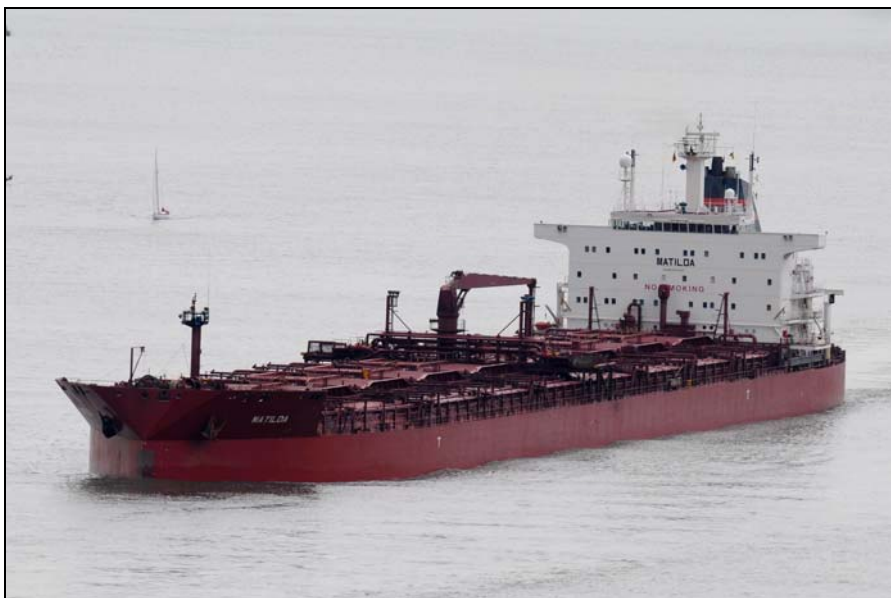
Figure 4: Tanker MATILDA

This overtaking manoeuvre was completed at 1513 by buoy 121. The next overtaking manoeuvre was then immediately begun in order to pass the tanker MATILDA sailing in the same direction. The tanker MATILDA, sailing under the Liberian flag, is 228 m long and 32 m wide.

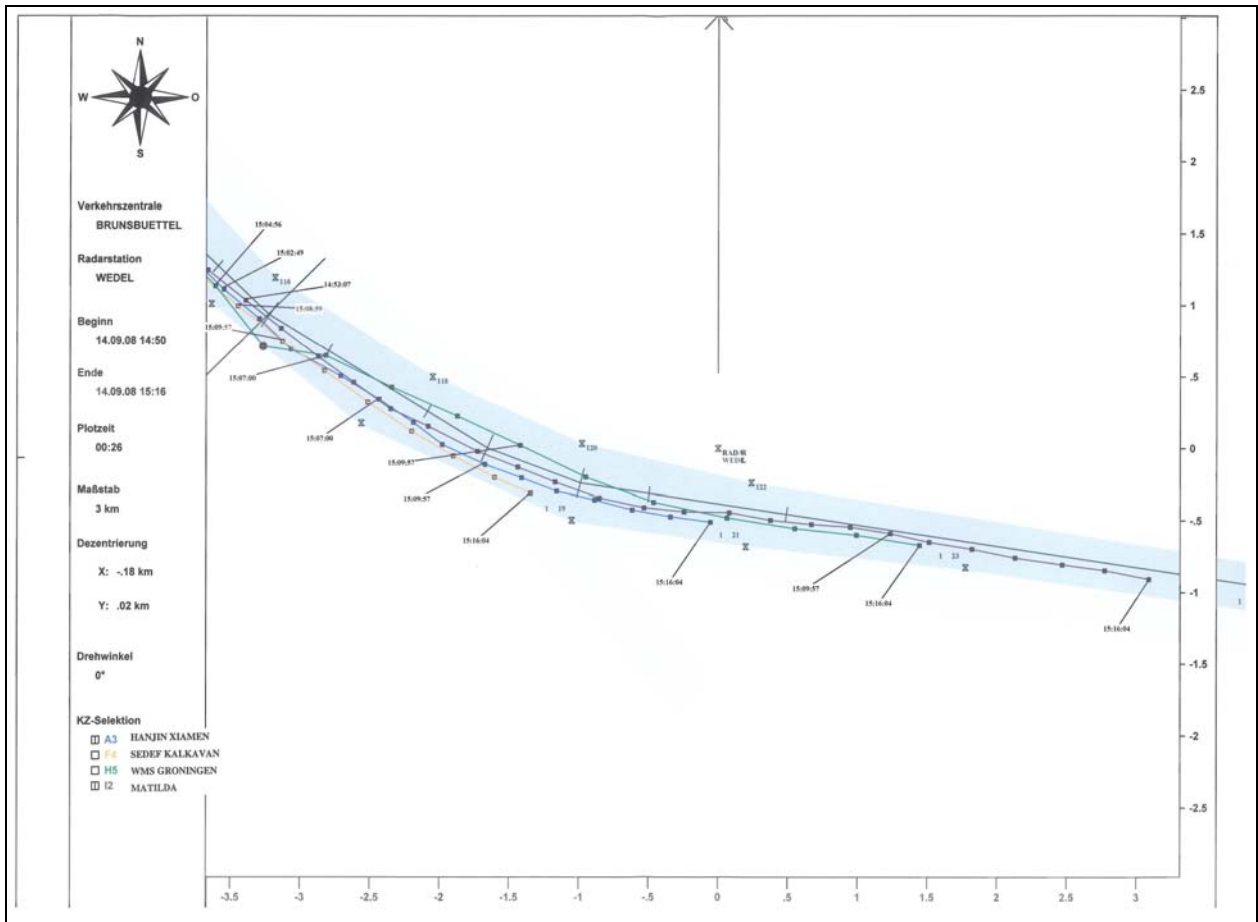
Figure 5: Plot from the Wedel radar station

The course of the voyage in the area of fairway buoys 115/LS 19 to 131 (Blankenese) was determined relatively precisely and virtually identically using the various recordings available (radar and AIS). The course of the voyage in the Lühebogen, recorded by the Brunsbüttel Vessel Traffic Service, is shown below.

MATILDA	1458
HANJIN XIAMEN	1507
WMS GRONINGEN	1508

Time	WMS GRONINGEN [ kts ]	HANJIN XIAMEN [ kts ]	MATILDA [ kts ]	Comment relating to WMS GRONINGEN
1506	14.6	12.1	10.2	
1507	14.9	10.1	9.6	Overtaking manoeuvre begun
1508	17.1	9.3	9.8	Vessel north of the radar reference line abeam buoy 117
1509	17.4	9.6	9.7	Alongside HANJIN XIAMEN
1510	17.3	11.4	10.0	
1511	17.5	9.3	10.0	
1512	16.3	8.6	10.2	Once again south of the radar reference line
1513	18.0	9.0	10.4	Passing buoy 121
1514	15.3	9.0	10.9	
1515	14.4	9.0	9.9

The above speed data was recorded by the Wedel radar station. This shows the clear increase in the speed of the WMS GRONINGEN for the overtaking phase. Random, inconclusive jumps in speed can be explained by the variation in radar echo capture.

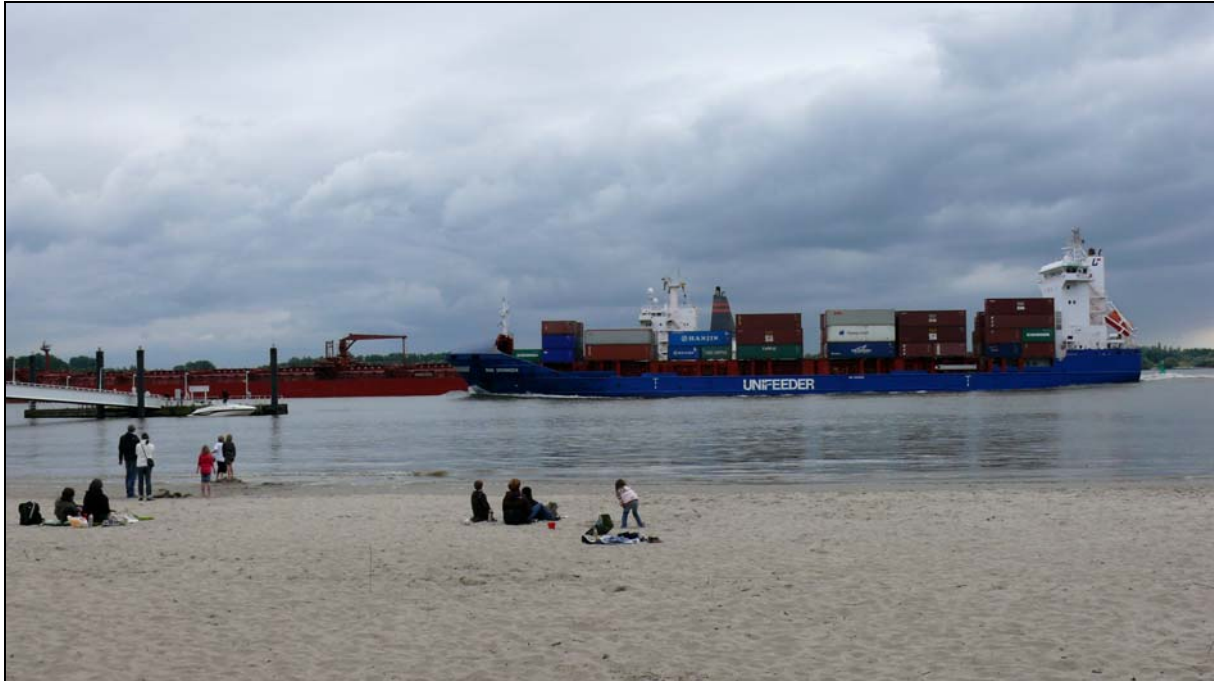
Figure 7: Overtaking manoeuvre at 1525

During this overtaking manoeuvre, suction and waves were caused by the vessel at around 1525 on the shore at Wittenbergen. A wave washed over the entire shore area, and at least five adults and six children were put at considerable risk. An oncoming HADAG ferry took evasive measures, moving to the north to ensure safe passage.

The phases of the overtaking manoeuvre by Wittenbergen were recorded by a witness in the form of several photos:

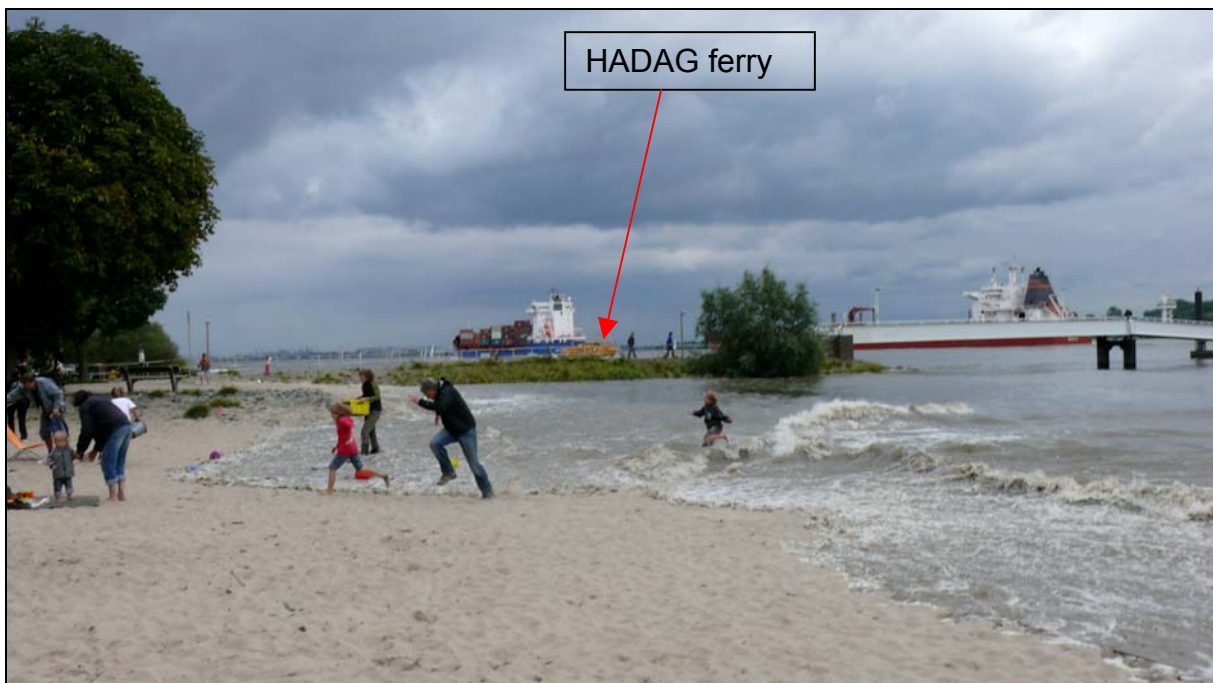
Figure 8: Overtaking manoeuvre at 1526

According to witness accounts, the WMS GRONINGEN moved a considerable distance to the north, leading to fears that she would collide with the Wittenbergen jetty.

As part of the investigation of the swell damage involving injury to five people on 11 June 2007, caused by the Ro-Ro vessel GRANDE NIGERIA (Summary Investigation Report 253/07 dated 1 July 2008), the Federal Bureau of Maritime Casualty Investigation produced a detailed report on the problems of suction and swell created by vessels at the Wittenbergen jetty. In 2008, the HPA subsequently put up additional warning and danger signs and filled in a steep concrete bank with sand replenishment to create a shallower shore transition point. However, these measures have evidently not lasted, as the sand in the west section of the former Lindenterrasse terraced area has already been largely washed away again. Unlike in 2007, however, this renewed depletion of sand did not have any direct influence on the marine casualty being investigated here. As shown in Figure 8, the waves did not rise as high as in 2007, and there was therefore still sufficient room to escape.
