Bundesstelle für Seeunfalluntersuchung
Federal Bureau of Maritime Casualty Investigation
Federal Higher Authority subordinated to the Ministry of Transport,
Building and Urban Development

Investigation Report 56/09

Very serious marine casualty

**Collision between Motor Vessel CHRISTA
and Pleasure Craft ODIN off Timmendorf/Poel
on 28 February 2009**

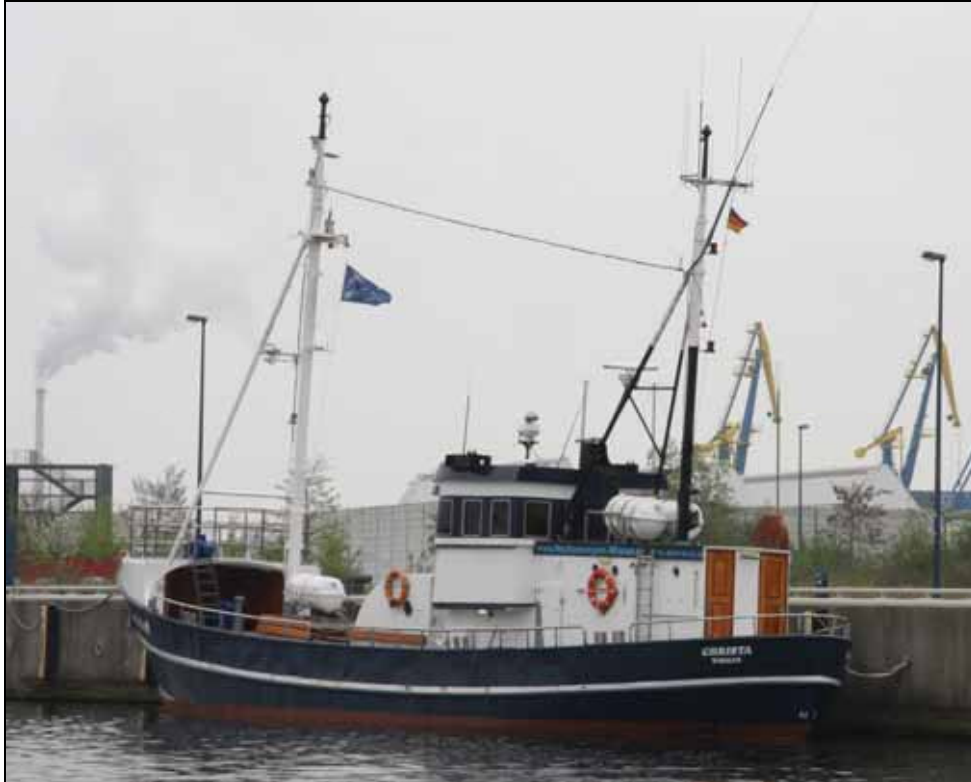
Figure 2: Photo CHRISTA

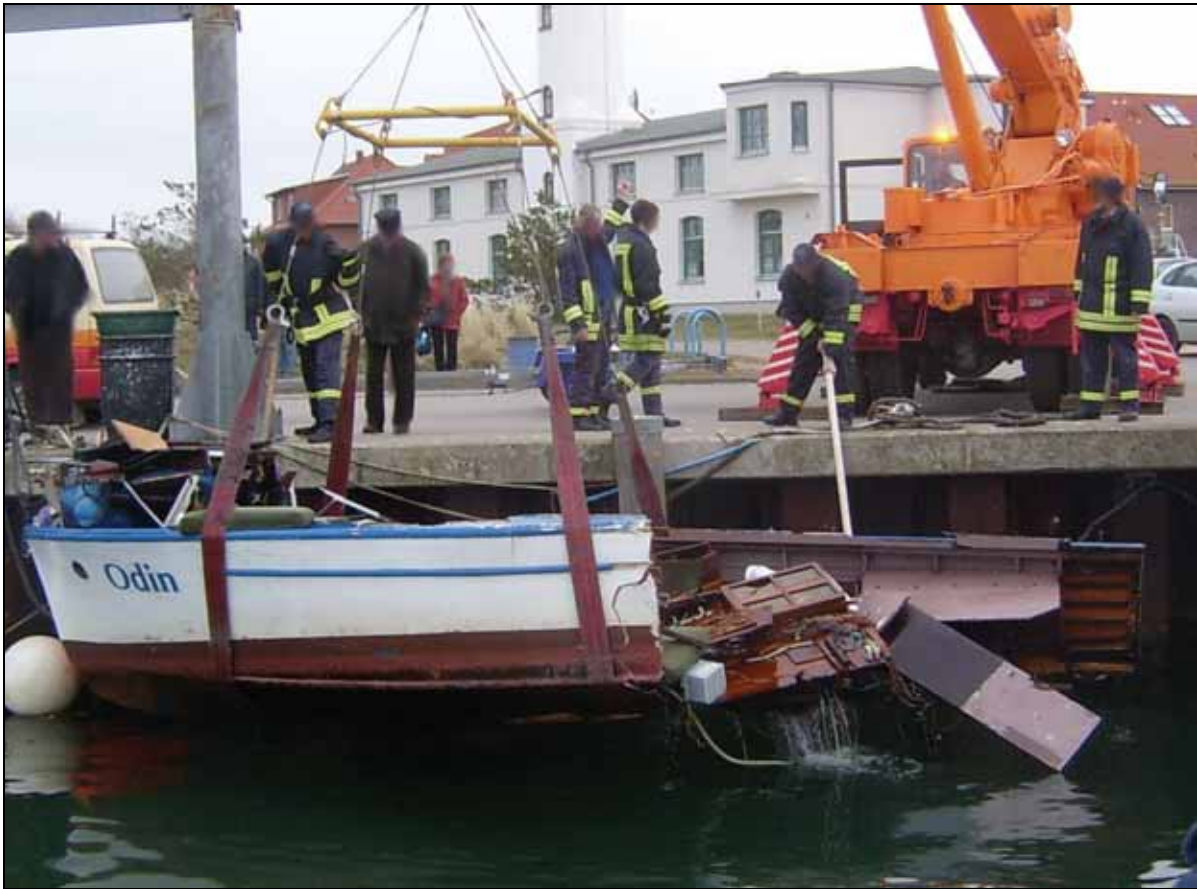
Figure 3: Photo ODIN

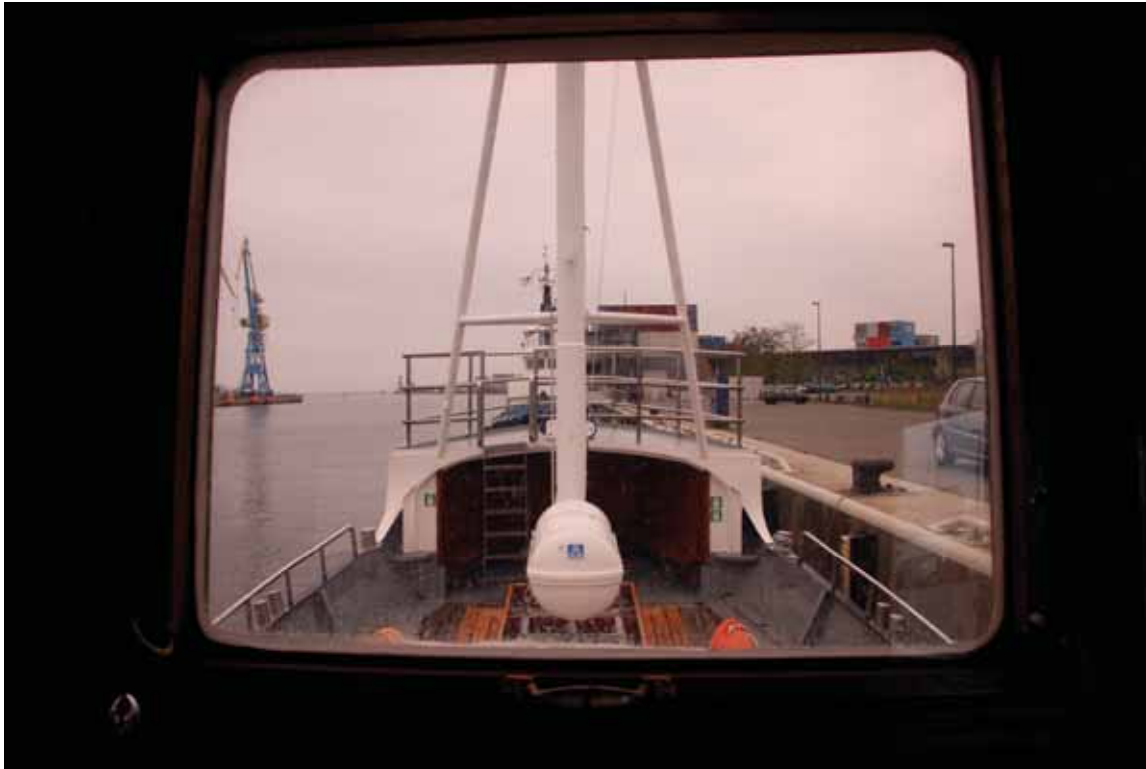
Figure 4: View ahead from the bridge of the CHRISTA; the colour of the image is due to the tinted windscreens

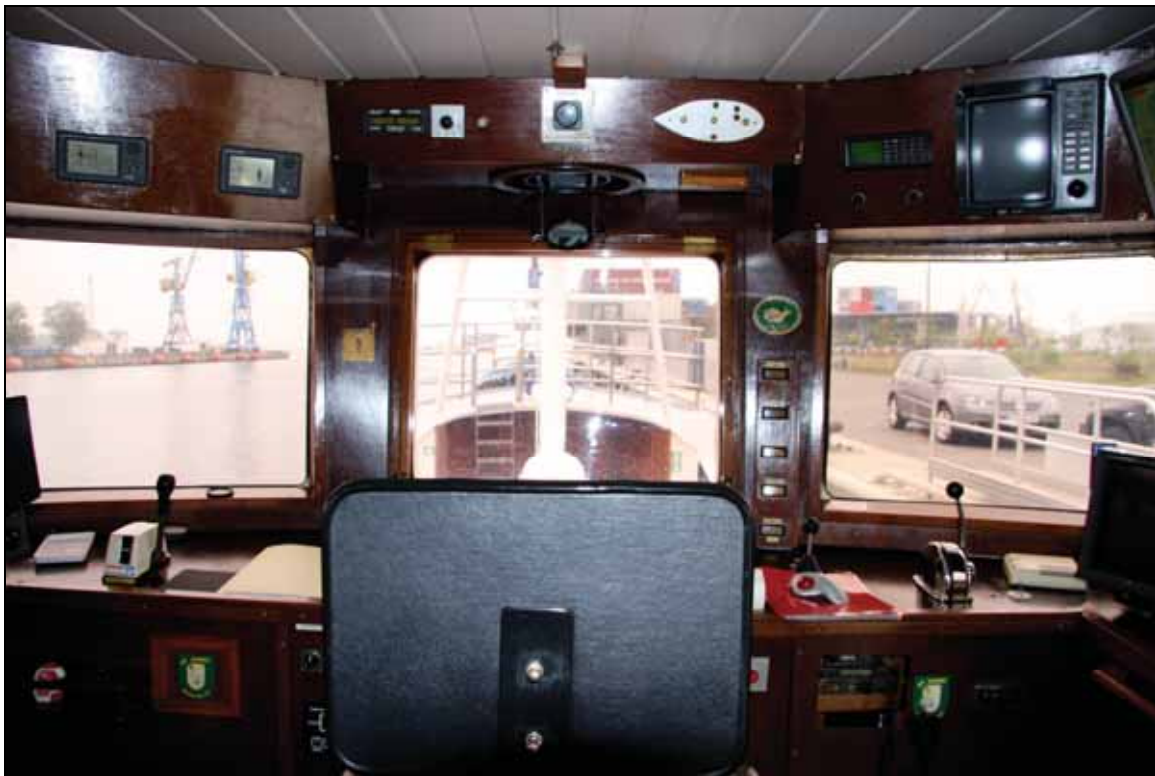
Figure 5: Bridge of the CHRISTA, looking ahead

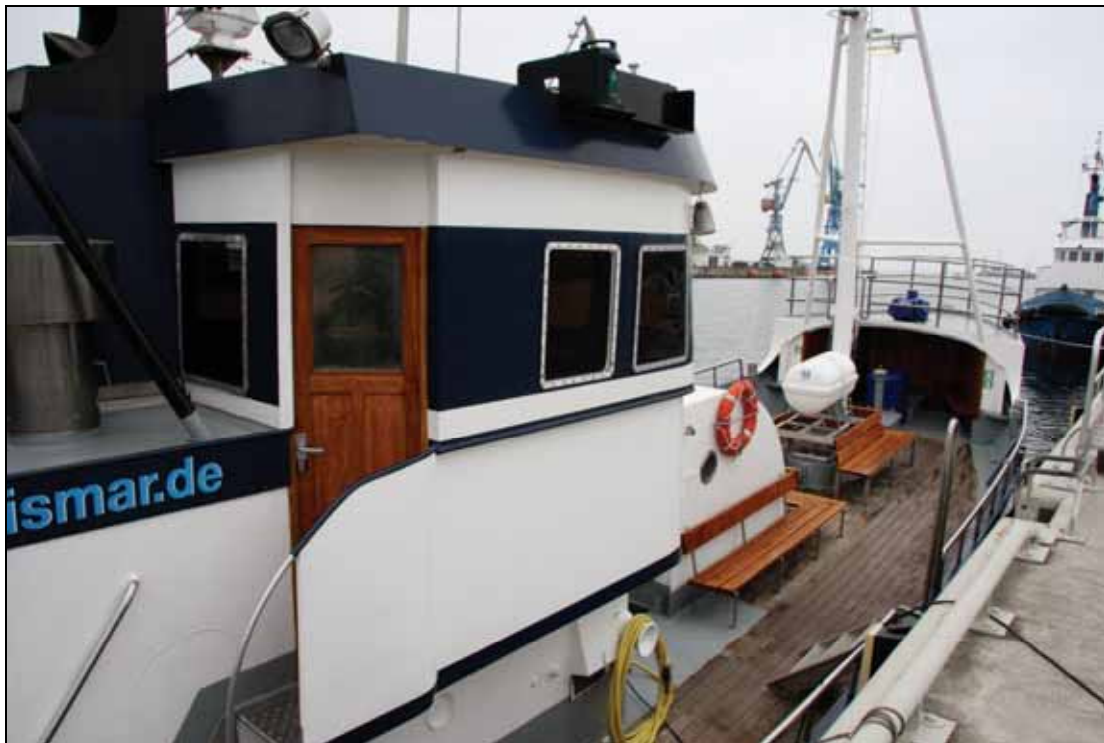
The CHRISTA was only marginally damaged by the collision with slight dents and paint abrasions in the bow area. None of the passengers were injured.

Figure 6: View of the main deck of the CHRISTA

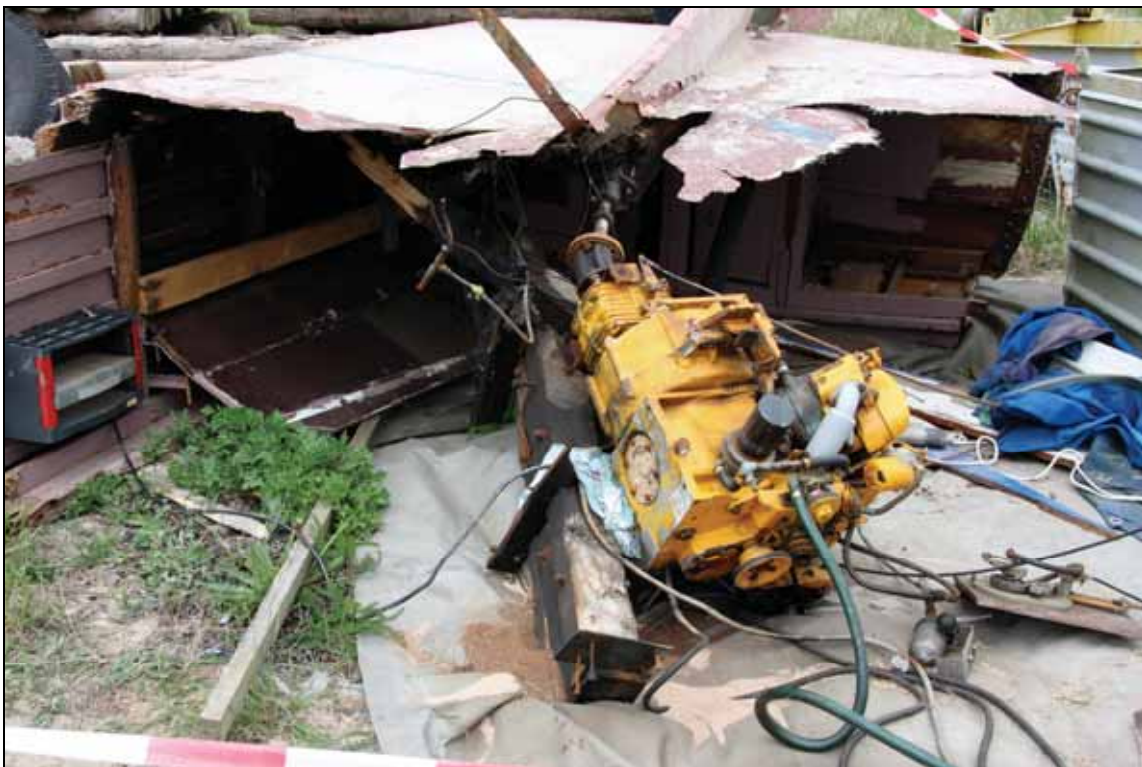
Figure 9: View into the rear of the ODIN and of the installed engine

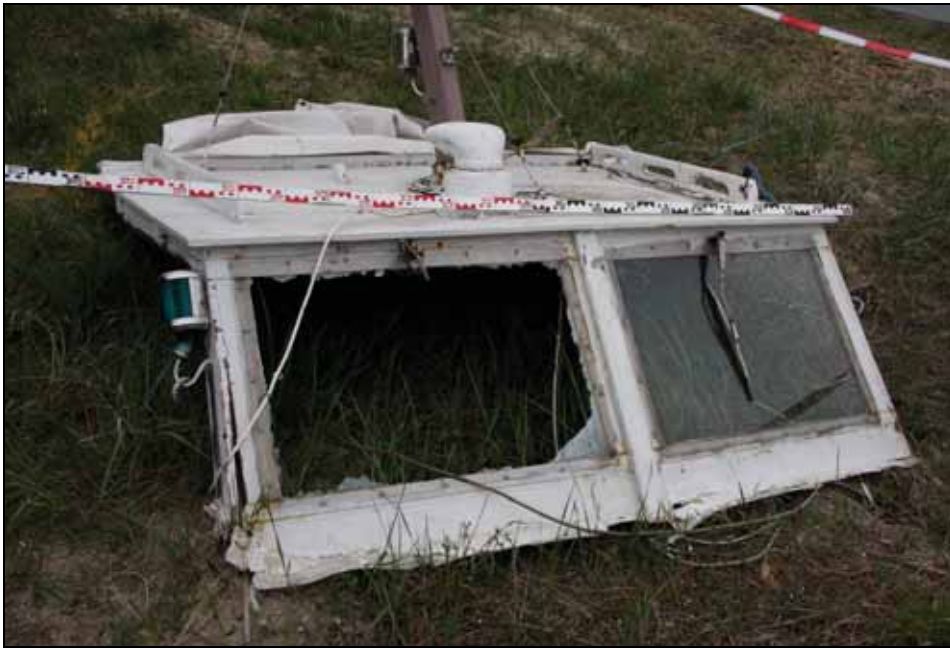
Figure 10: Wheelhouse of the ODIN

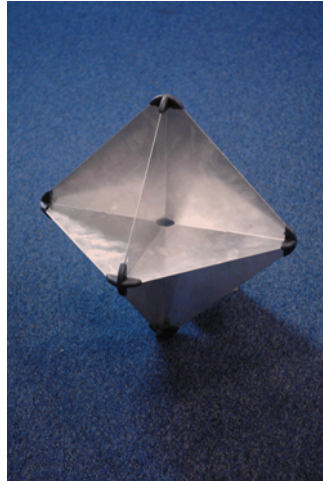
Plastimo 16" is a push fit octahedral reflector constructed from three aluminium diamonds slotted together, these panels are locked in place by plastic corner pieces. This reflector only had mounting holes for an upright position (not the generally recommended "catch rain" position). The Plastimo 16" Octahedral reflector is pictured in this mounting position in figure 2.

Figure 2 Photo of the Plastimo 16" Octahedral reflector

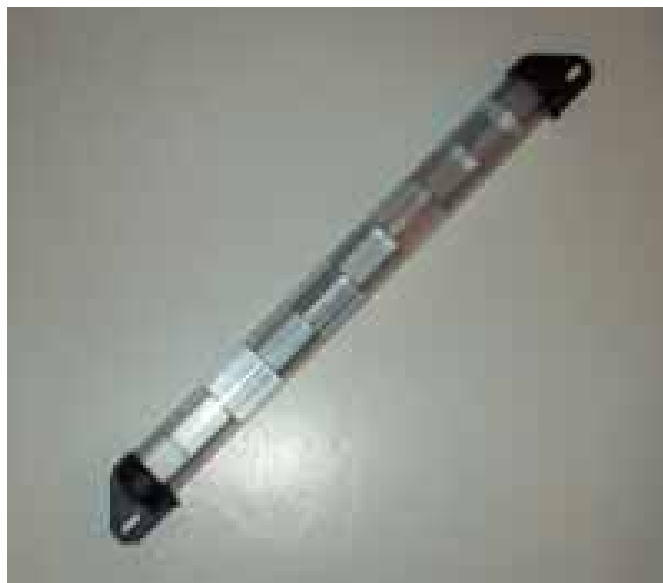
4" tube is the larger of the two tube reflectors currently on the market; it consists of an array of dihedrals stacked in the vertical plane which are encompassed within a clear plastic body. Manufacturers instructions show it vertically mounted. A Plastimo tube reflector is shown in figure 3.

Figure 3 Photo of the Plastimo Tube reflector.

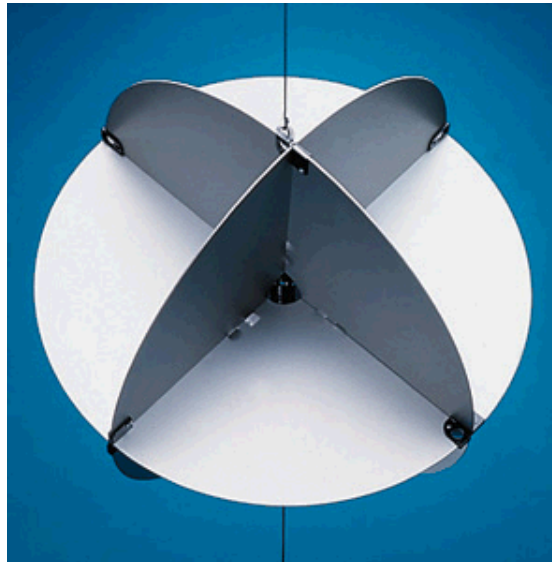
The Davis Echomaster is a push fit octahedral reflector constructed from three aluminium circular panels which are slotted together, these panels are locked in place by plastic corner pieces. This octahedral is designed to be mounted in the catch rain position, and is shown below in this position in figure 4.

Figure 4 Davis Echomaster radar reflector

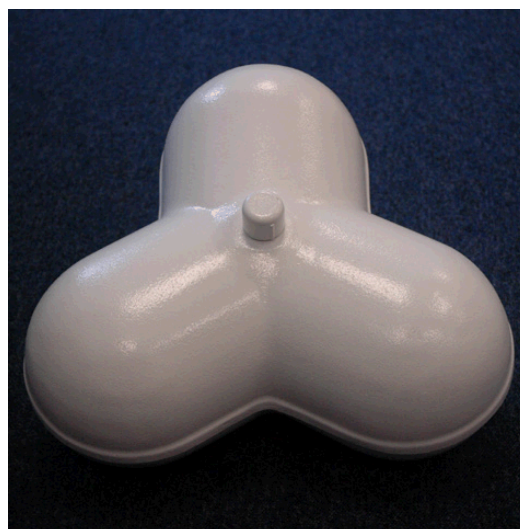
The Viking Large Tri-Lens is the largest of the Viking (also marketed as Rozendal) Tri-Lens range of radar reflectors, it uses three luneberg type lens reflectors spaced 120° apart and is encompassed by a moulded plastic case. At 5.5kg it is the heaviest reflector currently on the market. The large Tri-lens is pictured below in figure 5.

Figure 5 Photo of the Large Tri-Lens reflector

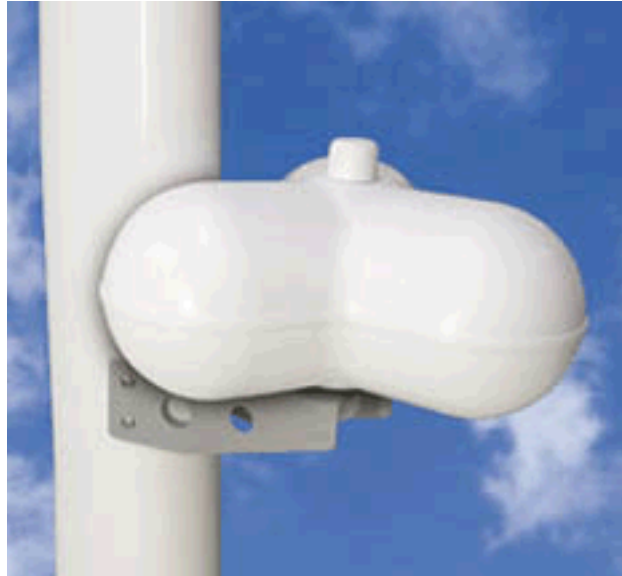
The Viking Standard Tri-Lens is the medium sized Tri-Lens, it utilises three luneberg type lens reflectors spaced 120° apart and is encompassed by a moulded plastic case. The Standard Tri-lens is pictured below in figure 6.

Figure 6 Photo of the standard Tri-Lens.

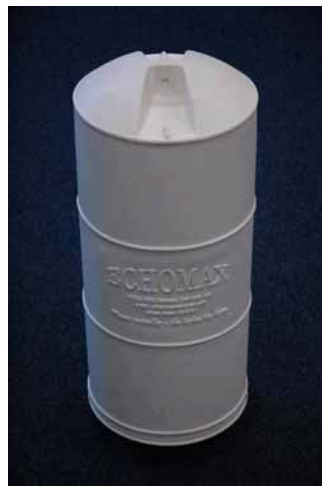
The Echomax 230 reflector comprises a vertical stack of three aluminium corner arrays enclosed in a plastic case. It relies upon interactions between each of the arrays to produce large peak responses. This reflector is only one supplied which has been type approved to ISO8729 [1]. The Echomax 230 reflector is pictured in figure 7.

Figure 7 Photo of Echomax 230 reflector

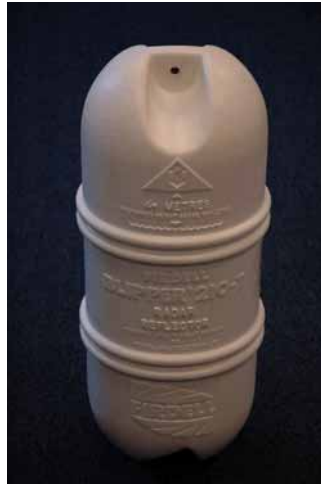
The Firdell Blipper is outwardly of a similar design to that of the Echomax 230 but it uses a vertical spiral array of 7 corners. It relies upon interactions between each of the corners to produce large peak responses. The reflector is encompassed within a plastic case. The Blipper 210-7 reflector is pictured in figure 8.

Figure 8 Photo of a Firdell 210-7 reflector

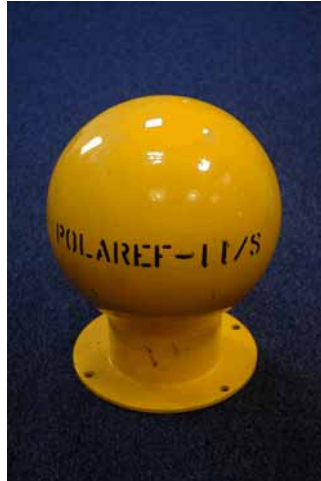
The POLARef 11 reflector is a precision radar target generally used for the calibration of radars. It is a luneberg lens which operates over its complete azimuth range. This reflector is usually made to order but has been included as a baseline to demonstrate what is achievable from a passive reflector. The POLARef 11 reflector is shown in figure 11.

Figure 10 Photograph of the POLARef 11 reflector.
