**Bundesstelle für Seeunfalluntersuchung**  
**Federal Bureau of Maritime Casualty Investigation**  
Federal Higher Authority subordinated to the Ministry of Transport  
and Digital Infrastructure

## **Interim Investigation Report**

# **Collision between the general cargo ship EVERT PRAHM and the Rendsburg transporter bridge on 8 January 2016 in Kiel Canal**

6 January 2017

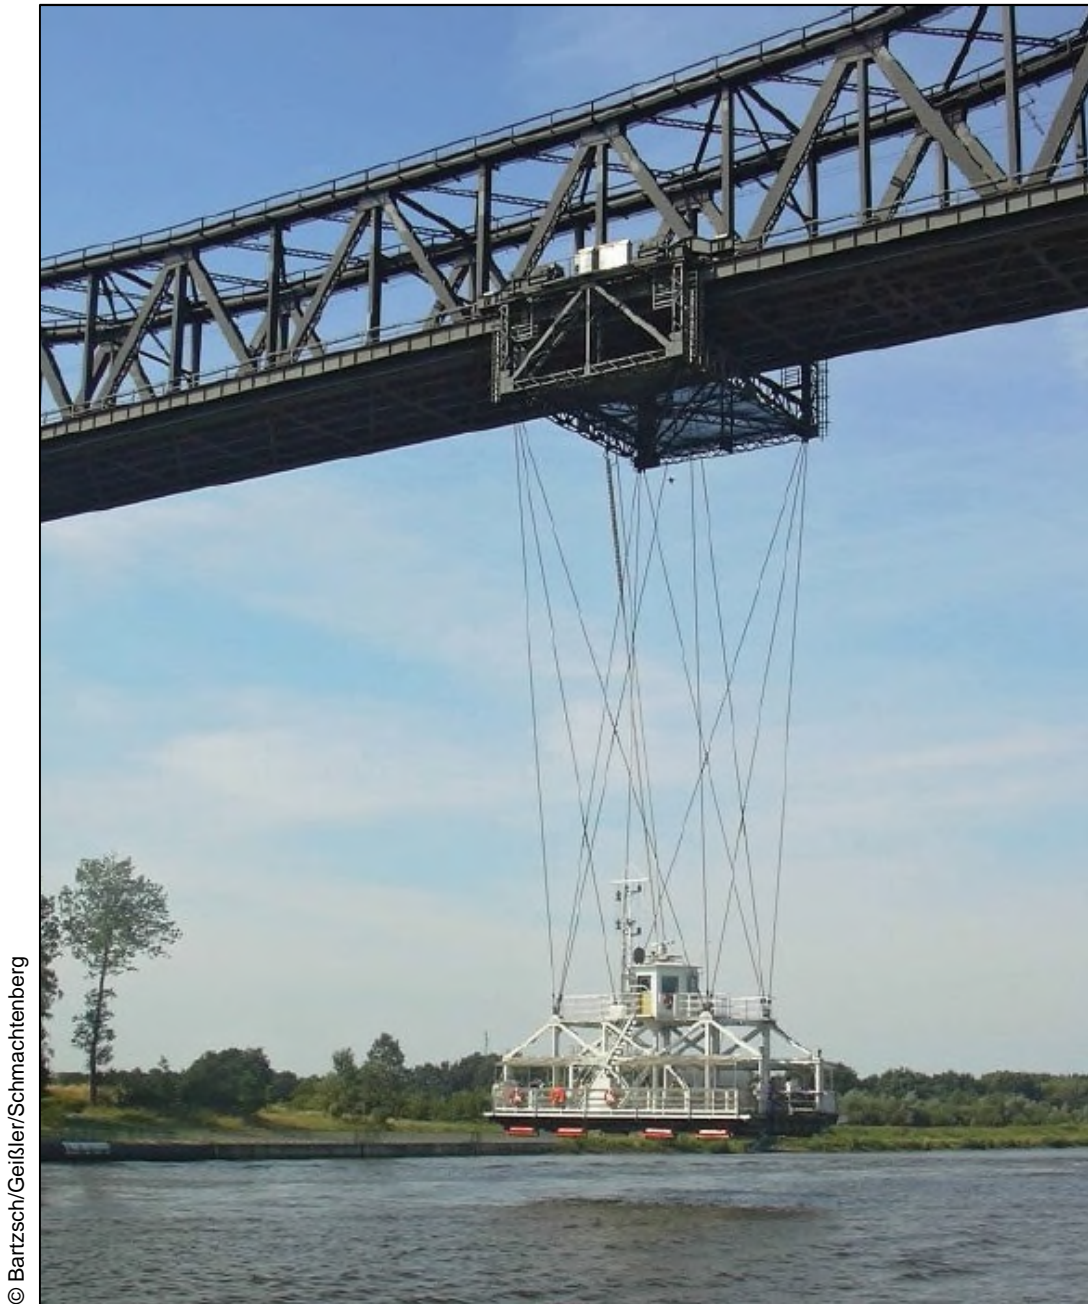
Figure 2: Photo of the Rendsburg transporter bridge

| Suspension: | Four vertical carrier cables, eight diagonal tension cables |

The transporter bridge was severely damaged due to the collision and partially torn out of the rail guide. It was caught centrally over the Kiel Canal.
