**Interim Investigation Report**  
pertaining to the investigation report 71/17

**Very Serious Marine Casualty**

**Collision of fishing vessel JAN MARIA with a fishing  
boat in the Mauritanian EEZ on 21 March 2017**

29 March 2018

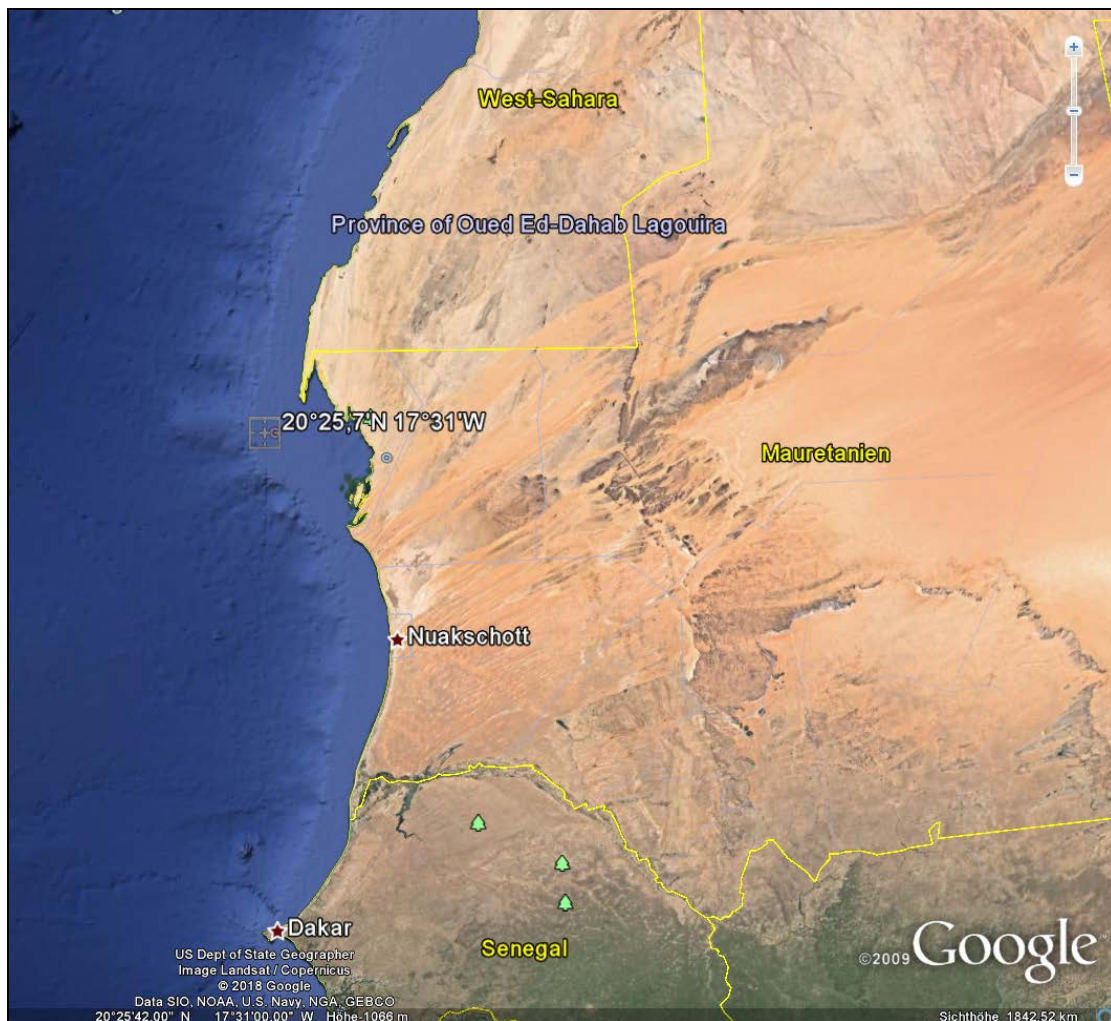
Figure 2: Scene of the accident

Type of marine casualty or incident:	Very serious marine casualty
Date, time:	21/03/2017 approx. 0113 UTC
Location:	Atlantic Ocean, Mauritanian EEZ
Latitude/Longitude:	approx. $\phi$ 20°25,7 'N $\lambda$ 017°31,0'W
Ship operation and voyage segment:	Preparation of fishing (search for fish)
Consequences (for people, ship, cargo):	Foundering of a fishing boat Death of three crewmembers of the fishing boat

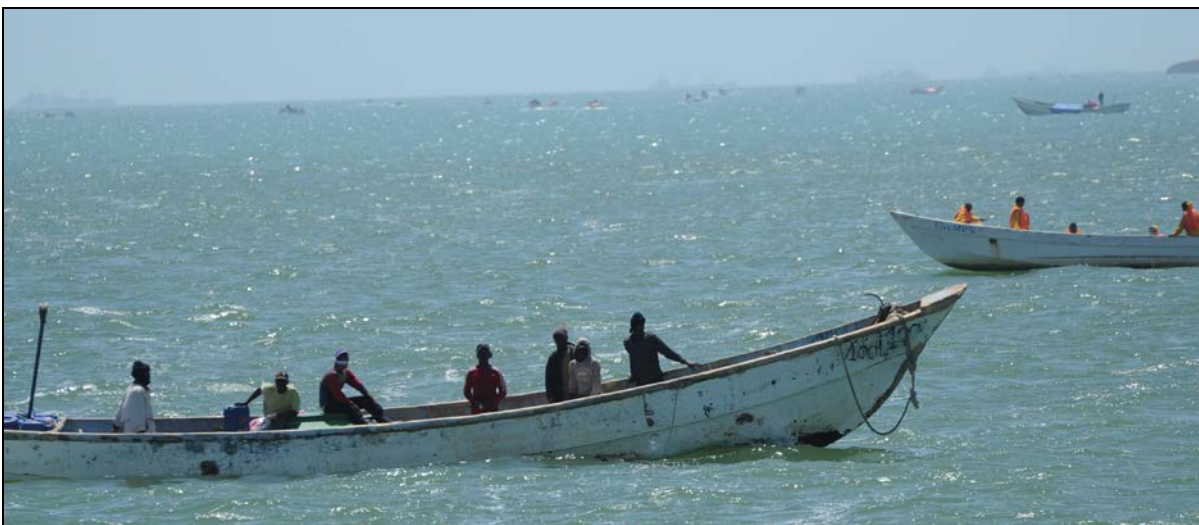
**Figure 3: Fishing boats (pirogues) off the Mauritanian coast<sup>1</sup>**

The fishing boat, which was manned with 6 fishermen, is a so called pirogue that is a simple, open wooden boat (cf. below by way of illustration figure 3). Locals use this type of boat, inter alia, for extended inshore fishing at the Mauritanian coast. Usually they are not equipped with safety appliances, radio sets, radar reflectors and – if at all – are only sparsely lit in the night.

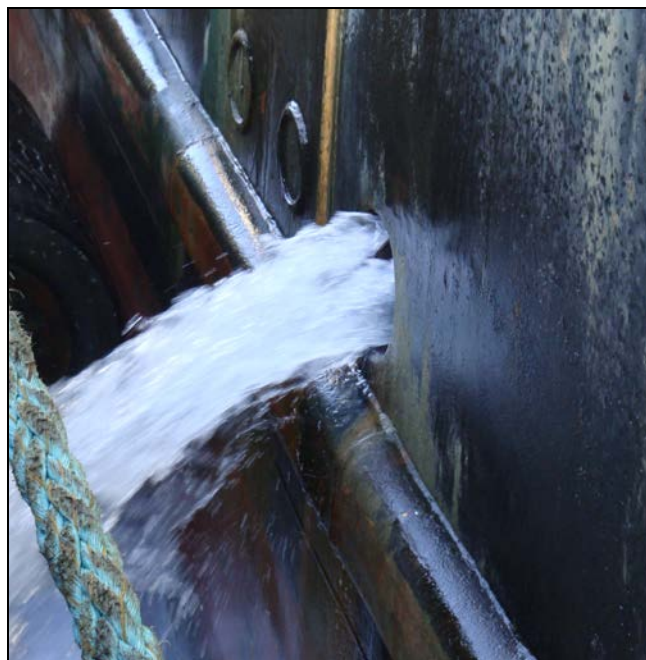
**Figure 5: Escape of cooling water (in this case on the port side of JAN MARIA).**

It is discernible in figure 4, that cooling water openings in the hull of JAN MARIA are located directly above the contact area of both vessels. At the time of the accident, a strong water jet visible in figure 3 and in the close-up view below (figure 4) burst out of these openings.

While sleeping, the crew of the fishing boat was taken by surprise by the sudden contact with JAN MARIA. The boat which was tied to JAN MARIA by the entangled anchor line was directly struck by the cooling water jet and flooded within a very short period due to the quantity of water continuously flowing in which was very large in relation to the dimension of the boat. The crew was unable to cut the anchor line and move away from the JAN MARIA within the short period available. As a consequence, the pirogue inevitably foundered in the sea within a short time.
