Bundesstelle für Seeunfalluntersuchung
Federal Bureau of Maritime Casualty Investigation

Interim Investigation Report No 343/22

Allision of the Kattwyk bridge by FAIRPLAY 82 on 21 July 2022

19 July 2023

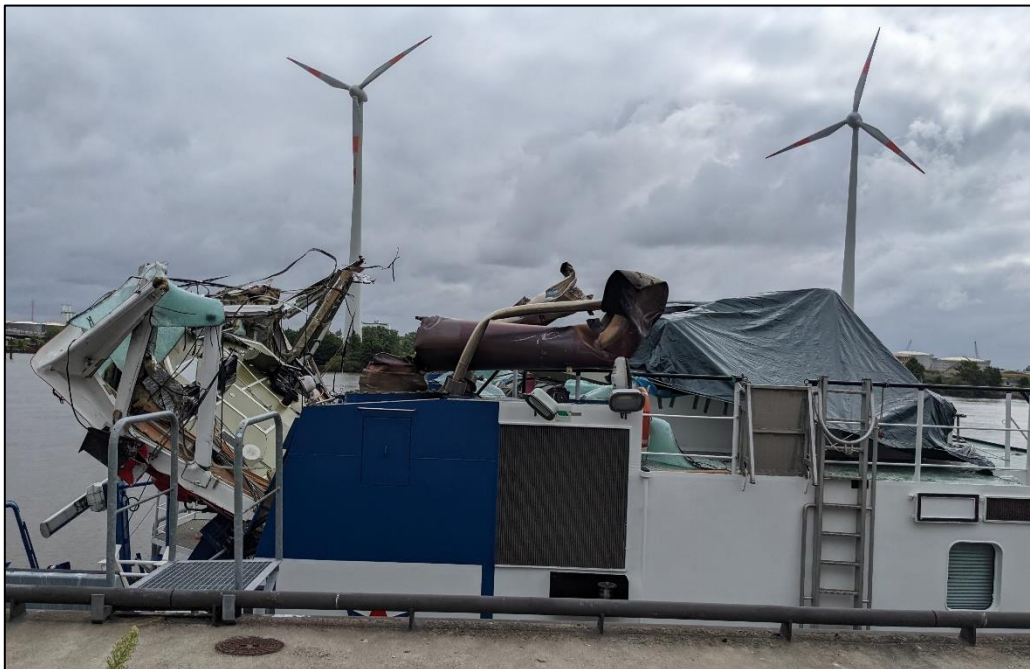
Figure 3: Damage² of the FAIRPLAY 82

Figure 3 shows that the wheelhouse ceiling was torn off, completely pushed aft and tipped over. The control positions and control panels remained standing and were later covered with a tarpaulin by the crew.

After the TANG LAND had berthed at the pier of Moorburg power station, the first tug to be released was FAIRPLAY 82. The tug left, picked up speed and sailed against the lowered, southern Old Kattwyk bridge with a speed of 6.5 knots. According to AIS, the collision, which caused severe damage to the wheelhouse, occurred at 1817. The people in the wheelhouse, the master and his chief engineer, managed to kneel down and protect themselves, so that they only sustained minor injuries. The third crewmember, a ship mechanic, was inside the superstructure and, due to the sudden jolt that went through the ship, fell down a staircase and subsequently also suffered minor injuries.
