**Bundesstelle für Seeunfalluntersuchung**  
**Federal Bureau of Maritime Casualty Investigation**  
Federal Higher Authority subordinated to the Ministry of Transport  
and Digital Infrastructure

Investigation Report 265/13

**Very Serious Marine Casualty**

**Foundering of the Sailing Yacht  
FALADO VON RHODOS  
on 9 August 2013  
off Iceland**

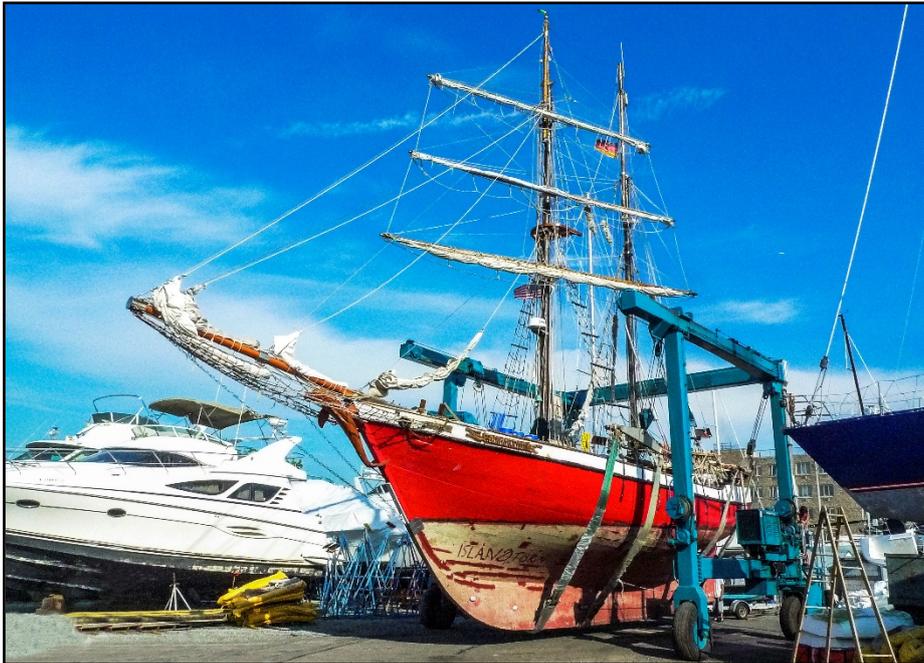
Figure 5: On the travel lift in the United States in May 2013

Dry-dock works were carried out on the hull in the Consolidated Yachts shipyard at City Island, New York, from 27-31 May 2013. Inter alia, several joints were re-caulked without outside assistance and the starboard shroud fittings relocated. On the stem, where the bobstay (the two chains in the following figure) is attached to the stem fitting, lead sheet was pinned/bonded beneath the stem fitting to prevent any leakage there. After she was launched, a leak was discovered on the port side in the lower berth, meaning the vessel had to be hauled out of the water again. This leak was sealed from the outside and also pinned with the application of lead; no further problems occurred after that.

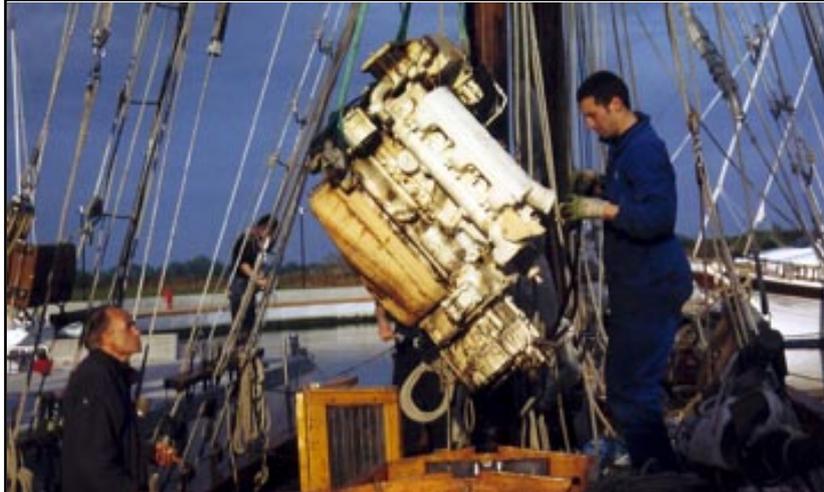
Figure 7: MTU with 147 HP; removal for overhaul in June 2004

A SABB two cylinder diesel engine with output of 20 HP (14.7 KW) was installed in the vessel when she was first built in 1968 at the shipyard in Greece. A second engine was installed in 1974 (MTU with 85 HP/62.5 KW). In 1988, the engine had to be changed in the Canary Islands. In 1993, the fourth engine, a six cylinder MTU with 147 HP (198 KW), was installed in the vessel. This engine was given a major overhaul in 2004 and the fifth engine, a four cylinder VETUS DEUTZ with output of 140 HP (103 KW), was installed in 2011.

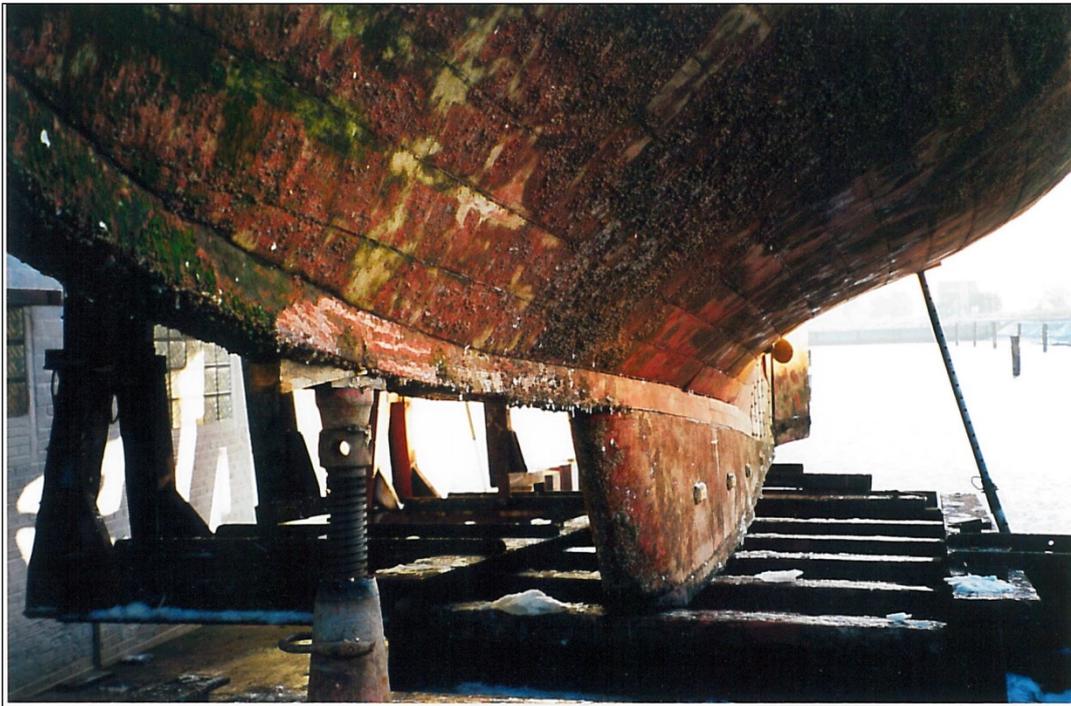
Figure 10: Keel before extension

The report also includes an opinion on a planned extension of the keel. It indicates that if produced as a hollow steel body, a keel extension has positive static effects as it provides additional support for the existing ballast keel's connecting point at the keel beam.

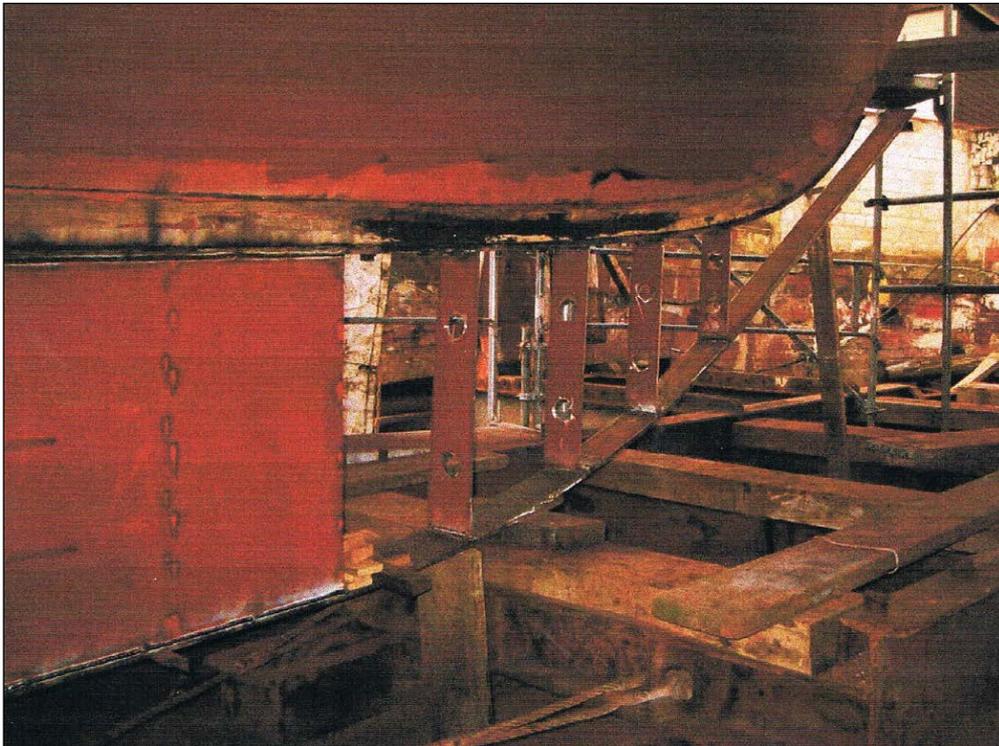
Figure 13: Keel extension

The keel extension was executed at the Rathje shipyard in Kiel in 2001/2002. Excerpts from the report were submitted to the shipyard for this. In particular, the shipyard was not aware of the proposed installation of three web frames to increase the torsional strength, however. After consultation with the association, a wooden beam of 3.7 m in length with a cross section of 220 x 180 mm was installed as the interior keel with mast step. The steel box keel with no ballast was bolted to this internal keel using keel bolts with a diameter of 20 mm.

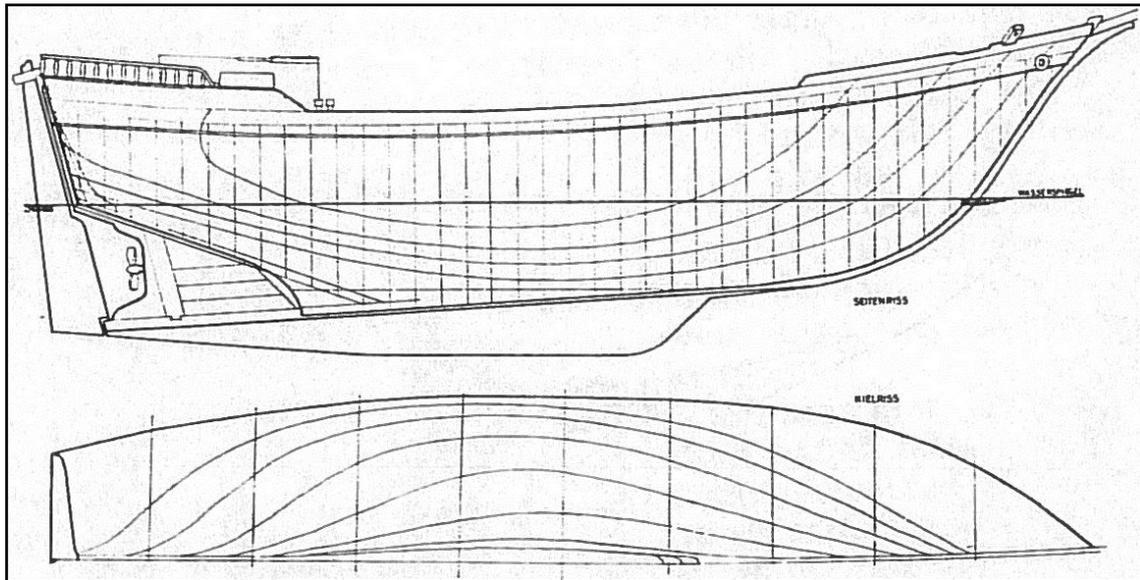
Figure 15: Lines plan with propeller

The FALADO VON RHODOS was originally equipped with an engine of 20 HP, which is what the seating, frames and aft section were configured for. The frames in the area of the engine room were already doubled during construction and connected by transverse bolting.

The shipyard installed a two cylinder engine with 1,800 r/min, as well as a transmission with a reduction ratio of 2:1. A two bladed, 590 mm controllable pitch propeller was installed immediately behind the deadwood in the screw aperture. Rather than using solid wood to produce this deadwood, it consisted of planks with planking on both sides, creating a void of about 100 mm in the middle.
