Tension Technology International Ltd

‘MV NORTHERN FAITH’

**VISUAL EXAMINATION AND TENSILE TESTING OF
A FAILED MOORING LINE TO ESTABLISH THE
CAUSE OF FAILURE**

**Federal Bureau of Investigation of Maritime Casualty
Investigation**

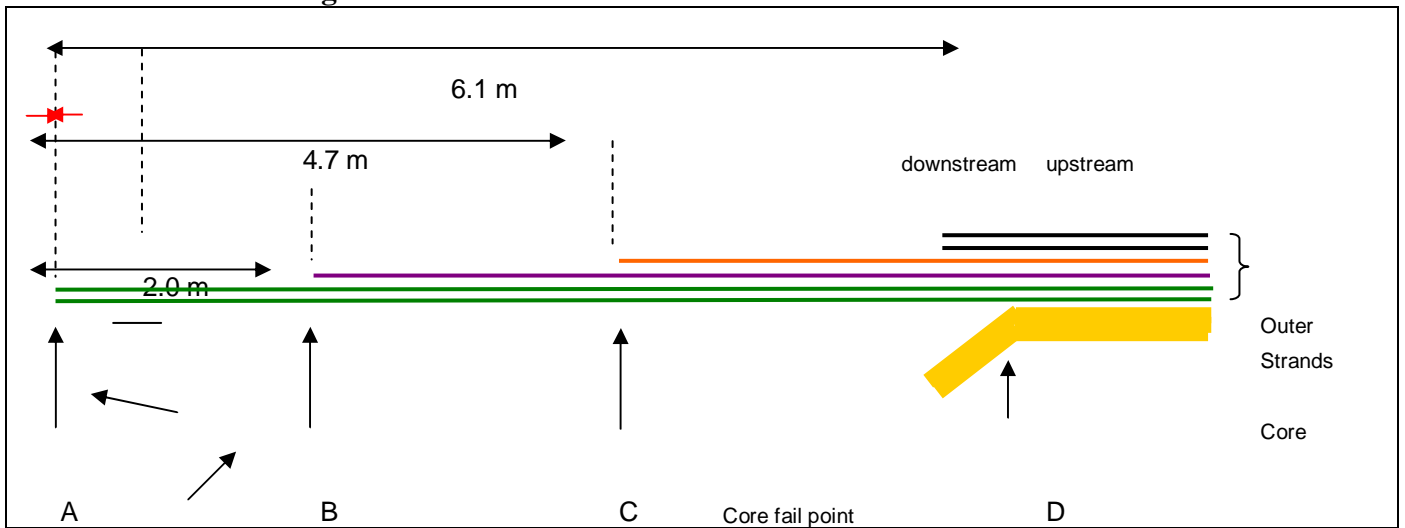
Figure 1 Sketch of main features of the failure

Above and below 'a', two zones of excessive damage are seen running in the line of the purple arrows across the image. These have been caused by pressure from the two strands, coloured black in figure 1, repeated below for convenience. During the investigation, these two strands were found to be severely melded to the outer rope yarns of the core and could only be separated by exerting considerable force

localised failure

one of two strands not melded with 4-strand c

The rope yarn failures found at 'c' are unusual as they have occurred on inner rope yarns whilst their partner outer rope yarns [at 'a'] have only been severely compressed. The damage to both sets of rope yarns has probably been caused by the two strands, black in figure 1. This evidence suggests that at the time of failure, there was excess load and that the load distribution between the elements within the core was poor. The inner rope yarns were strained to a higher extent than the outer rope yarns. The pressure from the outer strands would have resulted in localised restraint of the material lying beneath them, further complicating the load distribution. Due to the excess strain on the inner rope yarns, some have failed whilst the outer rope yarns, under less strain, have been able to withstand the strand pressure more successfully.
