Investigation Report
Release Mechanism
of Port Life- and Rescue Boat
MT „OLIVER JACOB“
Very Serious Casualty
Dated 21.01.2006

Report-No.: 2006-05/e

Prepared For: Federal Bureau of Maritime Casualty Investigation (BSU)
Bernhard-Nocht-Straße 78
D-20359 Hamburg

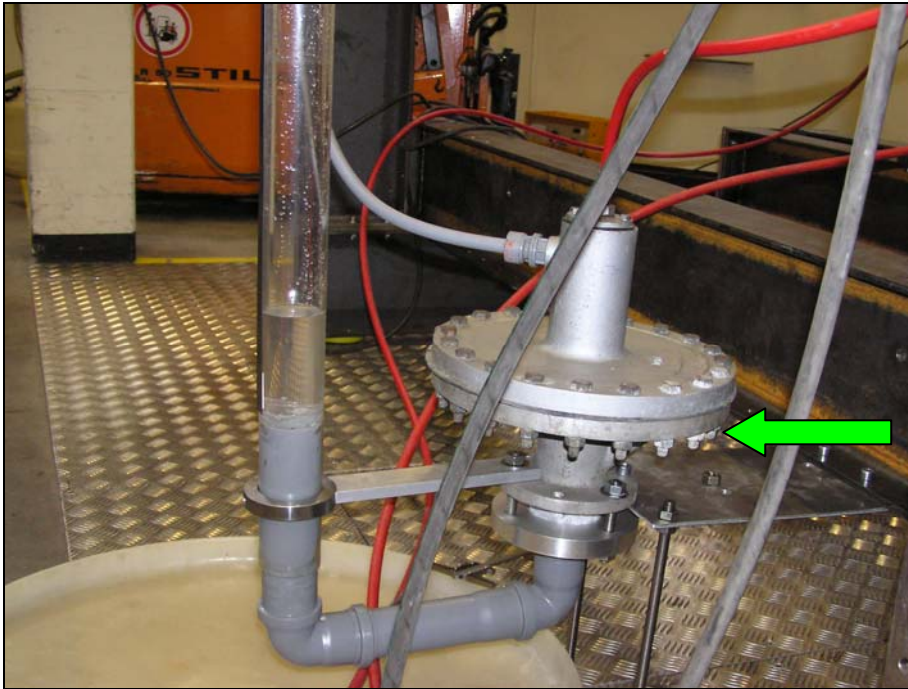
Figure 8:
Hydrostatic pressure cell with transparent filling pipe:
Distance between lowest point of flange of hydrostatic pressure box and lowest point of boat keel is abt. 317 mm. Draught of boat: abt 423 mm at this measurement point 0.

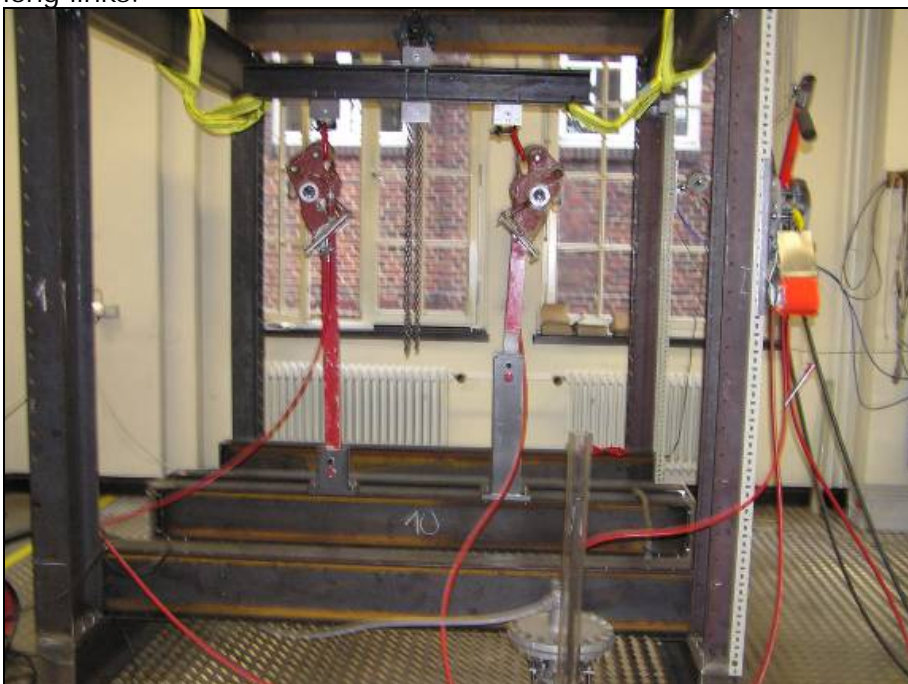
Figure 9:
Test Arrangement:
Test foundation structure with hoisting hooks, release cables, hydrostatic pressure cell und central release unit. Release cables are directed on top of foundation structure with generous radius between the elements.

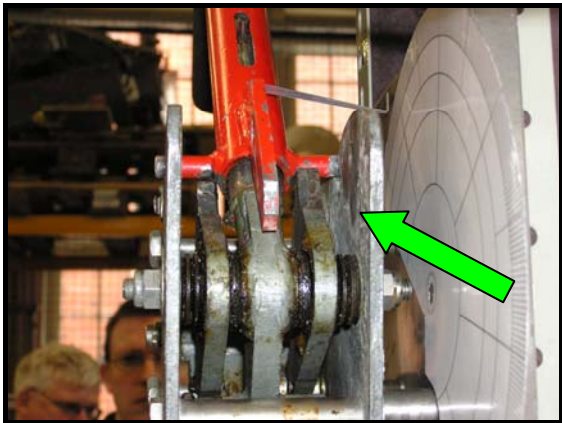
fig. 12

Figure 11
1.3.1.	Is it possible to fully secure release handle at central release unit?	A fully securing at central release unit is not possible. It is not possible to turn the aft operating quadrant (right washer in Figure 12) in the fully aft position for fully securing by safety pin. Right leading pin of release handle Has contact to aft operating quadrant causing friction to it. Release handle is in more or less secured and arrested position but a fully securing with safety pin can not be done. Safety pin can only be stick in partly.

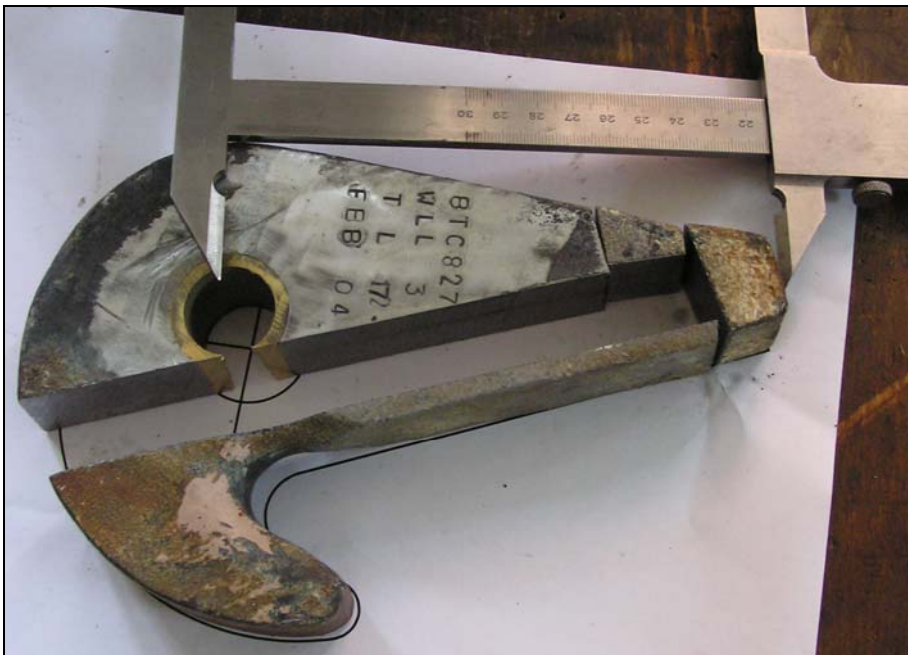
Acc. to photo (Figure 21) measurements could be determined only inaccurate. Underwriter has no doubt about correspondence between measurements and drawing of these hooks.

Further on it has been determined that brass bushings are seated perpendicular to middle area of hooks.

Figure 21:
Forward hook:
Measurement of
distances after
samples cut off.

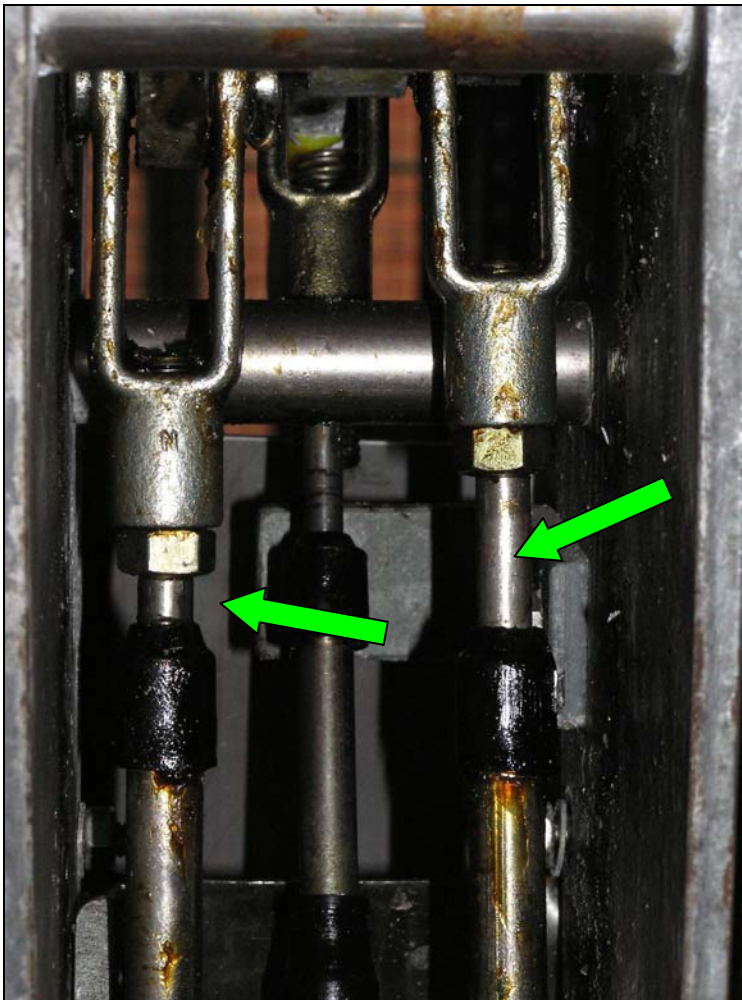
Figure 26:

This was not possible as shown in Figure 26.

B. By shifting the mounting point for the cable hose fixing on the aft foundation plate of the operating unit as specified in Figure 22 and 23.

The measure under B was carried out in Test No. A.3-1.9. At the same time the aft release cable on the fork head of the aft hook fixing was extended by 4.73 mm, in order that the release distance was sufficiently long.

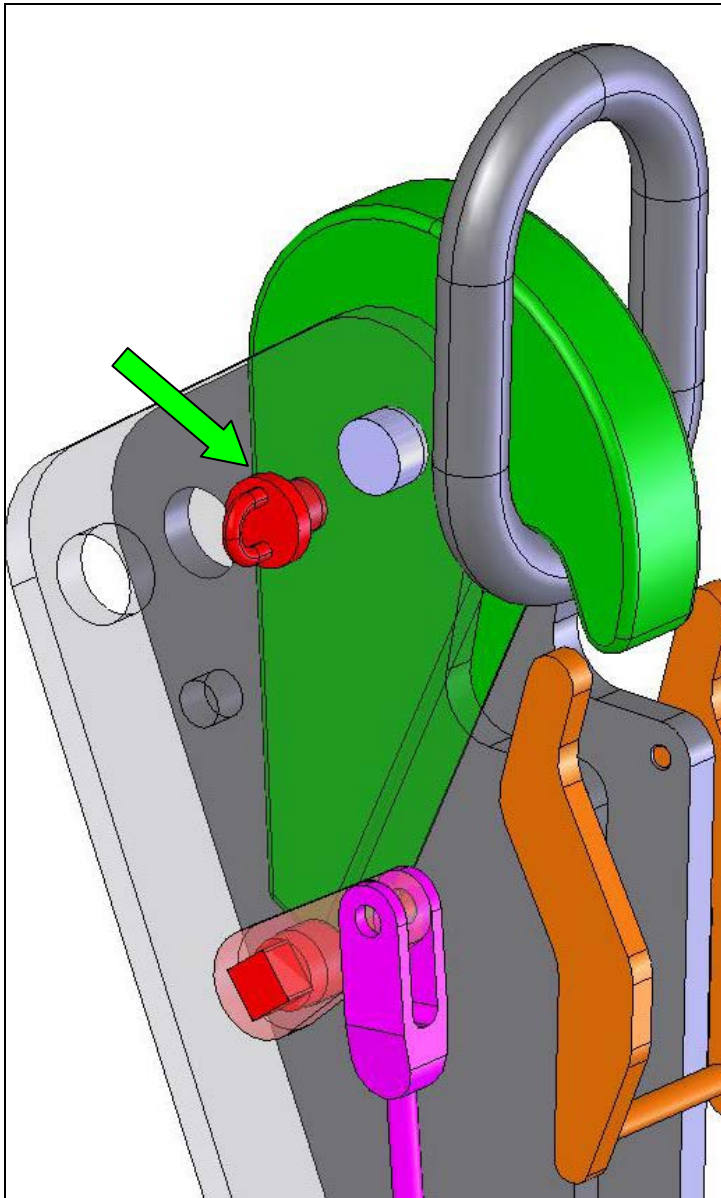
Figure 30:
Training and Maintenance protection:
An accidental ON-LOAD release of the hoisting hook is prevented by a safety pin manually pushed in to the hoisting hook cheek plates and the hooks.
(sketch shown as an example)

The standard should be so modified that for training or maintenance purposes the UNDER LOAD RELEASE can be made ineffective. Each hoisting hook should be fitted with a safety pin that can be manually put in as shown in Figure 30 which protects the hooks against accidental use during training or maintenance before a release by the central release mechanism. This safety pin can be put in both in the water or, if necessary, in the stowage position. The safety pin should be pulled out at every time also under ON-LOAD-conditions if the system is technically perfect.

The design of this pin, as well as the design of the complete construction, should have a factor of safety of six compared with the breaking point of the materials.

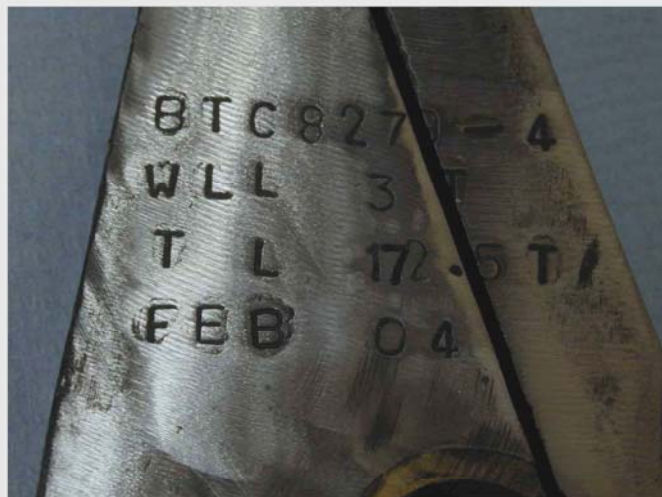
markiert. Die Stempelung TL 7.5 T ist nicht eindeutig lesbar. Es kann auch als TL 172.5 T gedeutet werden (s. Abb. 3).

Abb. 3: Stempelung an Haken „Vorn“

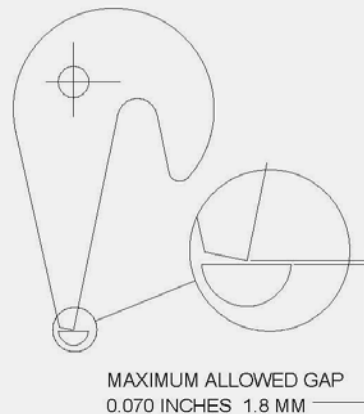
Sketch 2

- b. Check the gap formed between the tail of the hook and the flat of the release pin by using feelers as shown in sketch 2, lifting the hook as this is done will take account of any wear in the bush or pin. If the gap is in excess of that allowed, the gear must be withdrawn from service and the hook replaced.

Changes in this gap can only be due to wear and should be progressive rather than sudden.
