**Bundesstelle für Seeunfalluntersuchung**  
**Federal Bureau of Maritime Casualty Investigation**  
Bundesoberbehörde im Geschäftsbereich des Bundesministeriums  
für Verkehr und digitale Infrastruktur

**Untersuchungsbericht 34/15**

**Sehr schwerer Seeunfall**

**Tödlicher Personenunfall  
an Bord des MS HANJIN DALLAS  
am 1. Februar 2015 vor der Ostküste USA**

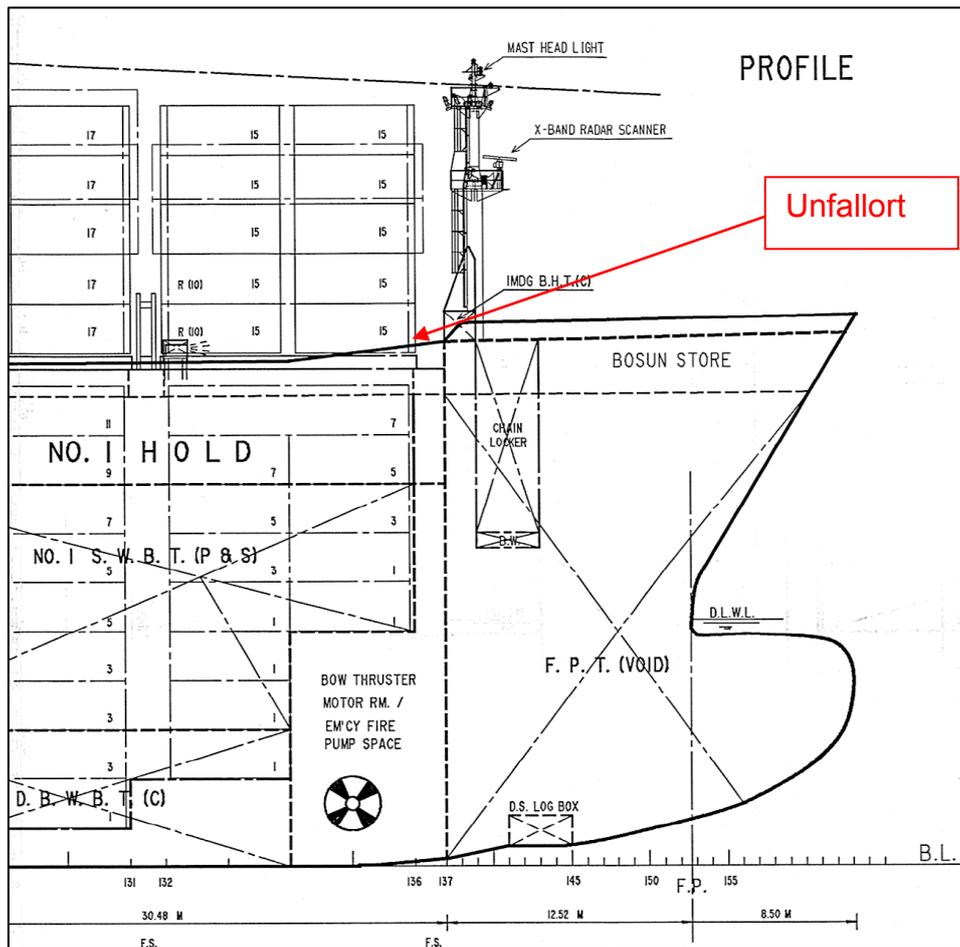
Abbildung 3: Auszug Generalplan, Seite

Die MS HANJIN DALLAS befand sich auf einer Reise von Singapur nach New York. Am 1. Februar 2015, gegen 10 Uhr, wurde der 50-jährige Bootsmann vom Schiffsmechaniker leblos hinter den Container-Zurrstangen auf einem auf dem Vordeck auf Steuerbordseite befindlichen Lukendeckel liegend gefunden.
