Bundesstelle für Seeunfalluntersuchung
Federal Bureau of Maritime Casualty Investigation
Bundesoberbehörde im Geschäftsbereich des Bundesministeriums
für Verkehr, Bau- und Wohnungswesen

Investigation Report 183/02

Sinking of the Fishing Vessel “IRKA” – Ort 6

on 28 November 2002 nearby Fehmarn

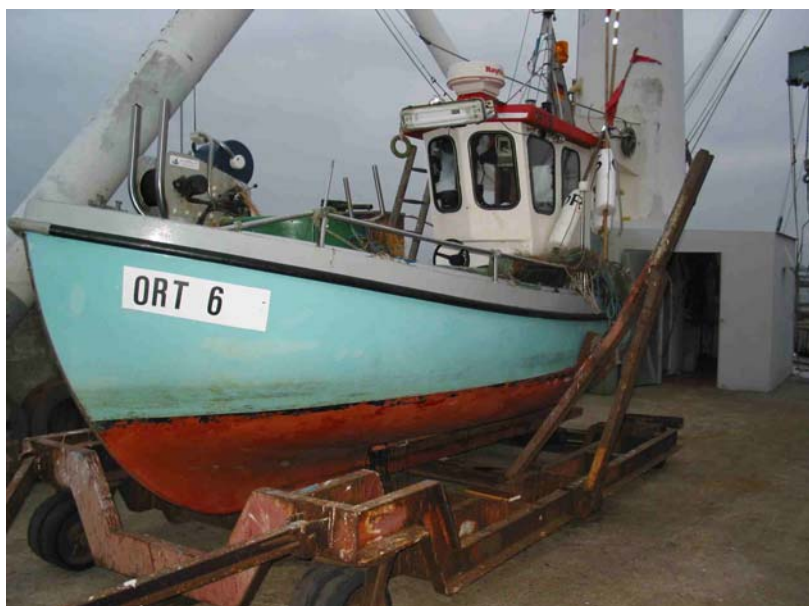
3.1 Vessel particulars “ORT 6”

Name of vessel	IRKA
Port of registry	Orth auf Fehmarn
Nationality/Flag	German
Fisheries call signal	ORT 6 ex LAB 11
International call letters	DF 5139
Type of vessel	Small fishing vessel, open craft
Crew	1 person
Classification/Authorisation	See-Berufsgenossenschaft (German Mariners' Association)
Sailing Permit Certificate	Part-time professional fishing in max. 1 sm distance from the coast. Valid until 18 November 2003
Year built	1983
Building yard	E. Bredgaard in Nystedt – Denmark
Construction material	GRP
Type designation	Danjolle 18.5 feet
Length over all	5.98 m
Width over all	2.30 m
Height	1.02 m
Minimum freeboard	0.45 m
Engine rating	18 kW
Propeller	Fixed propeller
Steering system	Hydraulic with check-back
Miscellaneous	The vessel has a fish well and is equipped for net fishing
