CASUALTY REPORT

May 26, 2003
Case 199926108/9
File 01.40.01

Collision between Danish m/v UNO and German pushbarge DETTMER TANK 116 on 11 July 2002

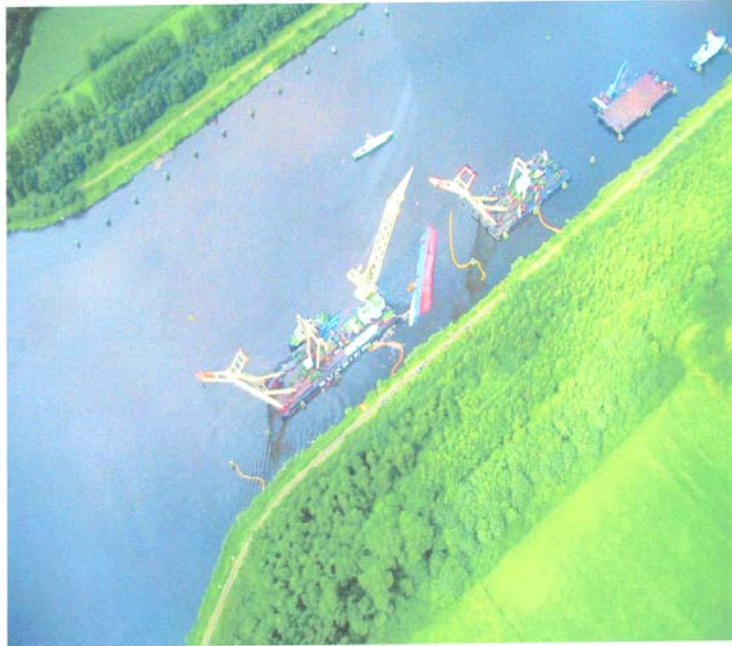
On 30 July between 10.00 and 13.30 UNO was towed to Brunsbüttel. The hole in the starboard side had been patched by a bolted on steel plate.
