Investigation Report 49/02

Very Serious Marine Casualty:

**Sinking of the
GOTLAND**

on 15 June 2002 near Damp

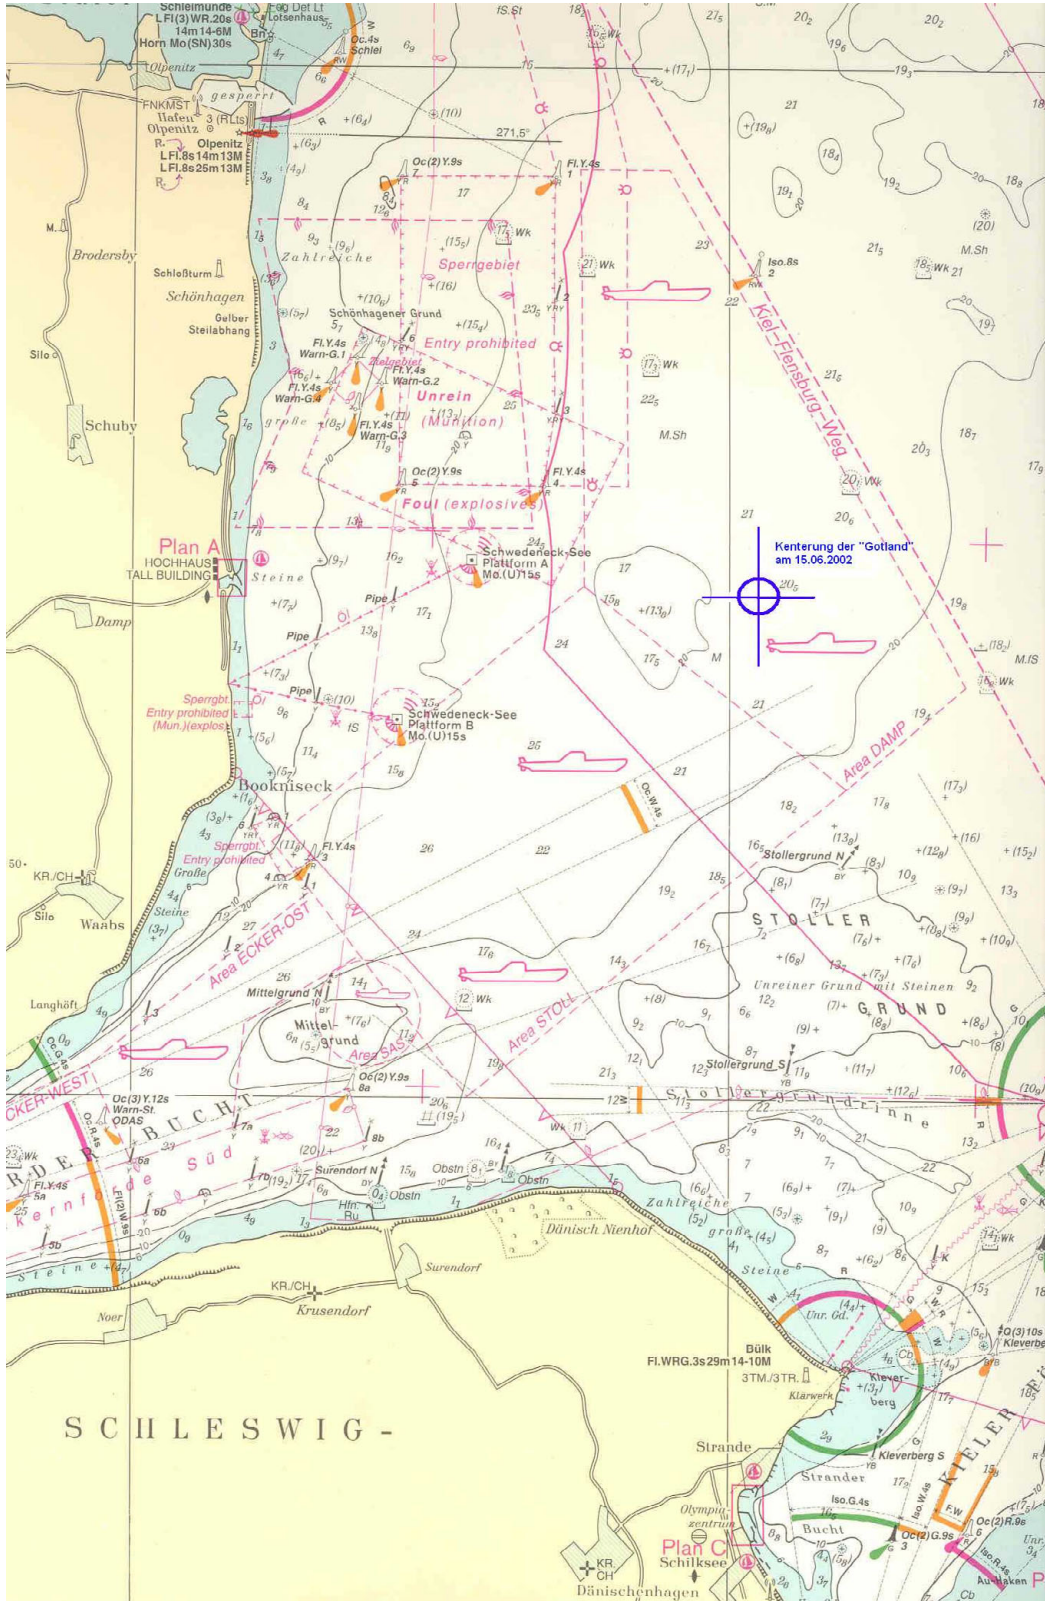
Photo 2, Place of accident of the GOTLAND

On 15 June 2002 at 14.15 h, the GOTLAND sank on her voyage from Kiel-Holtenau to Kappeln about 5 nm on the beam of Damp (see Photo. 2). Before the ship sank, the vessel OBAN, which was about 500 m ahead, made a distress call for the GOTLAND to the Maritime Rescue Coordination Centre (MRCC) Bremen. The crew of the GOTLAND, consisting of the navigator, two adult persons and a baby, could be rescued by the OBAN, a Dutch sailing-vessel.

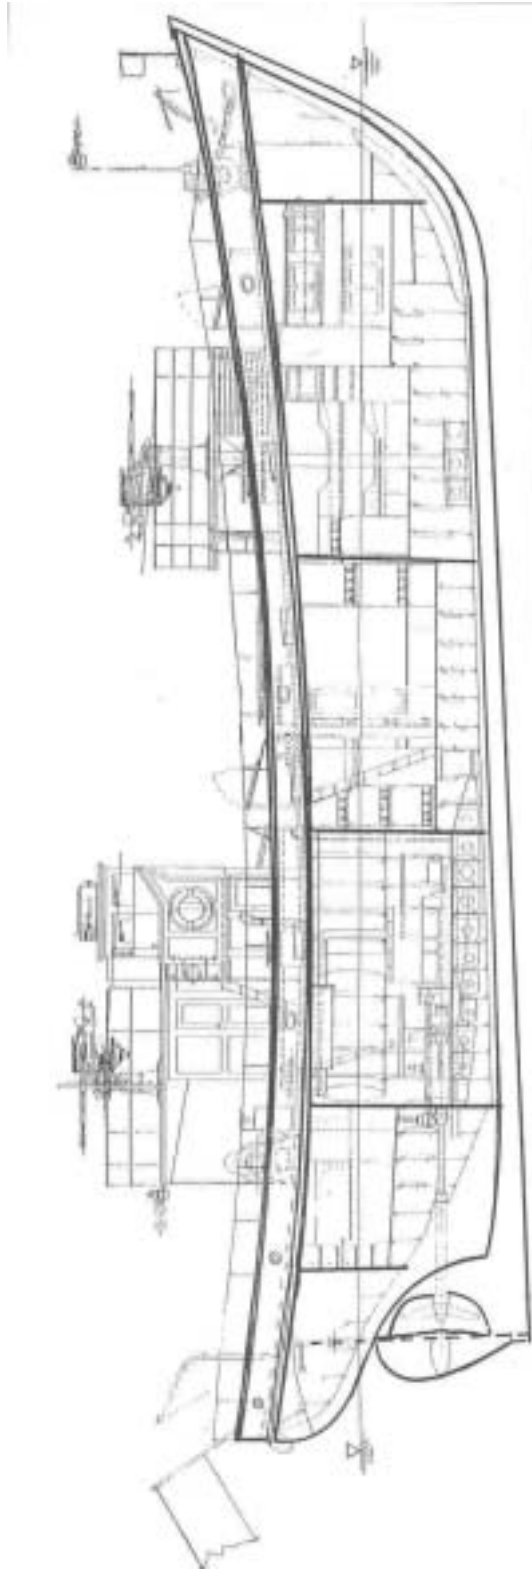
Photo 3, KFK (war fishing cutter)

The GOTLAND was put into service in November 1942 as a war fishing cutter (KFK 146, see Photo 3), and at first served the Marineoberkommando Ost as "M 3117". From March 1943 to June 1944, the ship was in action as "NB 53" in the harbour guard flotilla of Bergen (Norway). Then the ship sailed as "V 5523" in the 5. Küstensicherungsverband, and at the end of the war, she was in Bergen, where she served the "German Mine-Sweeping Administration" and was a war-booty of the U.S. forces. In July 1946, the ship was transferred to Kiel, and in August 1946 put into service for the OMGUS (Office of Military Government for Germany of the United States). In September 1947, the vessel was reconstructed with the HDW of Kiel (Howaldtswerke-Deutsche Werft) to become a fishery vessel (see Photo 4), and by 1991, she sailed as "KIE 709", "BX 553", "SO 283" and "SK37" in the fishing industry. Due to an agreement between the government of the Federal Republic of Germany and the government of the United States of America on August 20th, 1953, all rights to the vessel were transferred to Germany. In 1955 the former "KFK 146" was registered as GOTLAND with the Maritime Ships' Register of Kiel.

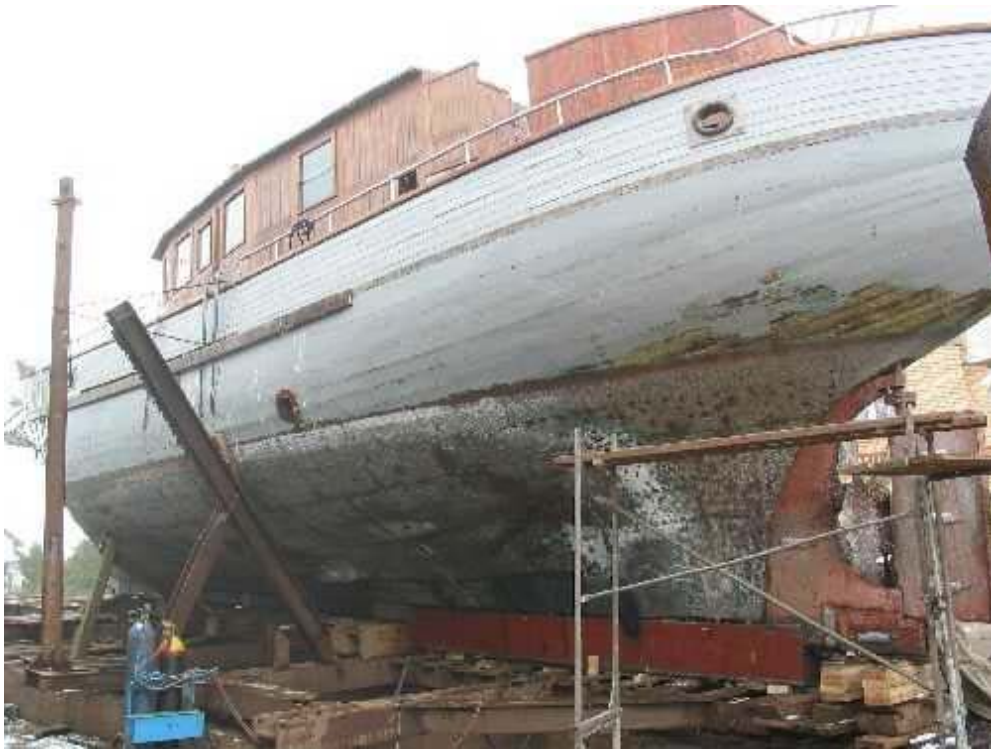
Photo 6, Shipyard of Arnis

On 4 March 2003, the BSU surveyed the GOTLAND at the “Heinrich Eberhard Werft” at Arnis (see Photo 6).

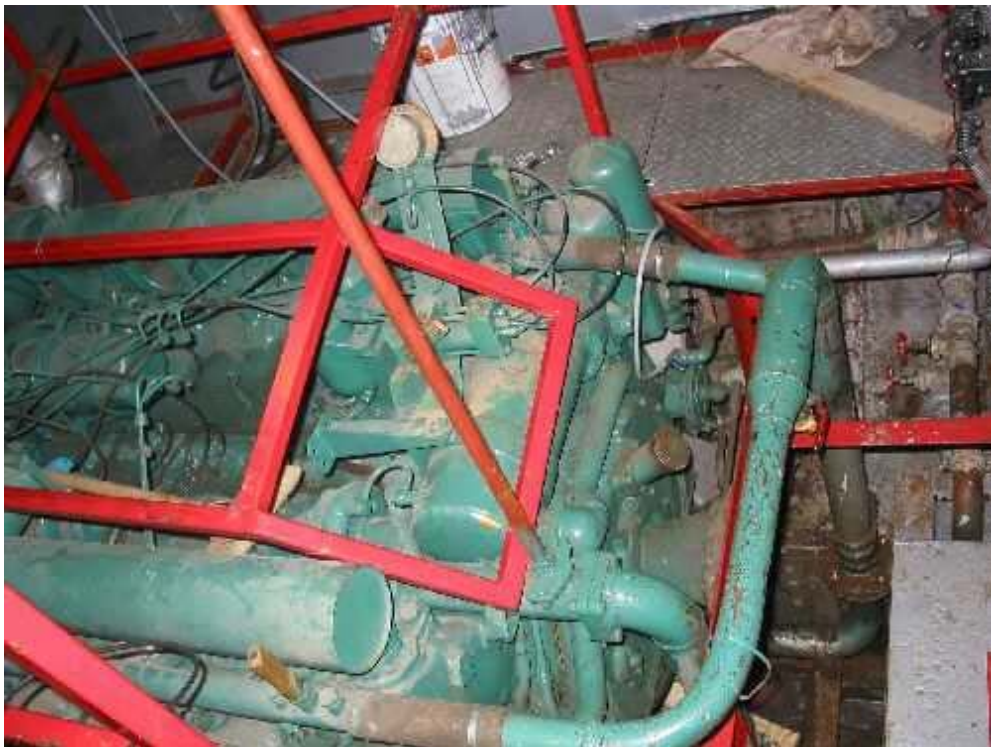
Photo 9, Engine

The engine (see Photo 9), two settling tanks, one daily service tank, one water tank and one sewage tank were measured.
