**Summary  
Investigation Report**

**63/03**

**Collision**

**Passenger Vessel SPIEKEROOG II  
with  
the Gandersum Flood Barrage**

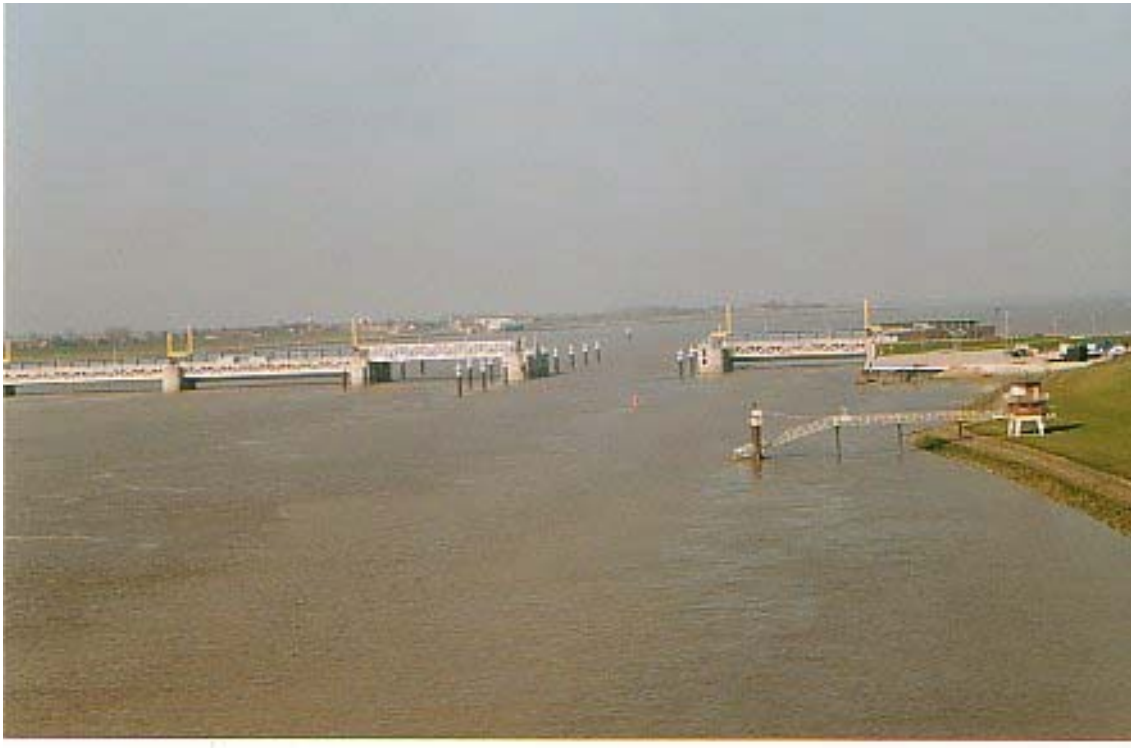
**Figure 5: Flood barrage**

Among other things the railing of the flood barrage, the lower part of its bridge over the inland navigation opening and the movable element of the channel were damaged.
