Bundesstelle für Seeunfalluntersuchung
Federal Bureau of Maritime Casualty Investigation
Bundesoberbehörde im Geschäftsbereich des Bundesministeriums
für Verkehr, Bau- und Wohnungswesen

Investigation Report 122/04

Very serious marine casualty

**Loss over board of the skipper
of SY RENI
on 31 May 2004
in the Bay of Mecklenburg
southeast of Fehmarn**

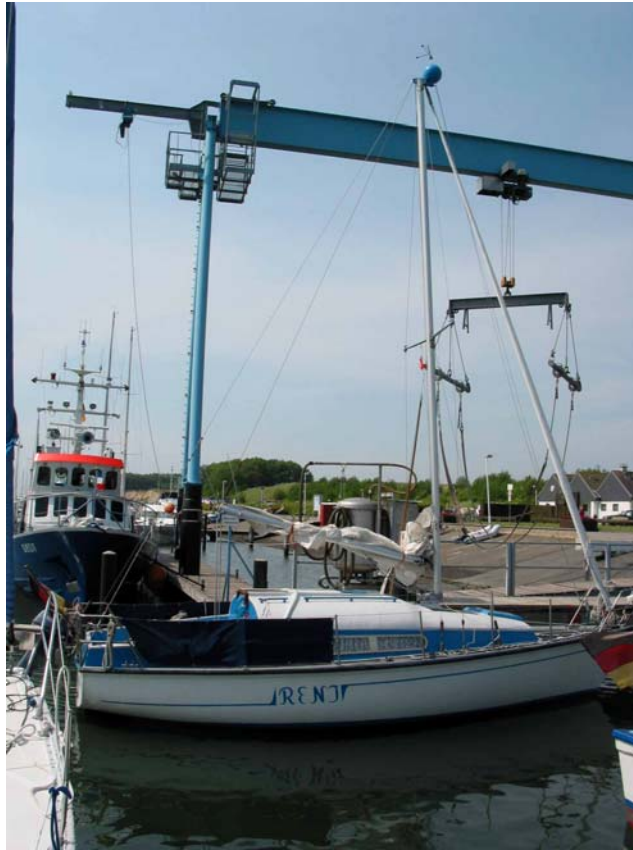
Figure 2: Photo of the vessel

The Sailing Yacht RENI was built by the owner and skipper himself in the years 1984 to 1989. The original in-board engine was replaced in 2002 by an 8 HP out-board engine. The vessel is a centre-board yacht. The sail area consisting of a roller jib and a mainsail, each with 10.5 m², was being sailed fully unfurled on the day of the accident.
