Bundesstelle für Seeunfalluntersuchung
Federal Bureau of Maritime Casualty Investigation
Bundesoberbehörde im Geschäftsbereich des Bundesministeriums
für Verkehr, Bau- and Wohnungswesen

Investigation Report 213/02

Collision

CMV P&O NEDLLOYD GENOA
and
MT EBRO

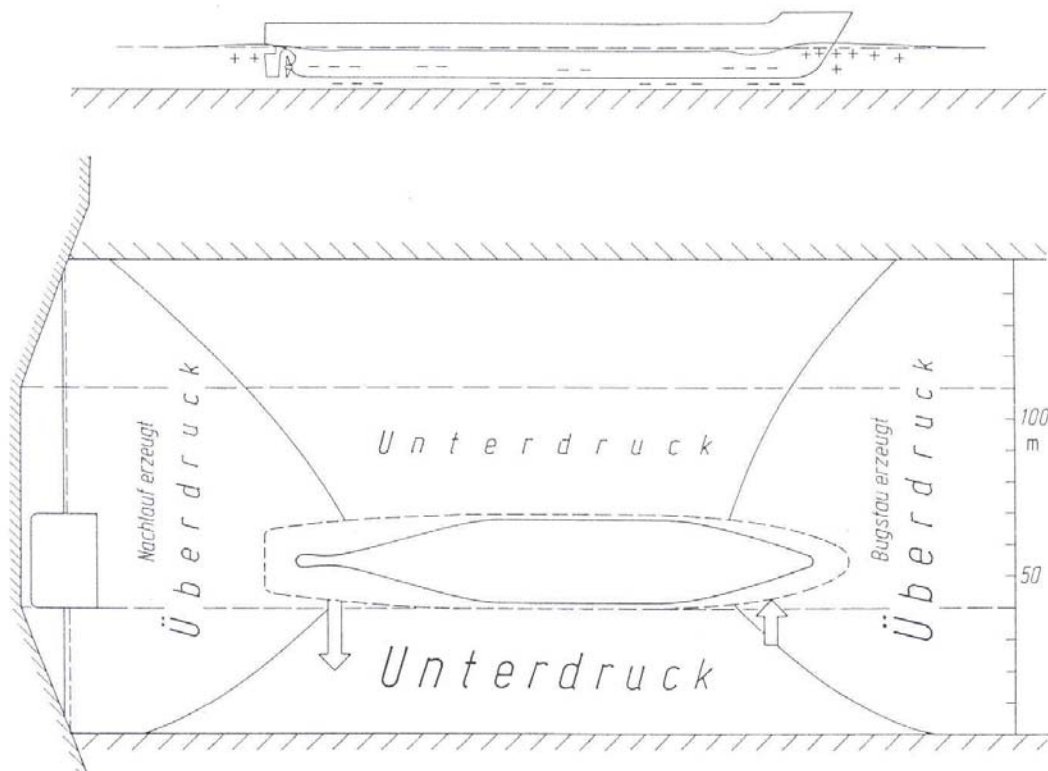
Figure 11: Schematic representation of the pressure conditions at the vessel's hull

As long as a vessel proceeds along the middle of a symmetrical channel, the pressure distribution described above results uniformly on both sides of the vessel, so that no lateral forces and moments become effective. However, if the vessel proceeds along a non-symmetrical channel and/or is located off-centre in the channel, then in the narrower off-flow cross section here (nearby shore) the damming up of the water at the bow is much greater by comparison with the larger off-flow cross section in the middle. (See Figure 11).

As a result of the differences in water level developing along the vessel, which increase the faster the ship travels, hydrodynamic transverse forces and moments act on the vessel's hull, and their total and direction are influenced very strongly by the speed of the vessel, the cross sectional relations, and the vessel's closeness to the edge of the navigation channel on one side.

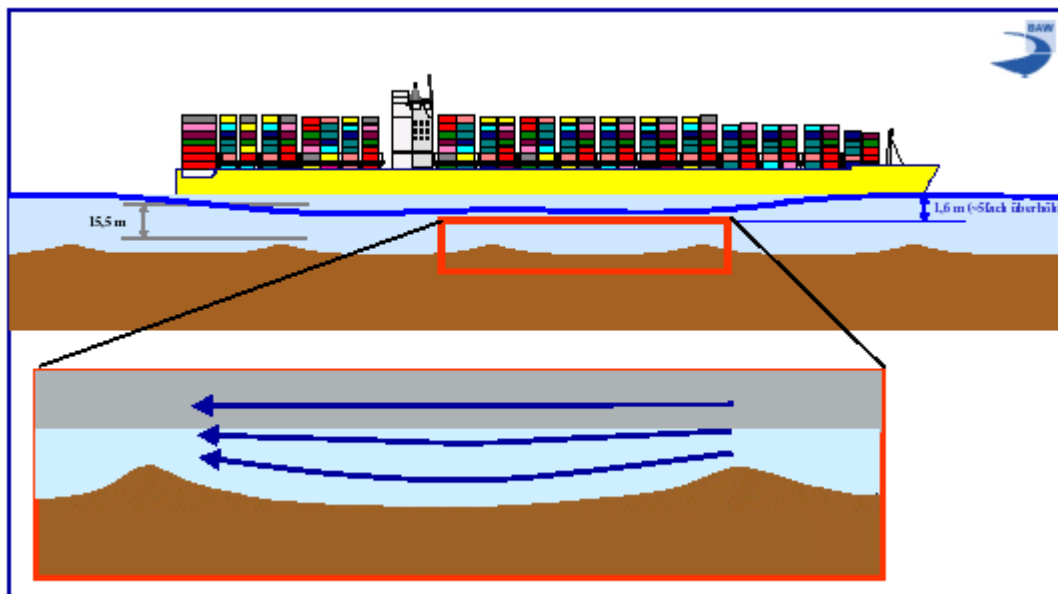
Figure 12: Principle of hydrodynamics over transport bodies

The bank effect described above (also called a suction effect) is influenced and superimposed additionally during sailing in shallow navigation channels by the squat effect that then occurs.

The squat effect is due to the fact that the water displaced by the moving vessel in the narrow cross section between the vessel and the limited remaining ground clearance has to flow back. Consequently this causes a lowering of the water level alongside to the vessel, which in turn involves an additional limitation of the remaining cross section. (See Figure 12).
