Bundesstelle für Seeunfalluntersuchung
Federal Bureau of Maritime Casualty Investigation
Bundesoberbehörde im Geschäftsbereich des Bundesministeriums
für Verkehr, Bau- und Wohnungswesen

Investigation Report 226/03

Very serious marine casualty

Foundering of FC NEPTUN
on 30 July 2003
in the harbour entrance of Norddeich

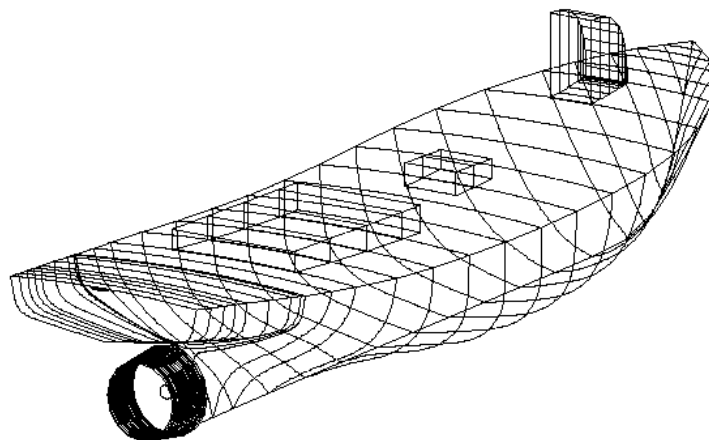
Hydrostatic Properties at zero, Heel = 0.00

A firm of design engineers commissioned by BSU measured the ship anew with the program AUTOHYDRO[®] and calculated the curve sheet and cross-curves of stability anew.

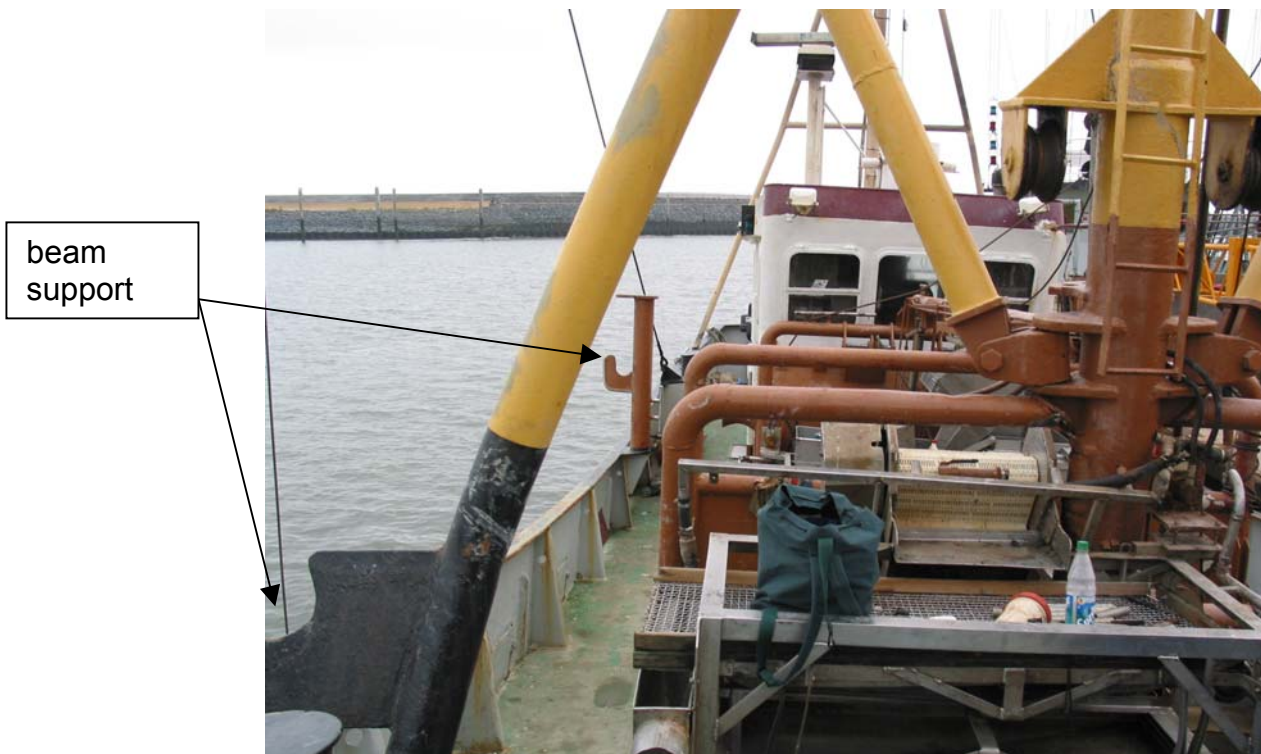
§ 261a (3) UVV-See

"During travel to the fishing grounds and back the fishing gear may only be heaved up and carried on the booms up to a wind strength of 4 Bft."
