Investigation Report 234/03

Very serious marine casualty

Foundering of SY DEERN
following a collision with an unknown vessel
northeast of Rügen
in the night of 3 August 2003 to 4 August 2003

20 March 2004

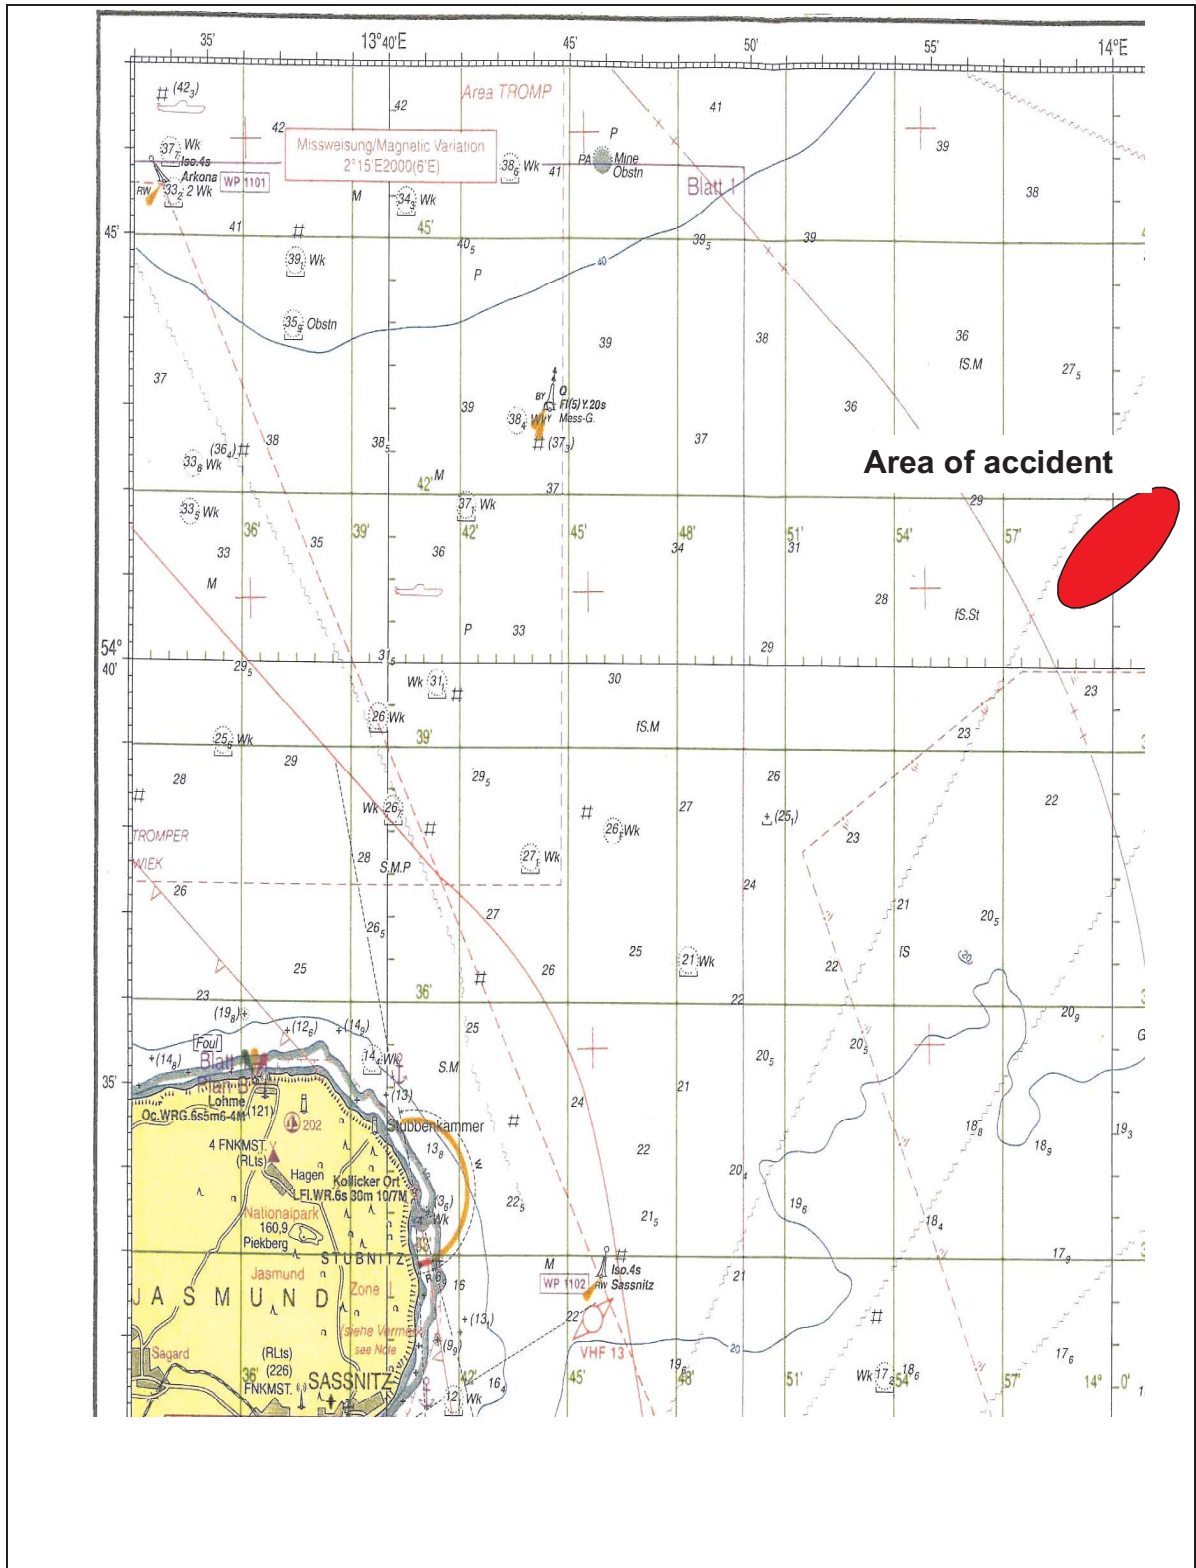
Figure 1: Scene of the accident - Overview

On 3 August 2003 during the period between approx. 23:45 h and 24:00 h CEST the German sailing yacht DEERN collided between the positions 54°40.6'N 13°59.0'E and 54°40.83'N 14°02.76'E outside German coastal waters with an unknown vessel that fled from the scene. The sailing yacht was on a passage from Karlshagen, Usedom, to Rönne, Bornholm, and was crewed by the owner as skipper and his wife.
