Investigation Report 314/03

Marine Casualty

**Serious back injury of a passenger on board
HSC HALUNDER JET
on 11 October 2003
on the Elbe estuary/German Bight**

3 May 2004

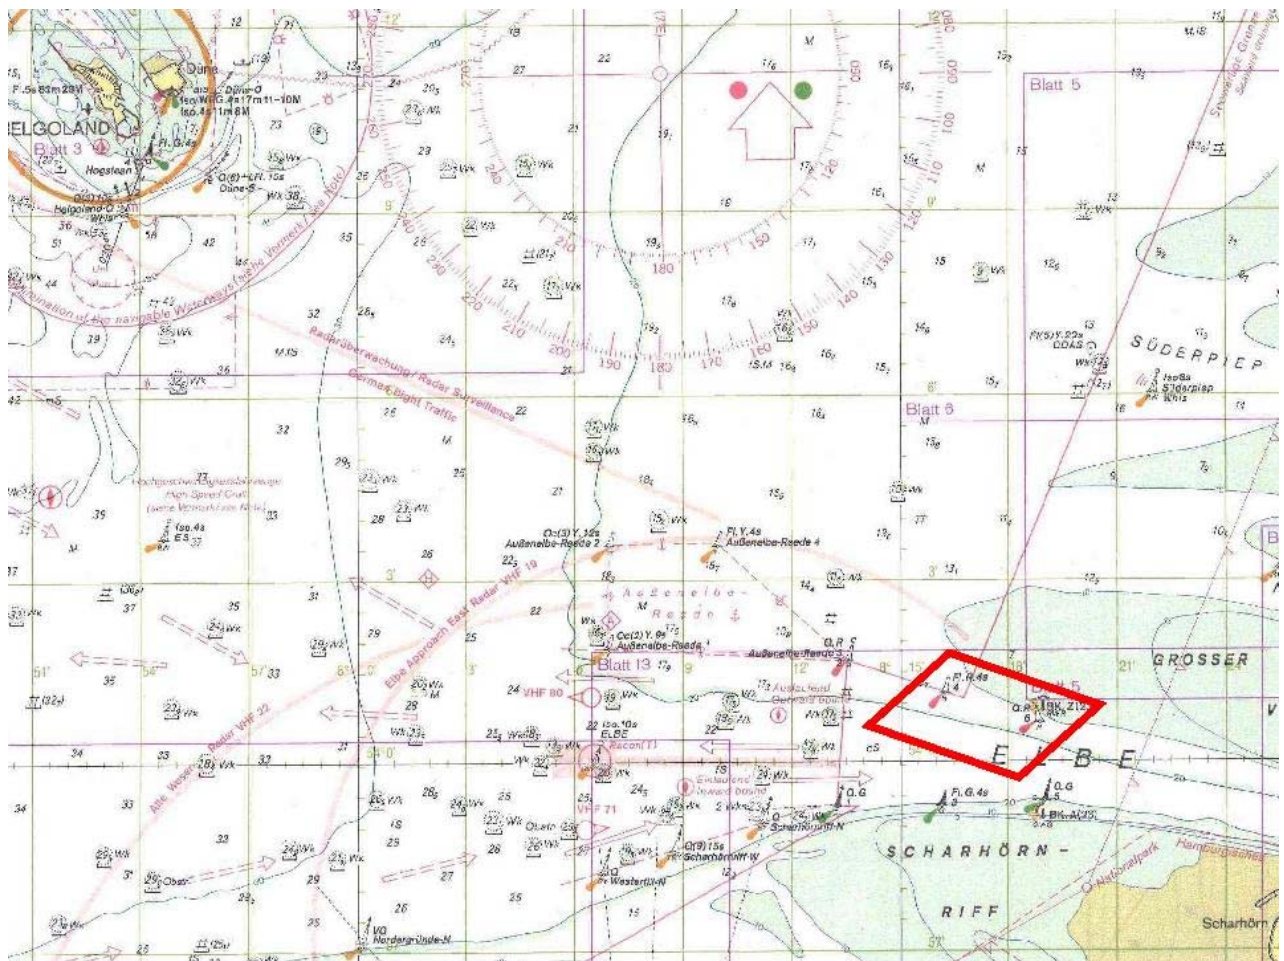
Figure 1: Scene of the accident

Nature of the incident: Marine casualty
Date: 11 October 2003
Time: approx. 12.15 h
Location: Elbe estuary/German Bight, River Elbe fairway outbound, between buoys Elbe 6 and 4
Latitude/Longitude: $\phi 54^{\circ}00.7'N$ $\lambda 008^{\circ}17.5'E$
