Investigation Report 330/03

Very serious marine casualty

**Fatal accident during welding in the
engine-room workshop of
MV DRESDEN EXPRESS
on 26 October 2003**

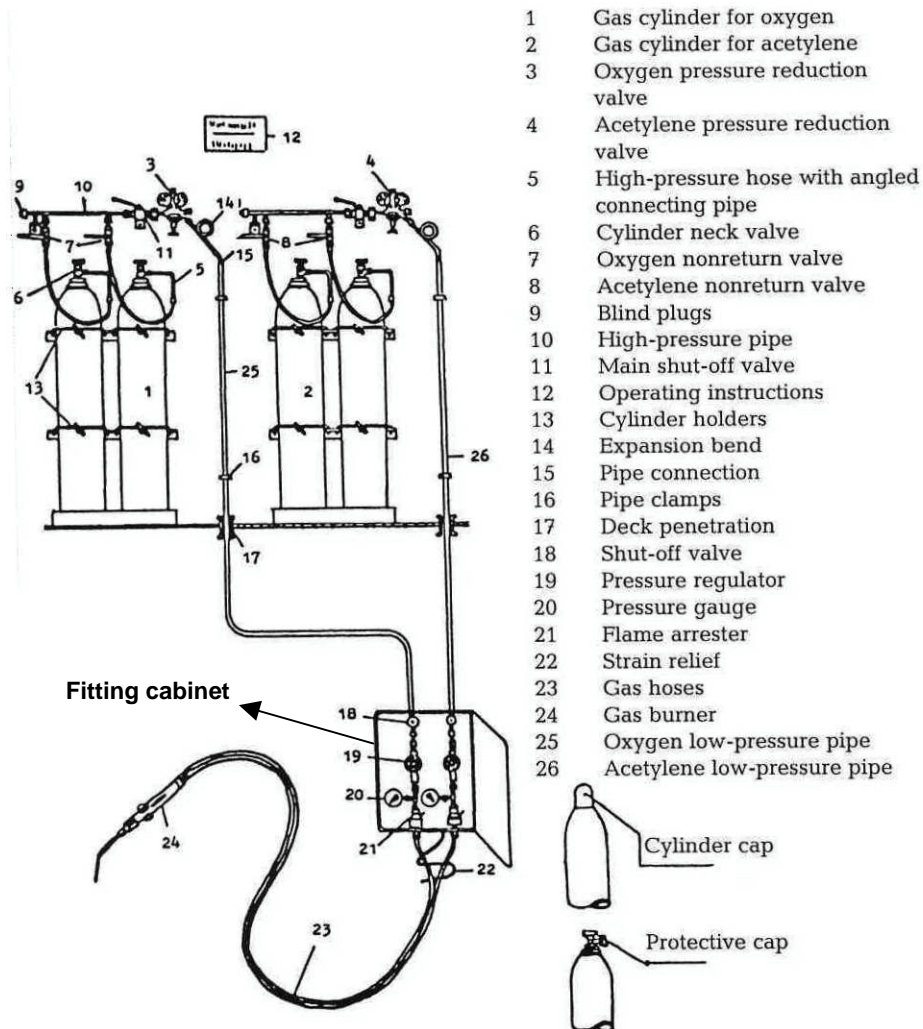
Figure 8: Set-up of the gas welding system²

Figure 8 shows the proper set-up of a gas welding system in diagram form in accordance with the Guidelines of the See-Berufsgenossenschaft (Safety Organisation) for Building, Fitting-out, Testing and Operating Welding Installations on Ships (Welding Guidelines) sailing under German flag.

In accordance with this Regulation, due to their particularly high explosion risk the gas cylinders (oxygen and acetylene) are to be stored in separate cylinder spaces or cylinder cupboards located above the highest continuous deck, gastight separated from the rest of the ship's spaces by steel walls, and they must be accessible through steel doors from the free deck.

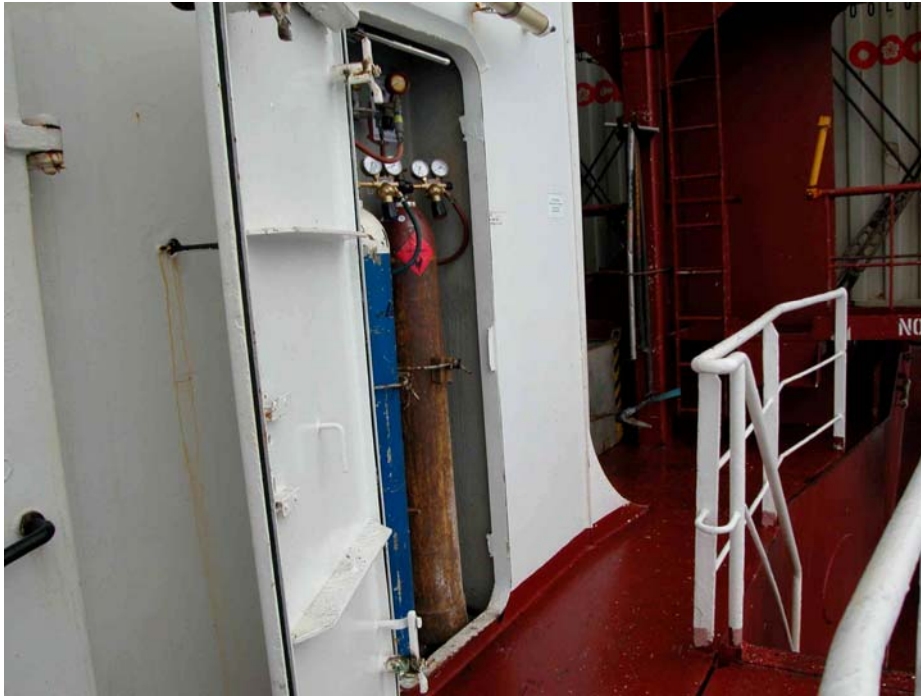
Figure 9: Cylinder space on the upper deck

The gas is supplied from the gas cylinder system to the consumer facility in the workshop via a piping system. The consumer facility (cf. figure 8 No. 18-24) is located in the engine-room workshop at the welding workplace. The gas outlet station with the shut-off valves, pressure regulators, pressure gauges and the Dry Use Storage is protected against mechanical influence on board by a fitting cabinet.
