Investigation Report 350/03

Very serious marine casualty:

**Death of a crew member of
MV AUTO ATLAS
on 11 November 2003
in the North Lock Bremerhaven**

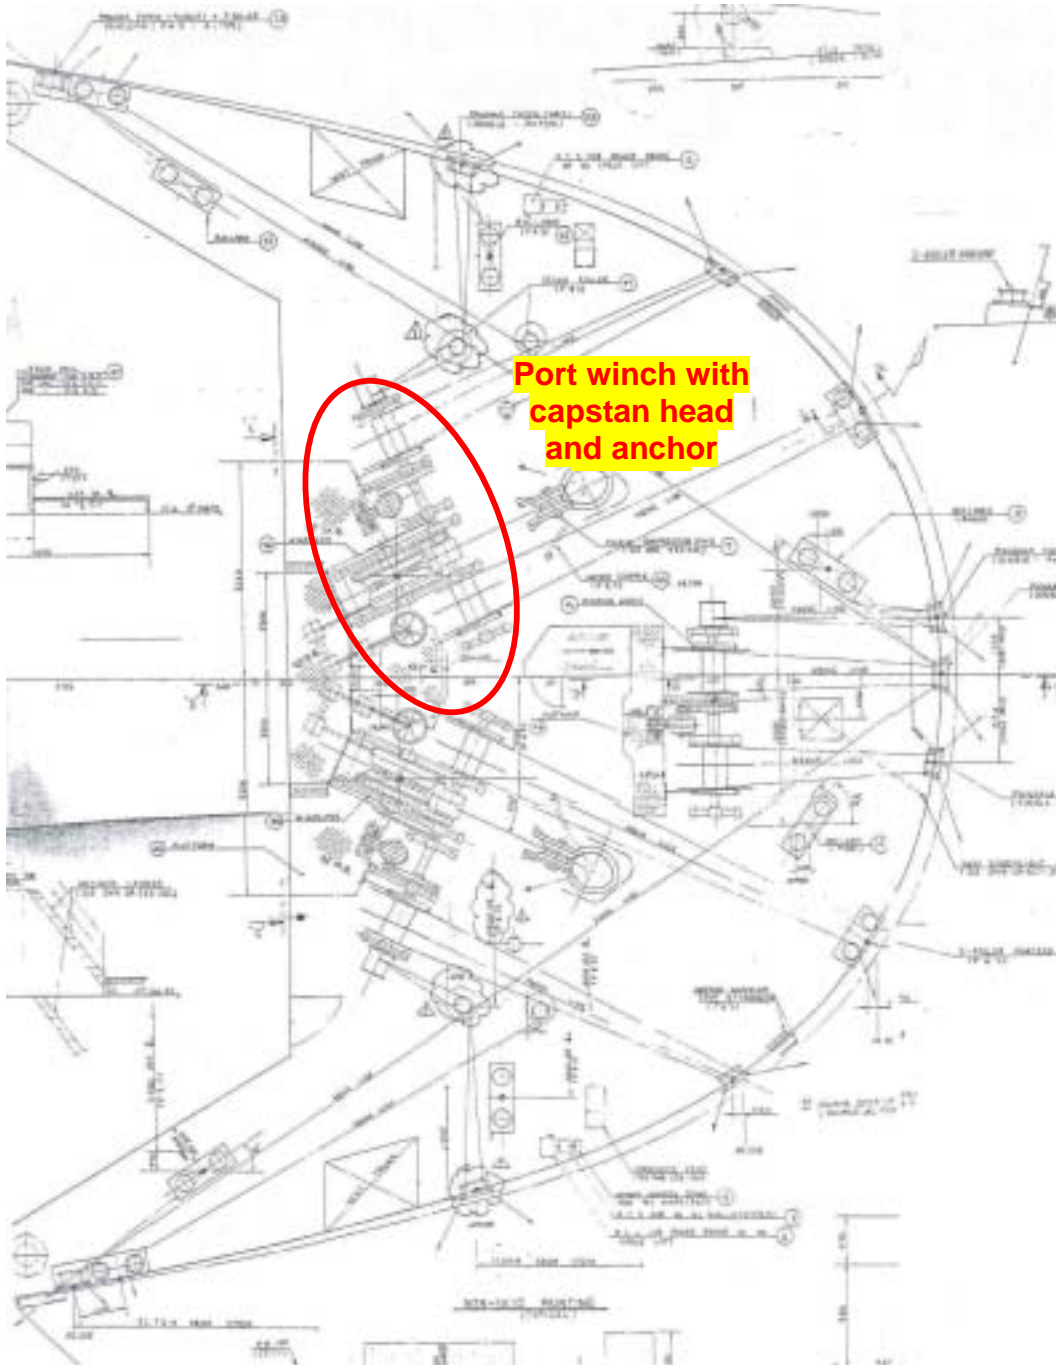
Figure 9: Arrangement plan of mooring equipment on forecastle

There were three mooring winches on the forecastle of AUTO ATLAS, one on the port side, one on the starboard side and one midships. The winches each have two rope drums, each of which is divided into a storage part and a working part by a middle plate. In addition each of these winches has a capstan head, on the port and midships winch located on the left viewed in the direction of the vessel, and on the starboard winch on the right on the outside of the winch. Furthermore the anchor capstan is integrated in the port and starboard winch.

The port winch relevant for the accident is a winch of type Fukushima K7681 III–W320 with the following technical details:

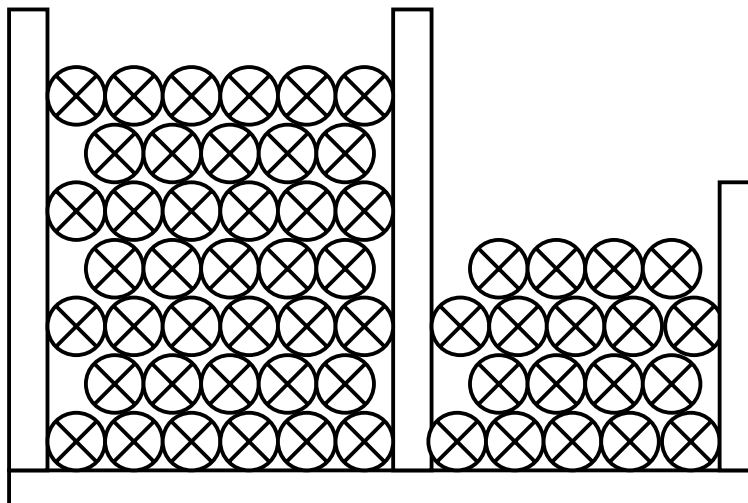
Winding pattern with absolutely clean winding
