Bundesstelle für Seeunfalluntersuchung
Federal Bureau of Maritime Casualty Investigation
Bundesoberbehörde im Geschäftsbereich des Bundesministeriums
für Verkehr, Bau- und Wohnungswesen

Investigation Report 88/03

**Fatal accident of the
Second Nautical Officer
on board MV PETUJA**

on 11 March 2003
in Hamburg

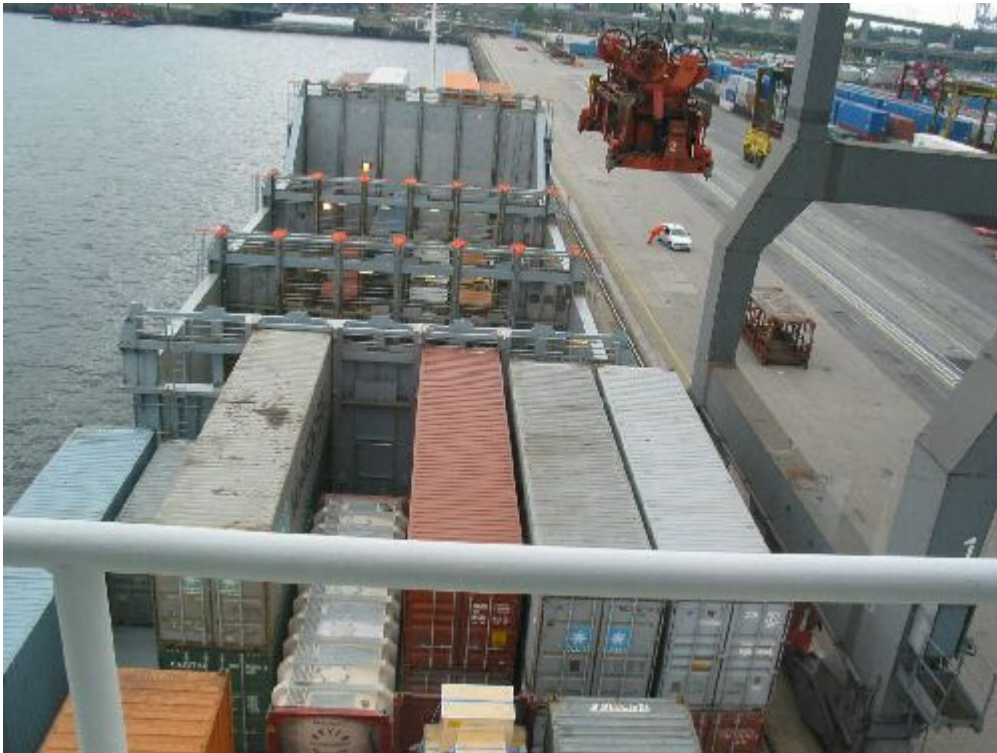
Figure 6, View from the bridge

There are no precise procedural instructions for port watches on this vessel in the International Management Code for the Safe Operation of Ships and for Pollution Prevention (ISM-Code). On MV PETUJA the officer on duty supervises the loading and discharging operations from the bridge (see figure 7). The cargo computer and the stowage plans as well as the switch control of the deck and hatch lighting (see figure 8) are on the bridge. The persons on watch from shore and sea are connected with each other via "walkie talkies" and telephone.
