Investigation Report 134/04

Very serious marine casualty

**Accident involving personal injury with fatal
consequence
on board
MV Hamburg Express
on 7 June 2004
off the French Atlantic Coast**

15 May 2005

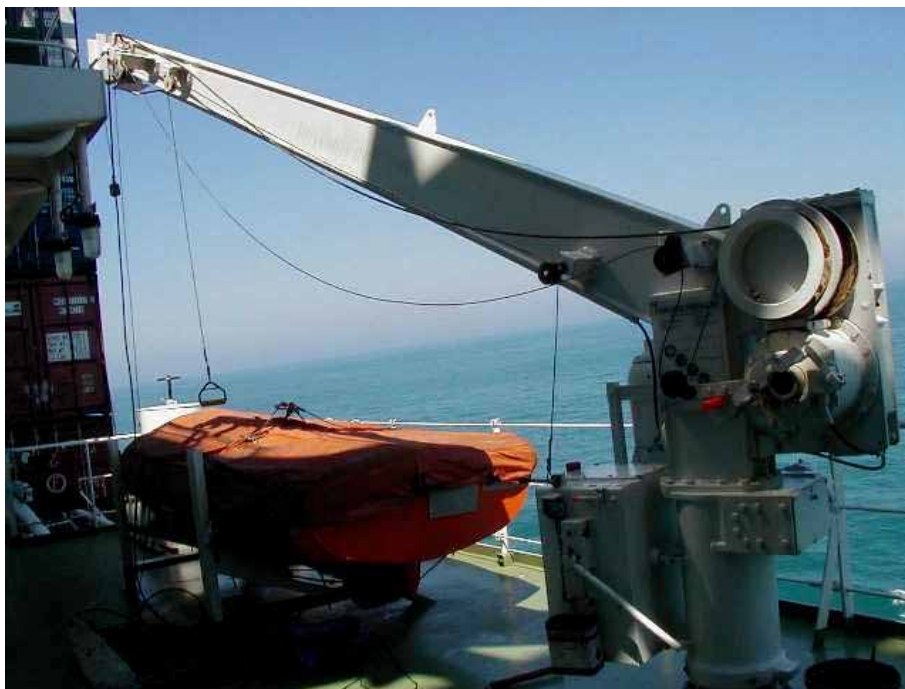
Figure 3: Crane with rescue-boat (photo taken on day of accident)

The crane used to lower the rescue boat to the water was produced by the firm Global Davit GmbH. It is a jib crane mounted on the deck of the vessel (Fig. 3). The crane has a load-bearing capacity of approx. 1 t, and for safety reasons can be operated both manually and mechanically. An electrically operated rope winch and a

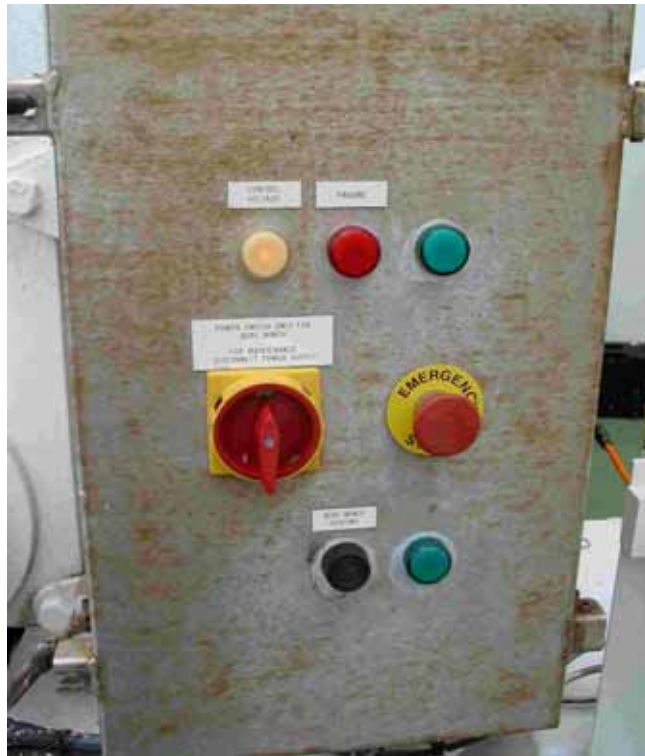
Figure 4: Switch cabinet; winch motor operating elements

hydraulically operated swivel drive are available to the jib davit for this purpose. The cable winch drive consists of an electric motor and a transmission that is connected with the cable drum. There is a disengaging coupling arranged between the electric motor and the transmission. The cable is guided from the rope drum over the davit jib. The trigger mechanism with which the boat can be released from the crane rope is located at the end of the rope. The rope drive is designed in such a way that under normal circumstances the rope can only be moved in the direction "Heave"⁷. For this purpose the winch motor is started up by means of two switches (red rotating switch = main switch; black push button = on/off switch) on the outside of the switch cabinet (Fig. 4).

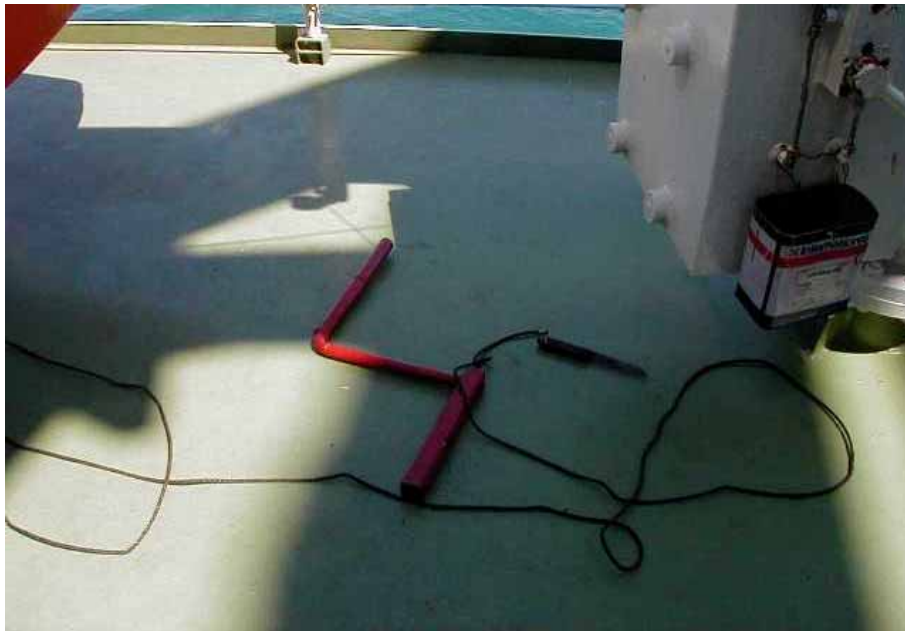
Figure 5: Crank-handle next to the crane

If the rope is to be wound up by hand, a crank-handle is available (Fig. 5) on the side opposite the drive that is mounted on the intermediate shaft of the transmission. The part of the shaft used for this purpose is designed as a square. In order to avoid incorrect operation, the crank-handle can only be mounted when the drive is not switched on (no current is flowing). To this end a swivel type safety bar is arranged in front of the square mount for the crank-handle. This bar is secured to the load-bearing structure of the crane with a screw that also serves as a joint for the bar. By swivelling up the safety bar, the square is released for mounting the crank-handle and at the same time the lever of a limit switch that switches off the electricity is switched over. The coupling is also disconnected with the same safety bar.

During the first care and recovery of the injured man, nobody had bothered with the actual crane. The crank-handle was subsequently found lying next to the crane. Traces of blood were detected on it. The nature and form of the head injuries of the seaman involved in the accident indicate that he was hit by the crank-handle mounted and turning with the winch when the Second Officer actuated the electric winch drive.

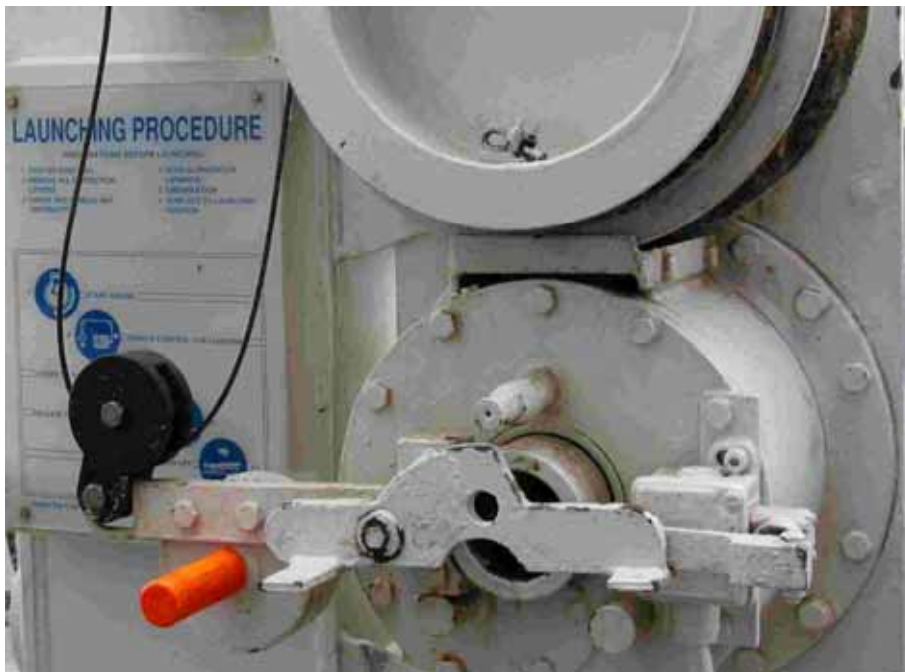
Figure 6: Safety bar locked

The joint of the safety bar should work in such a way that the bar closes automatically (in other words it drops down and covers the square socket) when the crank-handle is drawn off (cf. Figures 6, 7, 8)

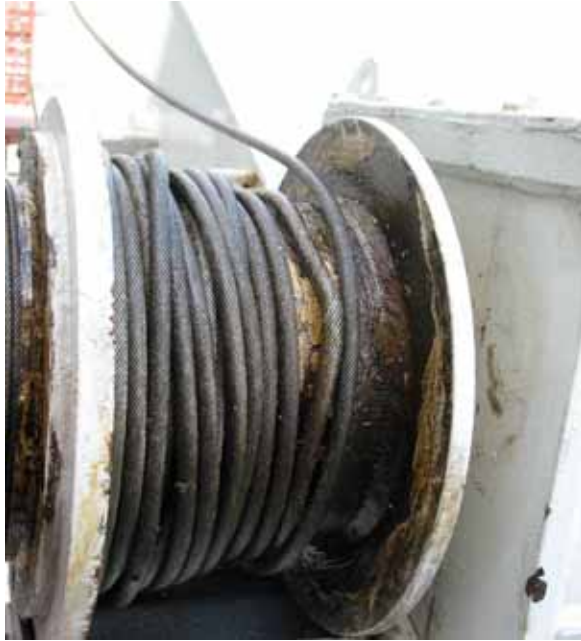
Figure 10: Cable drum

According to the statement by the Second Officer (cf. also Section 3 above) the boat fall of the rescue boat was to be greased on the day of the accident. For this purpose the Officer and J. had unwound the wire rope from the drum almost completely by hand. In addition the stop brake had been tied upwards so that the two could draw the wire rope from the drum by muscle power. The wire rope had been laid out on deck in bays with a diameter of approx. half a metre, roughly directly beneath the upper end point of the crane jib (Fig. 10, 11).
