Investigation Report 138/04

Very serious marine casualty

**Collision of
FV GRIETJE BOS with FV GRETJE GRE8
with one fatality
near Borkum
on 11 June 2004
at 02:32 h CEST**

21 February 2005

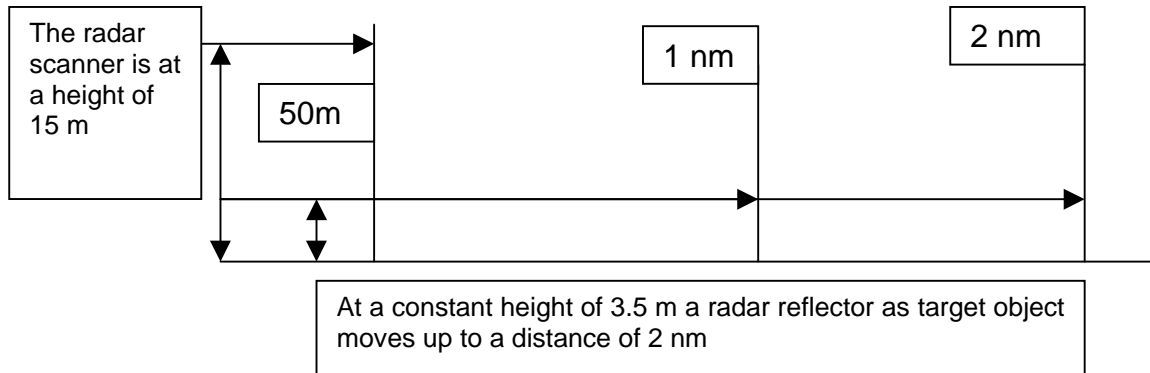
The following sketch of the required test serves to illustrate this:

To summarise, it can therefore be said that the German FV GRETJE GRE8 should have been seen on the radar by the Dutch FV GRIETJE BOS. The optical visibility is so restricted due to the design of the vessel, however, that is conceivable that the vessel could have been overlooked.
