Bundesstelle für Seeunfalluntersuchung
Federal Bureau of Maritime Casualty Investigation
Bundesoberbehörde im Geschäftsbereich des Bundesministeriums
für Verkehr, Bau- und Wohnungswesen

Investigation Report 145/04

Very serious marine casualty

**Loss over board of the Skipper of SY ALENA
on 20 June 2004, southwest of Gedser**

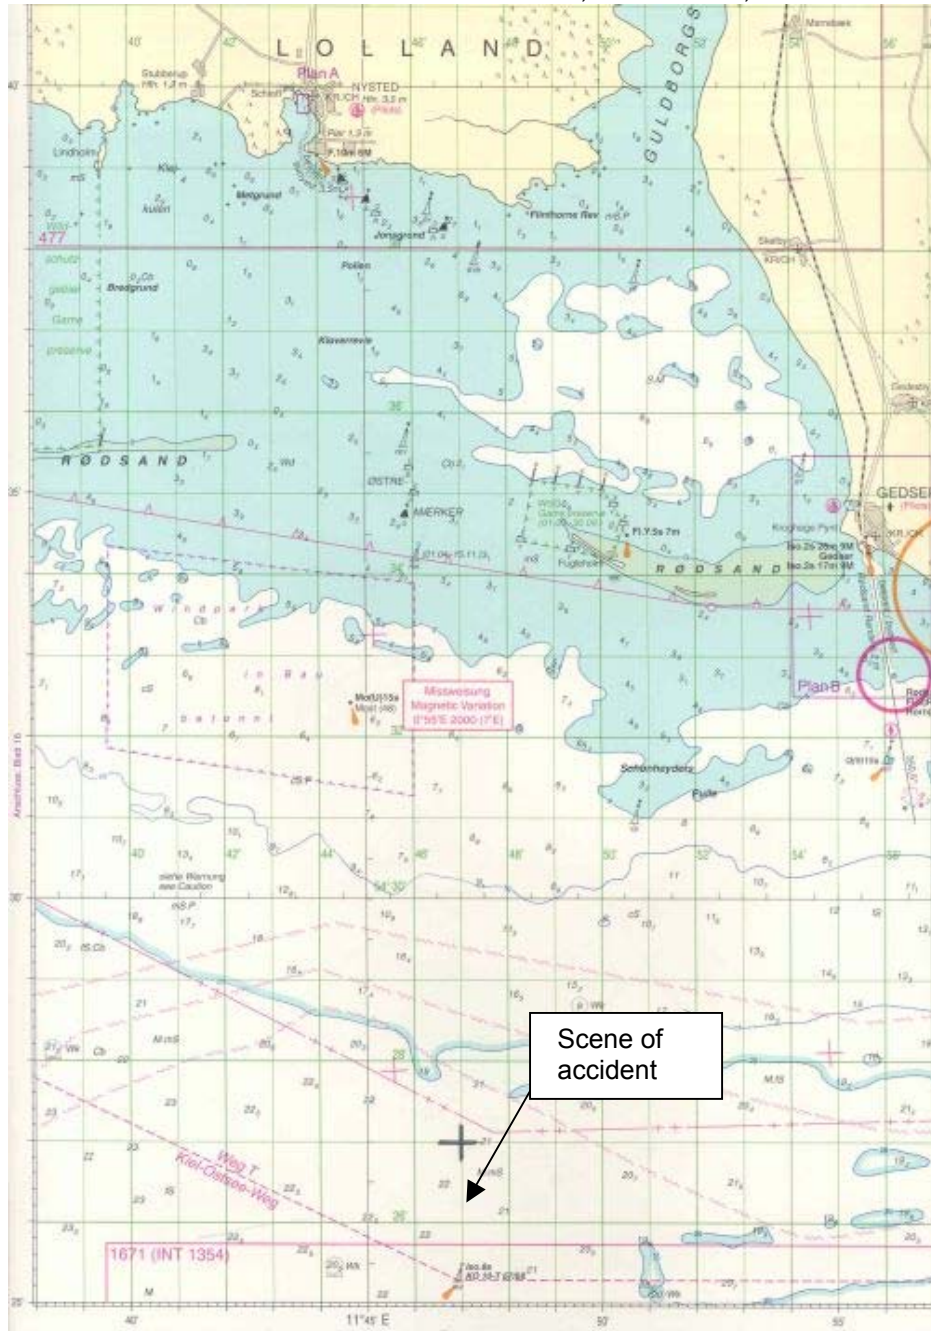
Figure 1: Sea chart with scene of the accident

Nature of the incident: Very serious marine casualty, loss over board
 Date/Time: 20 June 2004, 22:15 h
 Location: Southwest of Gedser, Denmark
 Latitude/Longitude: ϕ 54°27,0' N λ 011°47,0' E
