Investigation Report 155/04

Very Serious Marine Casualty

Collision
MV PUDONG SENATOR
with
MT ENA 2
and subsequent capsizing of
MT ENA 2
on 28 June 2004
in the Port of Hamburg
Parkhafen Waltershofer Hafen
and Petroleumhafen

15 June 2005

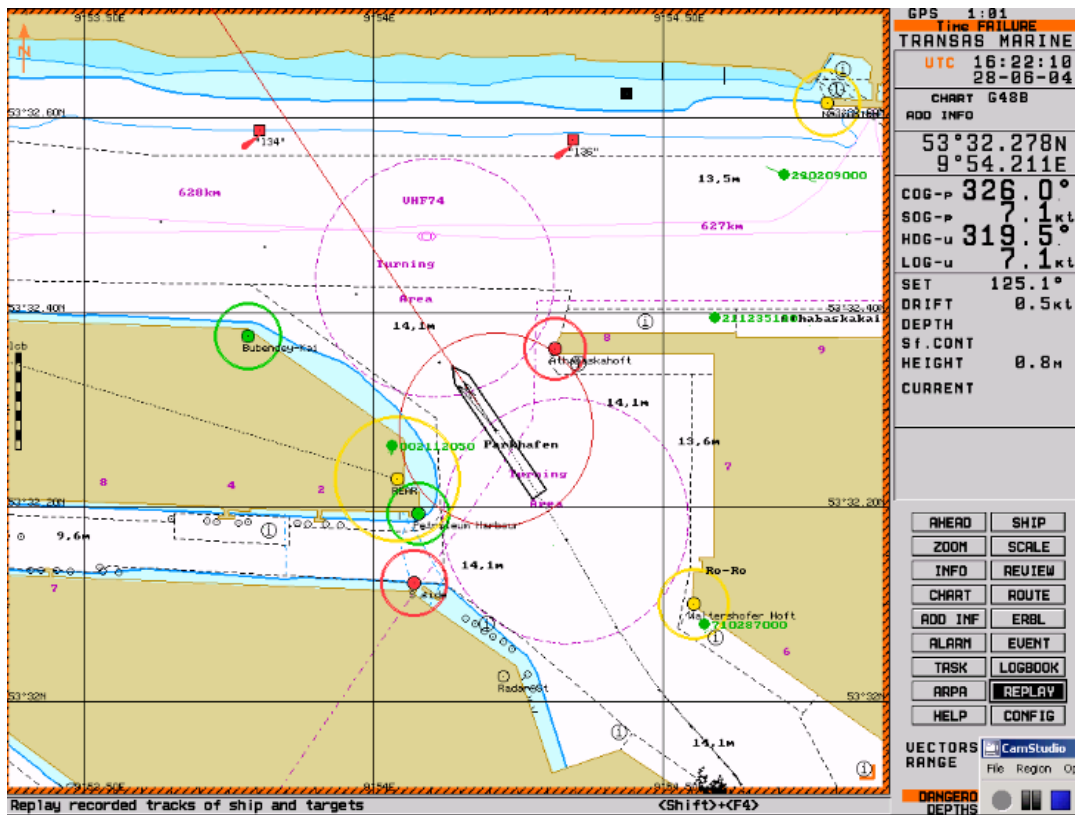
Figure 5: ECS of PUDONG SENATOR shortly before the collision

At **18:23:10 h** the port pilot of PUDONG SENATOR informed the VTS on channel 14 that ENA 2 had just run in front of their stem. In response to enquiries by the VTS, *"Did you have contact? Could you ascertain anything?"* the pilot answered, *"Yes, reportedly slight contact in the foreship, I can't see him any more"*. The VTS informed PUDONG SENATOR that it would look into the matter and instructed the vessel at **18:23:30 h** to first continue. After this the engine of PUDONG SENATOR was ordered to "dead slow ahead" and the vessel continued to turn out of the Parkhafen.

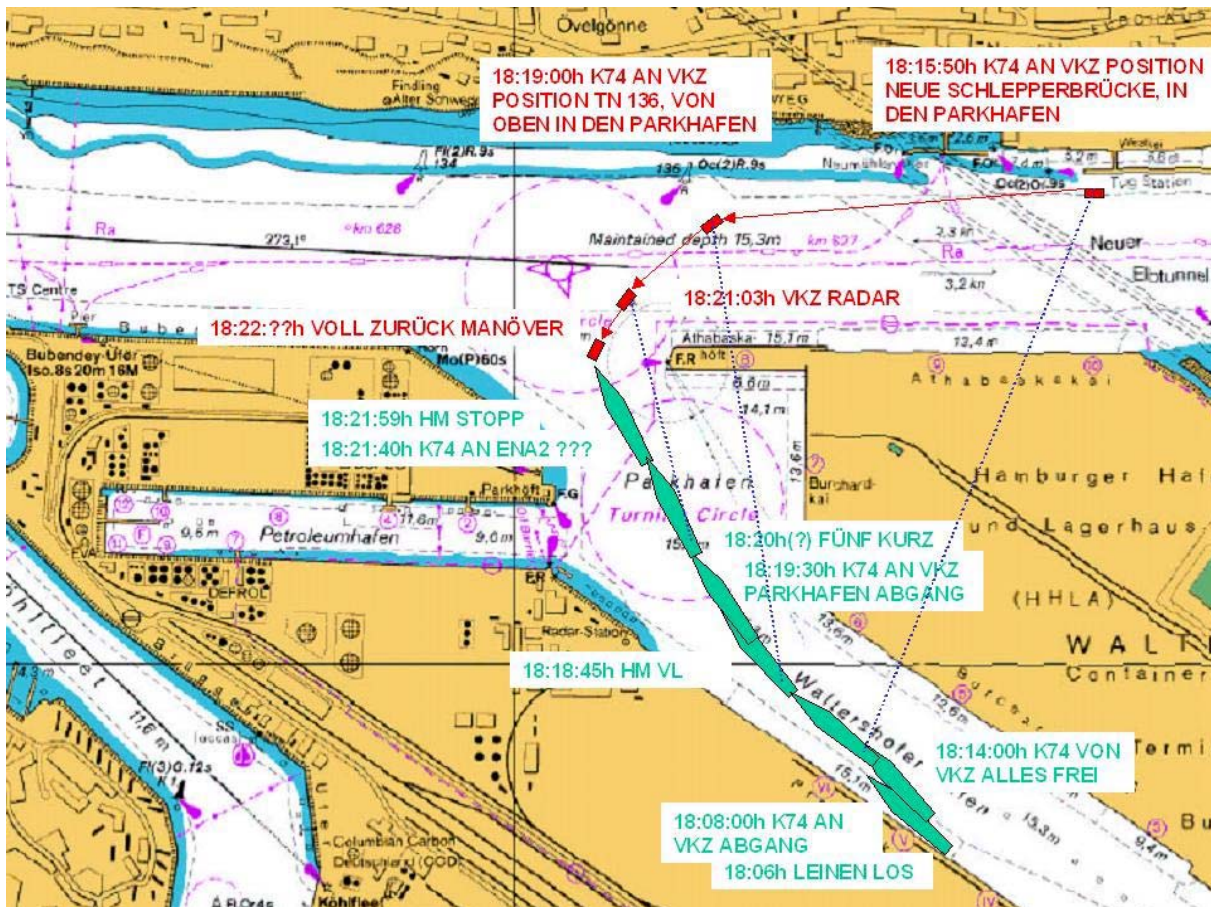
Figure 6: Overview of course of collision

The damage configuration on ENA 2,¹⁶ the situation of the vessels in relation to each other before and in particular after the collision, and the testimony by the Master of the aft tug CONSTANT indicate that the port side of ENA 2 slipped along the starboard side of PUDONG SENATOR before the two vessels came free of each other again, lying parallel with each other with the same direction of travel (cf. Fig. 2).

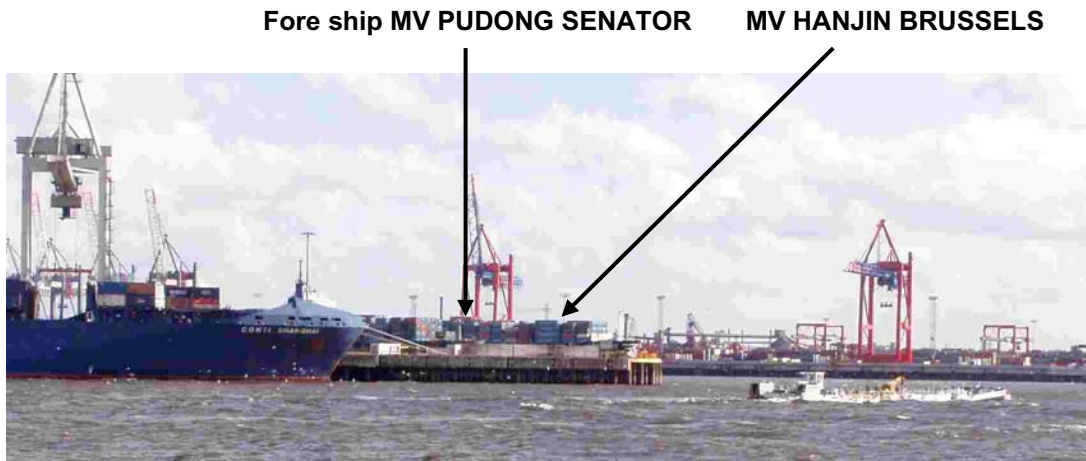
Figure 15: ENA 2 on the day of the accident turning into Parkhafen

⁴⁸ PUDONG SENATOR during the next run through the port (09/2004) lying at Predöhlkai: left part of picture Bubendey Shore, right part Athabaskakai; on the day of the accident a container vessel lying at Athabaskakai additionally prevented visibility (cf. here Figure 15, foreground)

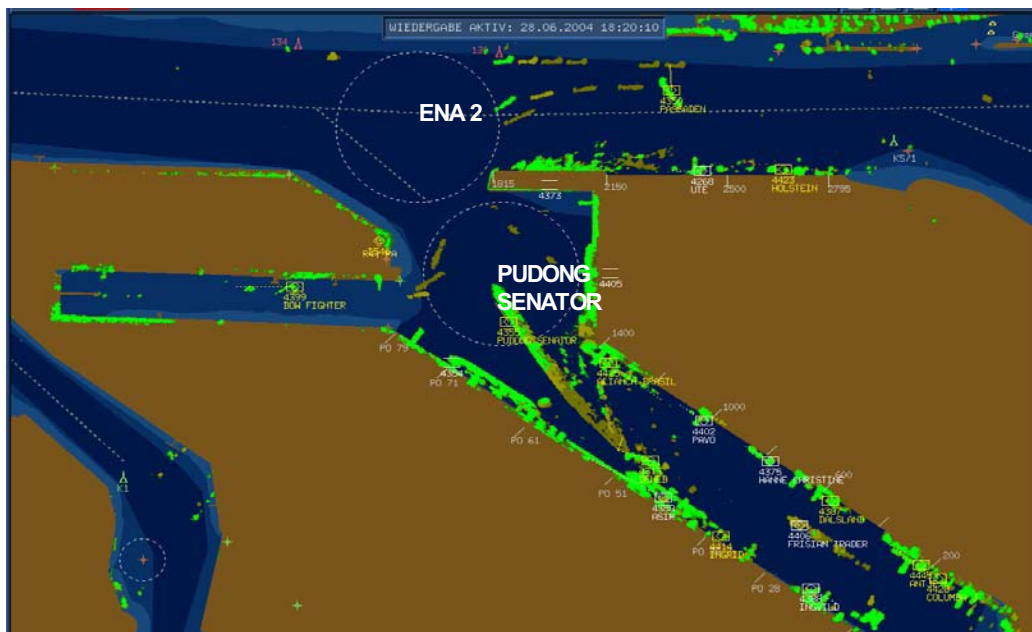
Figure 18: Radar image of the VTS at 18:20:10 h

assessment, since as already indicated above, he evidently did not initiate a resolute "hard-to-starboard manoeuvre" - at any rate not immediately. His claim that he did so as quoted above is contradicted by the radar records documenting the course of ENA 2 (see Figures 18 to 21 below). No radical course alteration is noticeable. The deckhand on board ENA 2 did not confirm the change of course to starboard either. He stated that during the accident occurrence he had been in the old bridge, the messroom of the vessel, and had been able to see ahead and to the side from there since the (new) bridge had been raised. Apart from the high engine speed he had not noticed anything prior to the collision. The statement by the Master of the aft Tug CONSTANT that he had observed ENA 2 trying to cross the bow of PUDONG SENATOR at high speed also contradicts the thesis of an early "hard-to-starboard manoeuvre" on board ENA 2. The statements by the pilot and Captain of PUDONG SENATOR indicate that instead ENA 2 initially maintained its elected course persistently, even after the container vessel came into sight. Both stated that ENA 2 did not initiate any change of course. The allegedly initiated "hard-to-starboard manoeuvre" would moreover in any case have necessarily led to a significant turning movement that would have been recognisable in the radar records of the VTS and also for the other participants/witnesses. This assumption can be justified on the one hand by the fact that ENA 2 had two fast-reacting Schottel rudder propellers that at least theoretically would allow the vessel to turn on the spot or to cross with full thrust.⁵⁷ Furthermore, the outgoing tide that was in full flow at this time would have additionally supported a turn to starboard initiated for ENA 2.

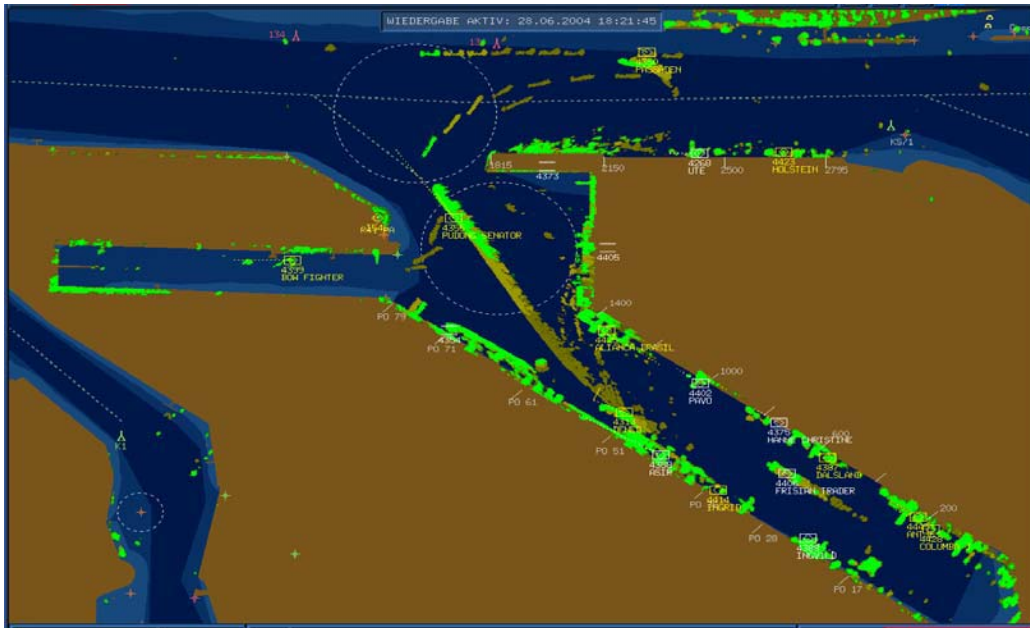
Figure 21: Radar image of the VTS at 18:21:45 h

On the contrary, the subject radar images (cf. below Fig. 18 to 21) show that at 18.21 h ENA 2 was evidently clear of the eastern molehead of Parkhafen (Athabaskakai)

Note.: The objection raised within the context of a lawyer's comment on the draft of the present report that the radar images of the VTS would not support the course of ENA 2 ascertained by the BSU, but instead on the contrary clearly confirmed the collision prevention measures claimed by their Master, is not convincing.

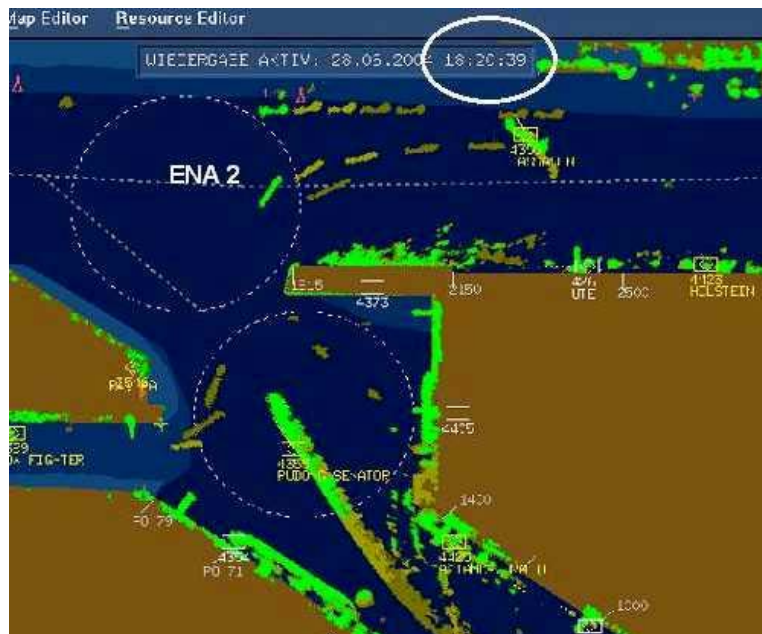
Figure 24: Radar image of the VTS at 18:20:39 h

The radar display of the radar station Parkhafen showed ENA 2 north of the mole head Athabaskahöft at this time. Although the tanker barge was thus on the wrong side of the navigation channel for entering Parkhafen, a passage green to green with the outgoing PUDONG SENATOR appeared to be possible at this time, which may have been a further and crucial reason why the VTS still did not classify the forthcoming encounter situation as dangerous.

However, on the basis of the radar records of the relevant channel opening area, especially as of about **18:20:40 h** (cf. Figure 24 above), it should have become clear that a dangerous approach was directly forthcoming between a large container vessel running out and a small vessel running in and crossing in the opening area of Parkhafen. HOWEVER, it is questionable whether the traffic assistance measure in the meaning of § 27 of the aforementioned service instruction that would be indicated now at the latest could have actually prevented the collision, in other words whether it could have been carried out in good time in accordance with the aforementioned § 25 Para 2 of the service instructions.
