Investigation Report 181/04

Very serious marine casualty

**Fatal accident of diver
on CMS CMA CGM VERLAINE
on 11 July 2004
in Marsaxlokk (Malta)**

1 June 2005

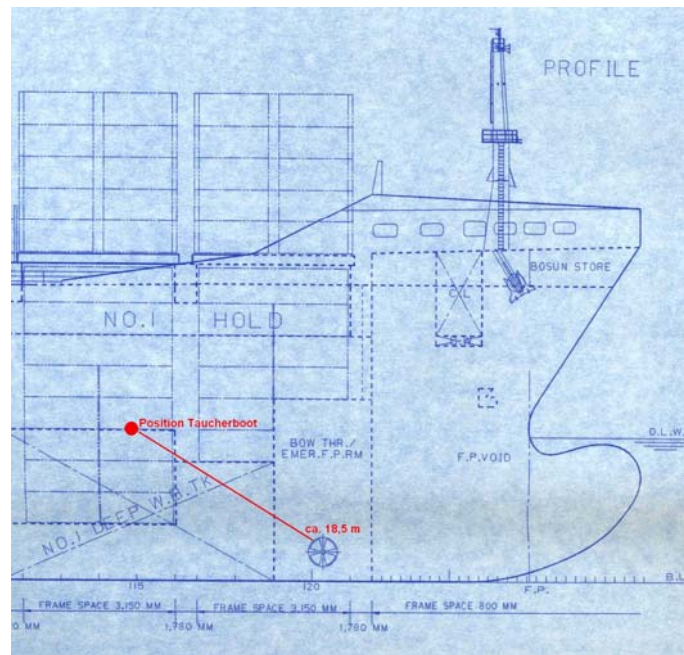
Figure 3: Side elevation foreship

After completion of the boiler survey the GL surveyor, the officer in charge of the watch and the diver met at about 08.50 h to prepare the lines for shifting the diver's boat. The diver began to prepare his equipment. At about 09.00 h it was reported to the diver that all was clear and the Master and the GL surveyor proceeded via the pilot ladder on to the launch. This was shifted forward approximately up to the level of frame 115 (see Figure 3). At about 09.15 h the diver went into the water there and

started the survey that the GL surveyor and the Master followed from the wheelhouse of the launch. The fatal accident occurred at about 09.35 h.

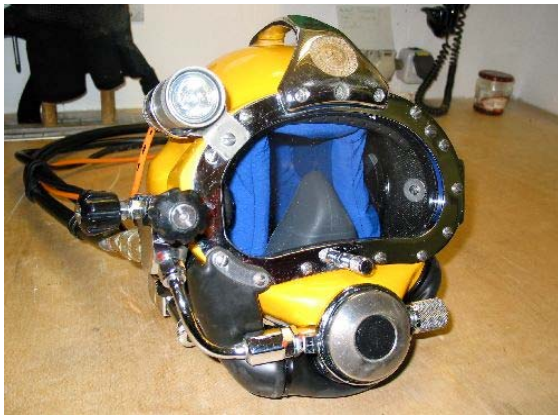
Figure 12: Diver's helmet

For professional divers the diving equipment normally consists of a helmet (see Figure 12), a wetsuit or dry suit, a buoyancy jacket or harness with additional air cylinder for approx 15 minutes of working air and weights. The cables/"umbilical cord" (e.g. for video, lighting, communication and compressed air) are twisted together and coloured differently. In addition the diver always carries a knife or pair of scissors in a chest holder (see Figure 13) or fastened to his leg. The video camera is carried freely or mounted on the helmet.
