**Investigation Report 240/04**

**Very serious marine casualty**

**Sinking of SY MADAME PELE  
and drowning of two sailors  
off Borkum on 26 August 2004**

1 May 2005

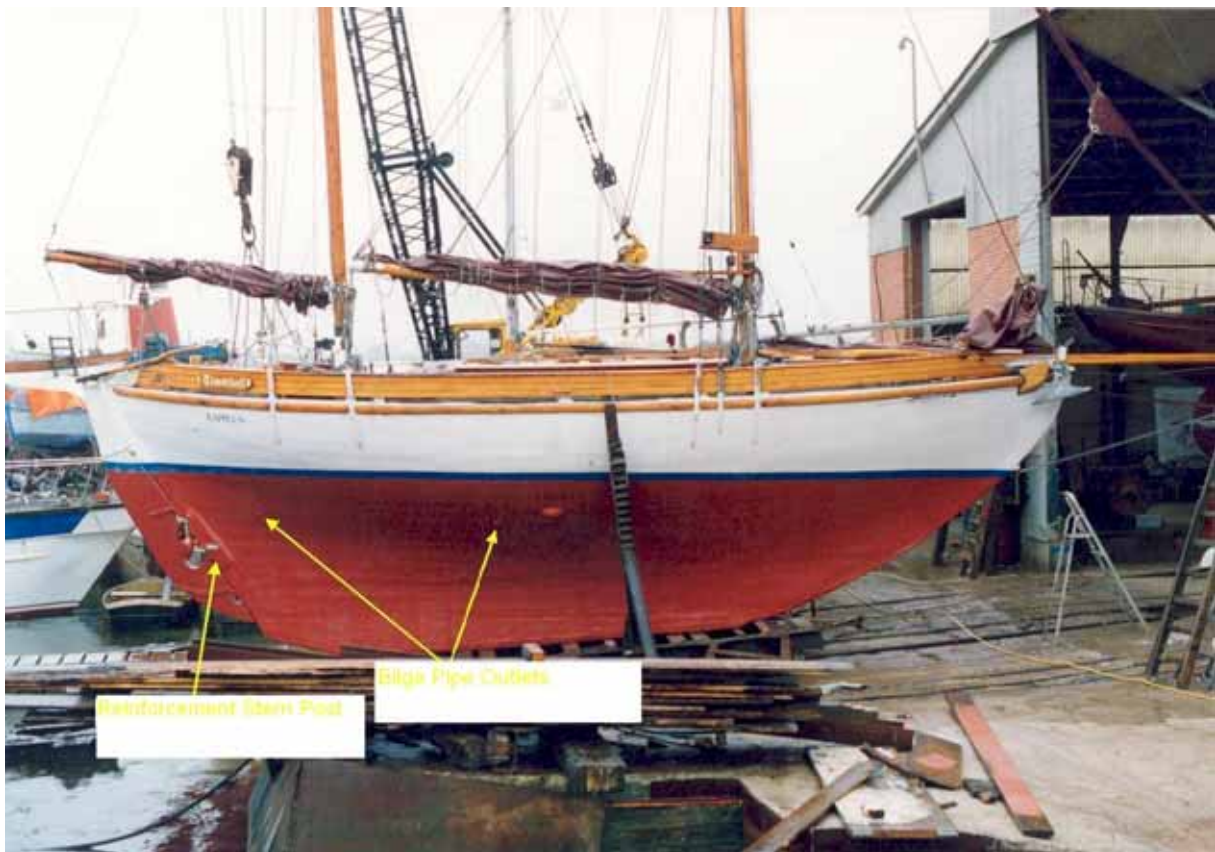
Figure 3: Side view

The previous owner had purchased the vessel in 1981. At that time the vessel had already been ashore in the city of Kiel for two years. An engine was installed at this time. The stern post had been drilled through to install the propeller shaft and strengthened at the sides with wooden jaws.

The hull of the vessel was made of Norwegian pine. The frame dimensions were 150 x 150 mm with a frame spacing of 600 mm. There were no water-tight transverse and longitudinal bulkheads. The carvel planking was 30 mm thick and the hull of the vessel was coated with glass fibre-reinforced plastic (GRP) in approx. 1974.

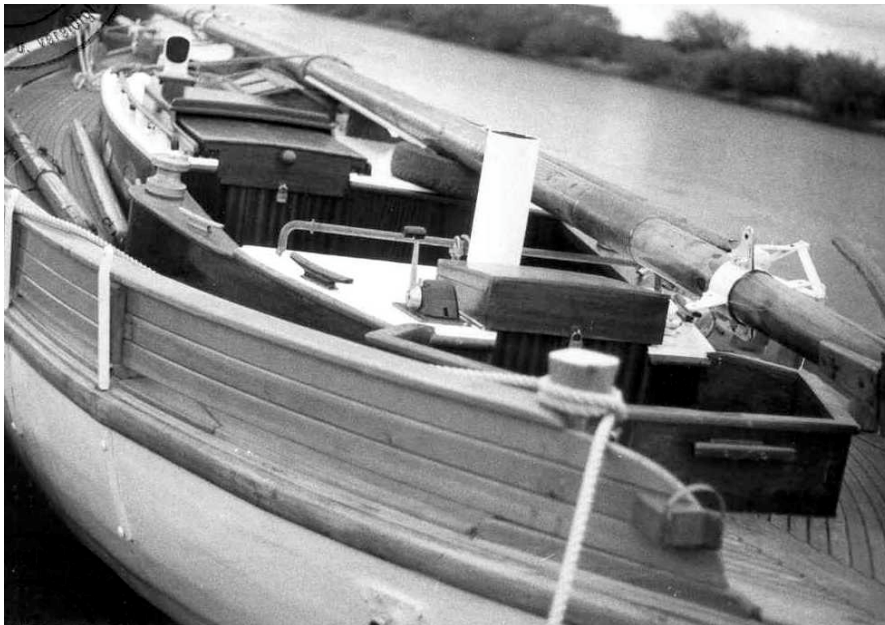
Figure 4: Centre cockpit and steering cockpit

The vessel possessed a self-draining steering and middle cockpit. It had been completely overhauled inside and built up anew by the previous owner together with a boatbuilder friend and provided with five fixed bunks, a pump WC, a sink and an oven. There was an additional superstructure above the forward companionway. The superstructures and the cockpit were made of solid mahogany and boat-building plywood. The engine, type Mercedes OM 636, was given a general overhaul and new sea valves were installed. The vessel was equipped with altogether six new, red-brown sails and rigged as a two-mast ketch, with the mizzen (wing sail) rigged jib-headed and the main sail as a gaff sail. The jib was run as a boomed jib and the jib-sail could be hauled in with a reefing roller.

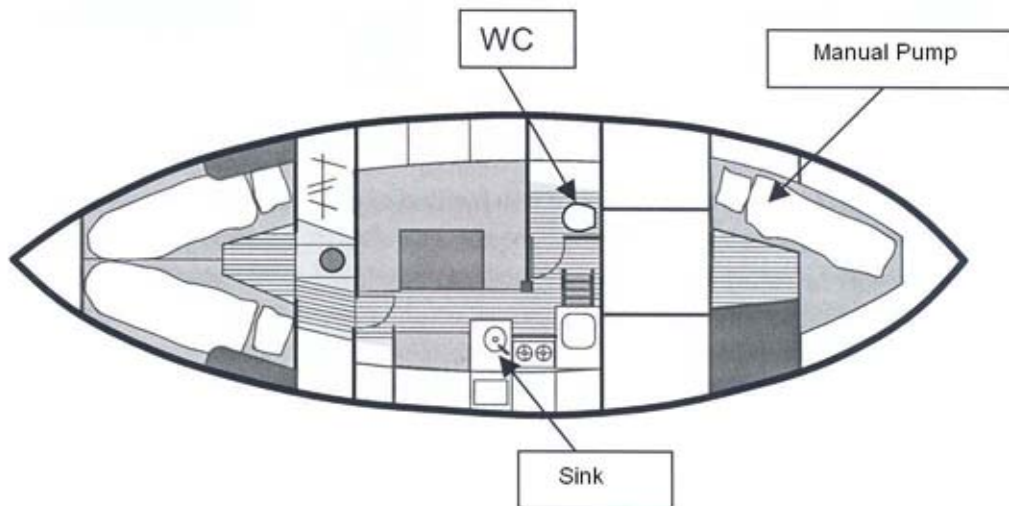
Figure 9: Below-deck drawing

The skylight was provided with a moss rubber seal and latch and a tarpaulin could be drawn over it too.

There were two Dorade ventilators that were installed on a wooden box. This box was built up as protection against water infiltration. It was not possible to lock this from inside. The ventilators could be turned aft and as an additional protection be locked from the exterior with cover caps that were on board. There was one mushroom ventilator each in the WC and the aft cabin area. These could be locked from the inside.

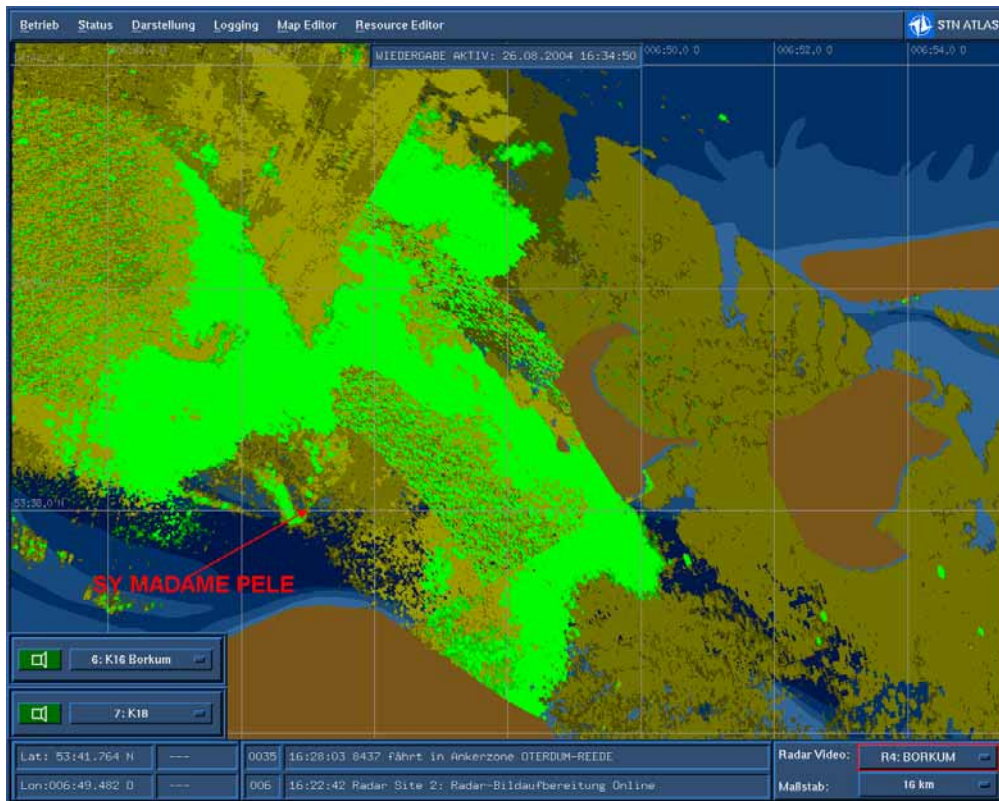
Figure 17: Plot of 16:34:50 h

After the larger rain front had passed with wind speeds of approx. 8 Bft the echo of SY MADAME PELE was lost at 16:36 h.

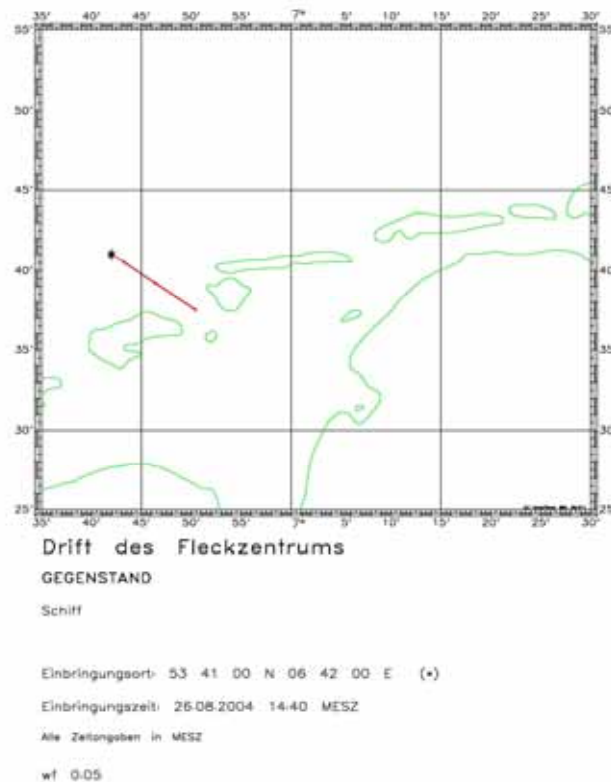
Figure 19: Drift characteristics of the yacht

It was assumed that the yacht was without engine and sail propulsion at approx. 14:40 h and possibly unmanned. Two variants were calculated. Firstly, a drifting yacht that was still fully floating, and secondly a drifting yacht half under water. Two different simulations were carried out for this with different wind thrust coefficients. The wind thrust coefficient describes the factor with which the wind directly determines the drift of the boat. The value 5% applies for a vessel that has not capsized with a relatively large wind attack area due to the rig and the part of the vessel above water. The factor 1% was taken for a vessel that has instead capsized and is lying flat on the water. According to the calculations of the two simulations the yacht can have drifted on the way recorded by the Revierzentrale in both cases.

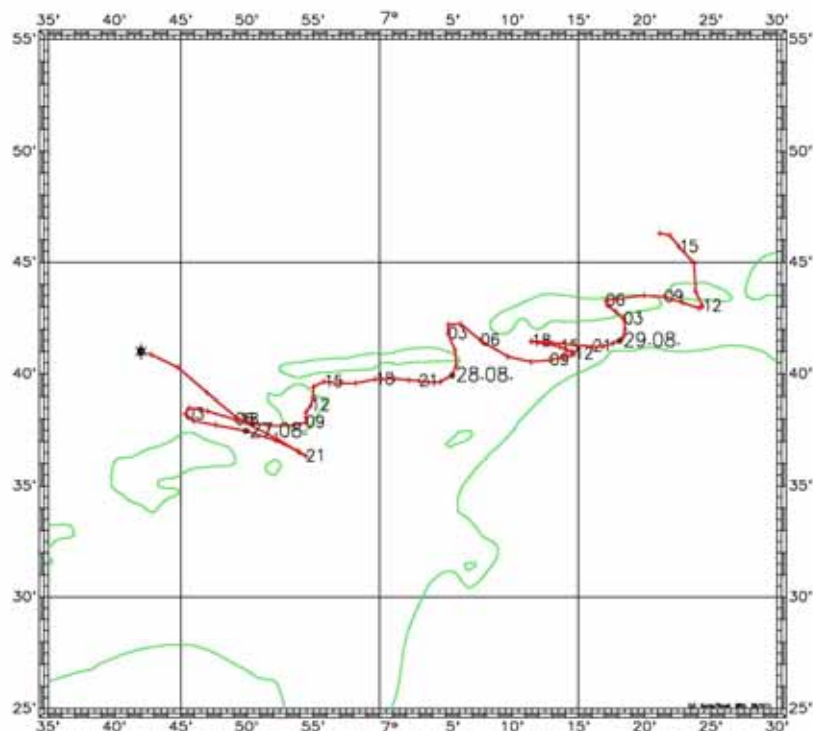
It is possible that he went over board at 14:40 h or after 16:36 h judging by the drift path.

The following chart shows the drift of several possible position locations. If possible position locations lie on both sides of an island, as shown in the following chart the drift path islands can cross the land. This is largely due to the relatively high resolution of the calculation model of one nautical mile.

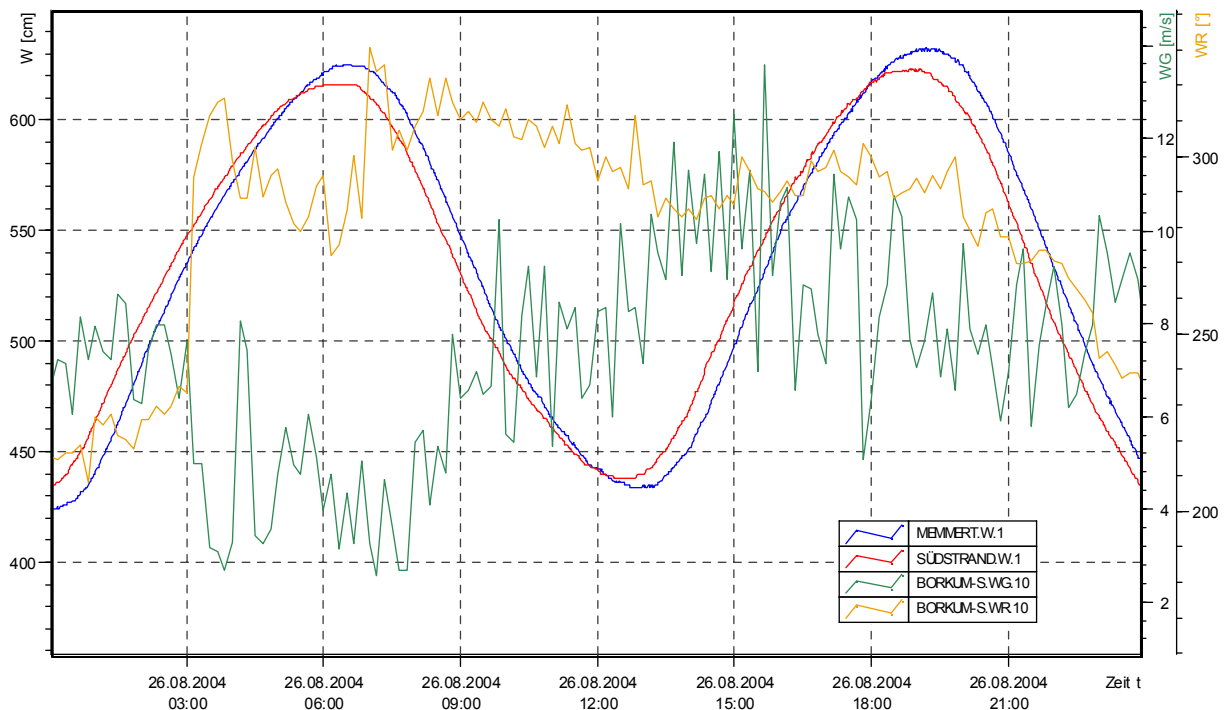
Figure 21: Water gauge curve and wind display

According to the water gauge curve above it was low water at 14:10 h (CEST) on Memmert on 26 August. The wind direction at Borkum South Beach at 09:00 h was from 320° and the wind turned back slowly. At 13:00 h a direction of 290° was measured. The highest wind force was measured at approx. 16:45 h on Borkum with 13.8 m/s (approx. 6 to 7 Bft) from direction approx. 290°.
