Investigation Report 343/04

Very serious marine casualty:

**Collision between MV RITHI BHUM
and MV EASTERN CHALLENGER
with subsequent foundering of
MV EASTERN CHALLENGER
on 14 November 2004
in the South China Sea / Taiwan Strait**

15 July 2005

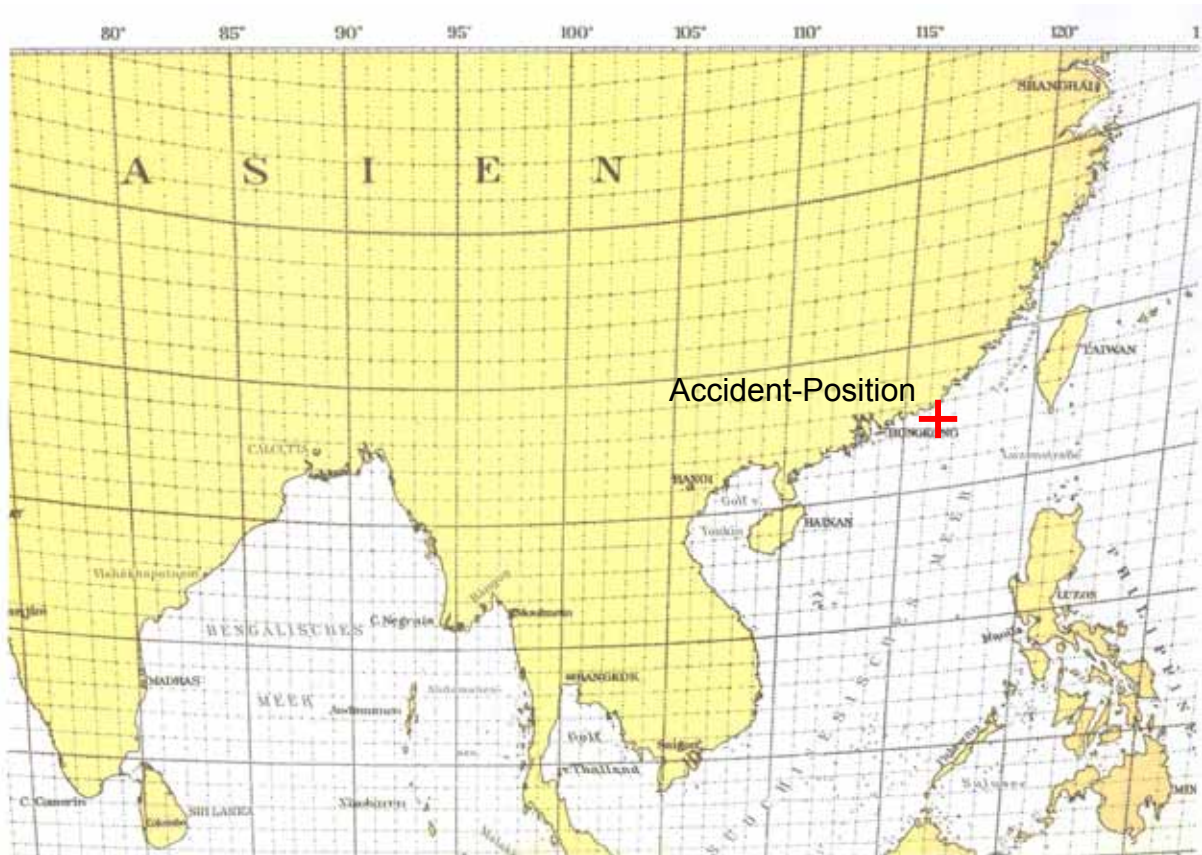
Figure 1: Scene of the accident

Nature of the incident: Very serious marine casualty
Date/Time: 14 November 2004, approx. 02:12 h
Location: South China Sea / Taiwan Strait
Latitude/Longitude: ϕ 22°35' N λ 116°25.8' E

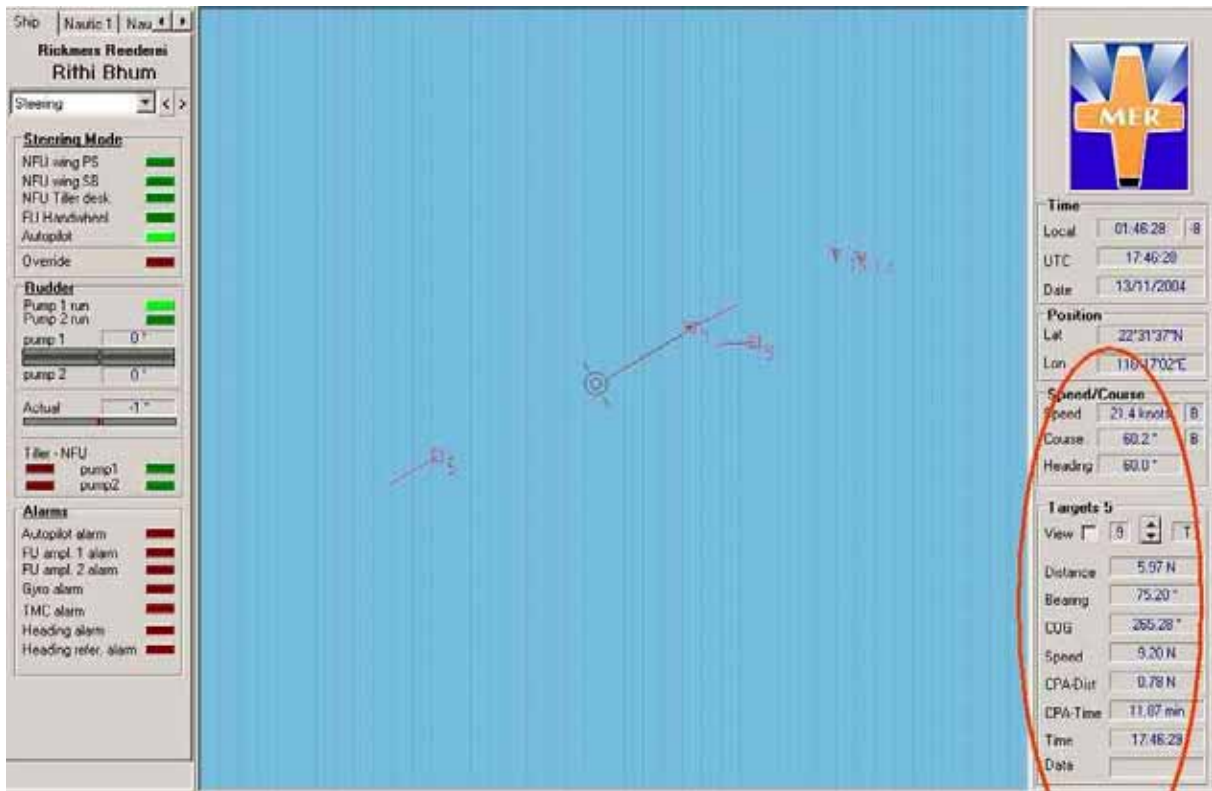
Figure 10: VDR data for the new ARPA target recorded at 01:46 h (print out of VDR RITHI BHUM)

Following the change of course at 01:45 h the second officer of the watch on RITHI BHUM could no longer assume that he would overtake EASTERN CHALLENGER on the port side of his vessel. With a vessel right ahead with a slight change of the compass bearing to starboard, he should instead have assumed at this time that he would pass at close quarters on starboard. At about the same time as the change of course at 01:45 h a further vessel had been recorded and tracked on the starboard side as an ARPA target. In the following minutes this vessel quickly became a close-quarters opponent on a crossing course from starboard due to changes in its course and speed. The second nautical officer of the watch on RITHI BHUM switched over to manual steering shortly before 02:00 h and initiated a hard to starboard evasion manoeuvre. The vessel was passed at a distance of about two cables. After this the second officer switched back to the automatic pilot mode and RITHI BHUM turned back to port. The last course ordered had been 057°.

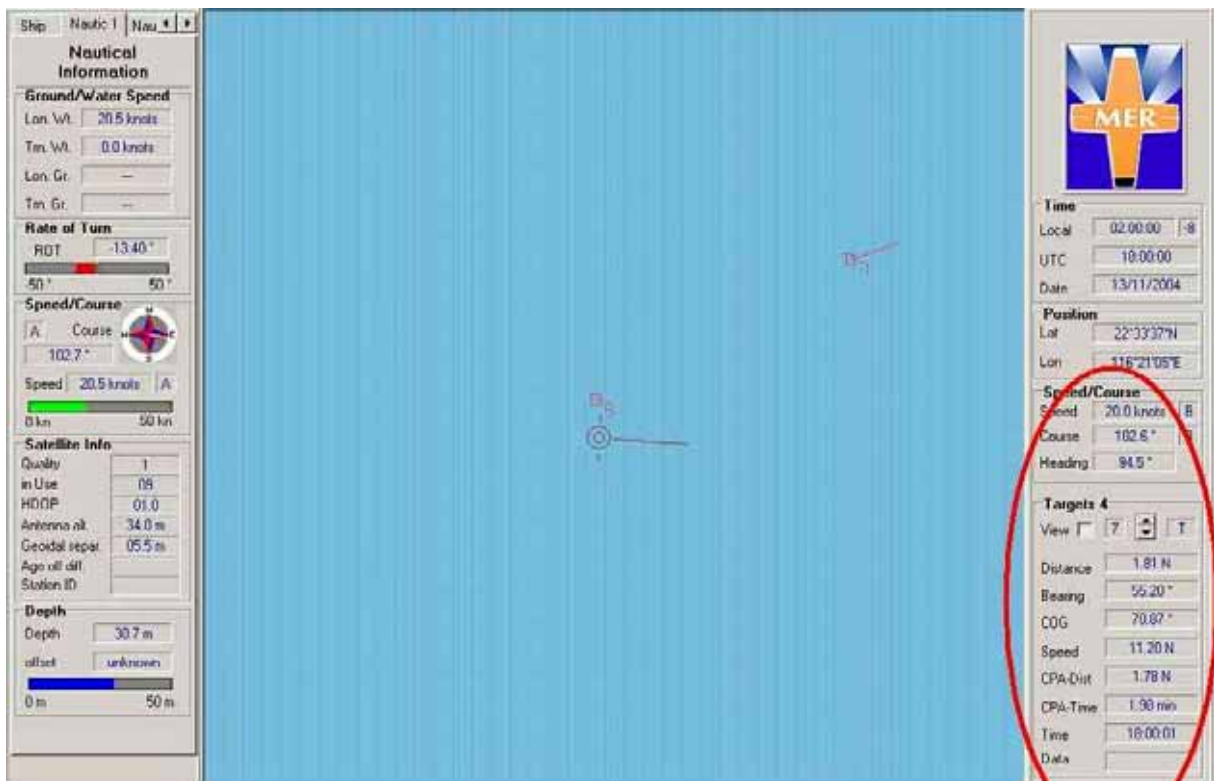
Figure 13: VDR data for EASTERN CHALLENGER on termination of the evasion manoeuvre at 02:00 h (print out from VDR RITHI BHUM)

The situation with regard to EASTERN CHALLENGER changed again with the evasion manoeuvre to starboard for the new vessel detected in the radar shortly before 02:00 h. The other vessel in the subsequent collision was again on a port bearing at a distance of now only 2 nm. On subsequently turning back to port to then 057° the distance had become even further reduced and EASTERN CHALLENGER was now on a bearing approximately right ahead. The second officer on RITHI BHUM should now have assumed the possibility of the risk of a collision. Up to the collision she continued on a constant course, no last minute manoeuvre was initiated.

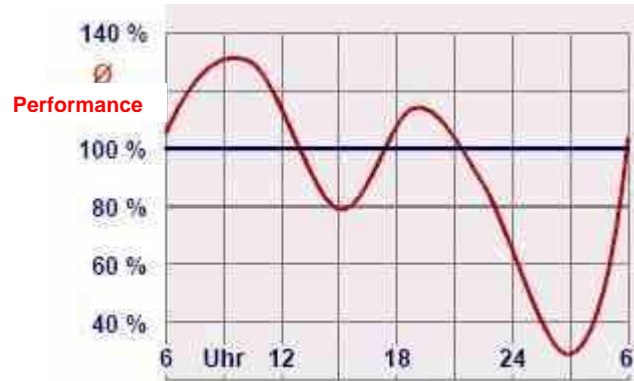
Figure 16: Circadian rhythm of humans

officer of the watch could not entirely be ruled out as a contributing factor to the accident.

There are no records concerning working and rest times for the second officer of EASTERN CHALLENGER. Here too impairment of human performance capability due to the time of day is assumed to be co-responsible.
