Investigation Report 381/04

Very serious marine casualty

**Capsizing and foundering of the
Tug JULIUS with one fatality
off Brunsbüttel on 16 December 2004**

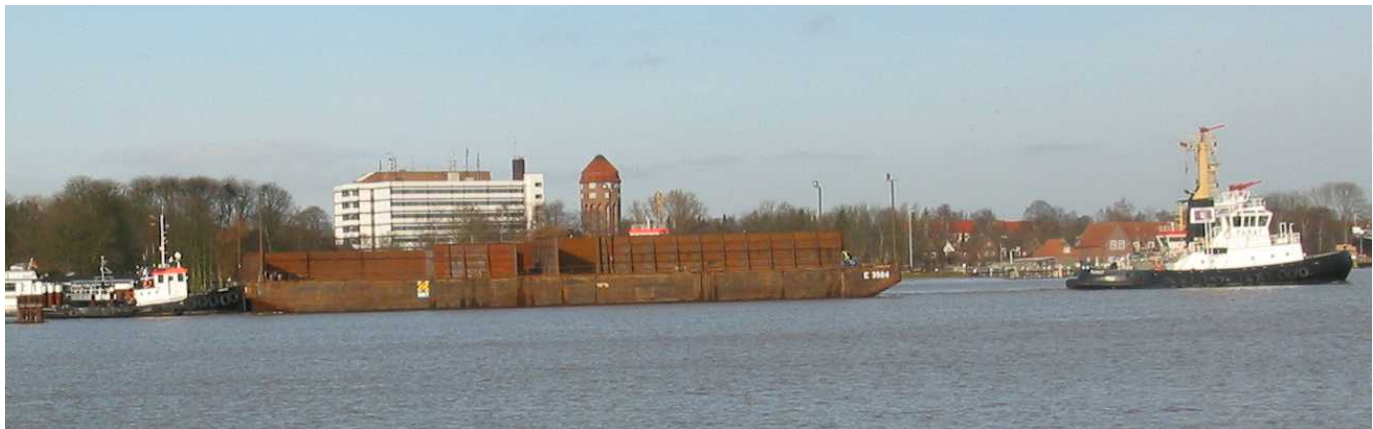
Figure 3: Tug-pontoon formation

The head tug PARAT has a Voith-Schneider drive and was connected with the pontoon via an approx two times 20 m long bridle made of wire and a 4 m long poly-line as stretcher. The stretcher then led via an approx. 10 m unwound towing wire onto the winch.

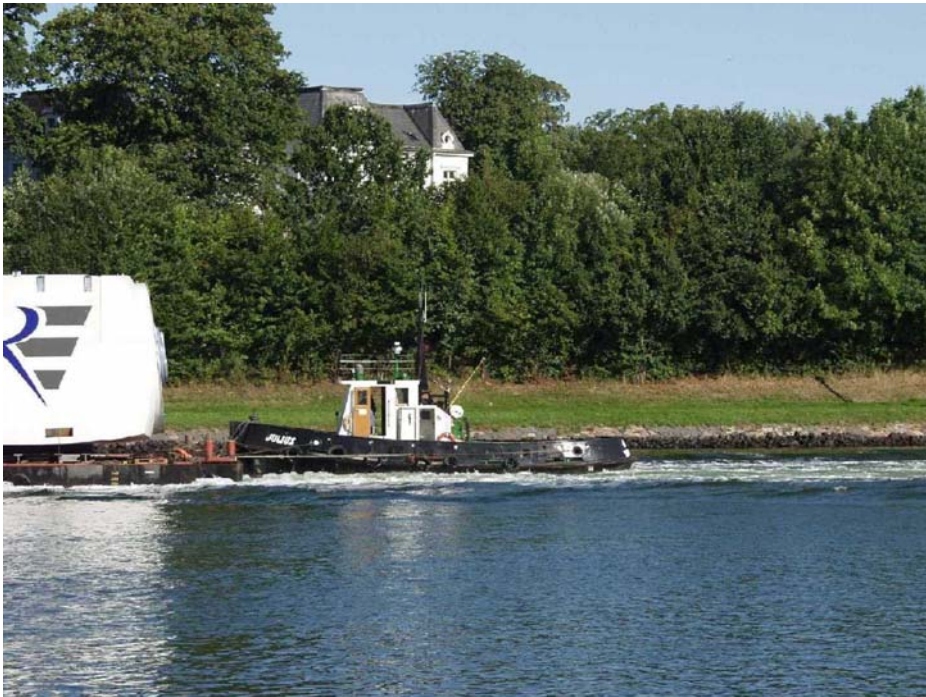
Figure 4: Towing journey Kiel Canal

pontoon. The following photo of a pushing voyage of the Tug JULIUS through the Kiel Canal shows an example of the proper connection.

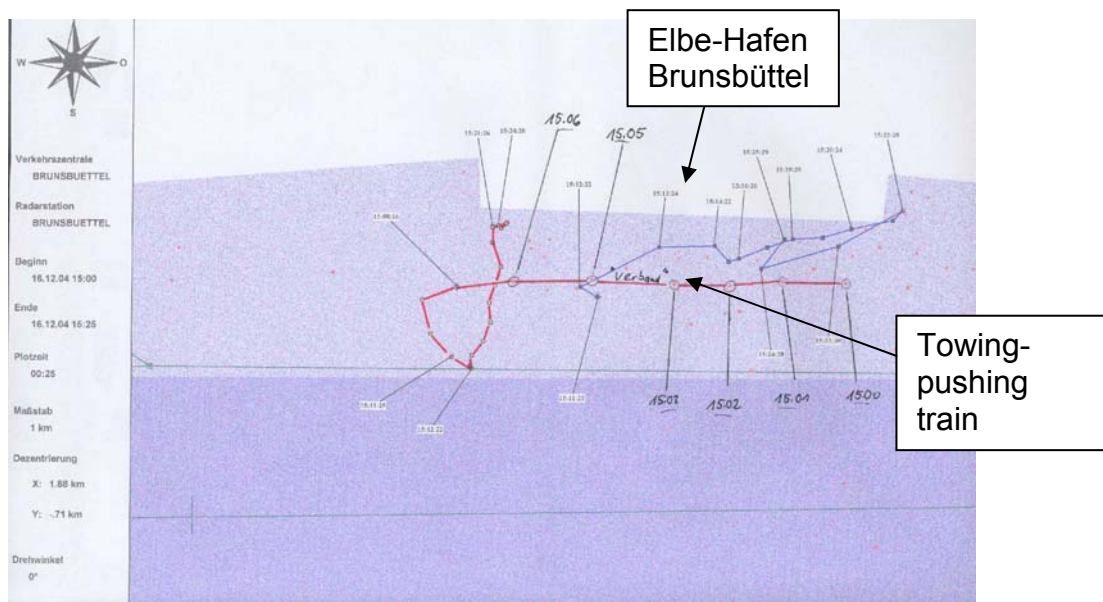
Figure 14: Plot VTS-Brunsbüttel

There are plot and radio records of the Revierzentrale (VTS) available showing the course of the journey of the towing-pushing train.

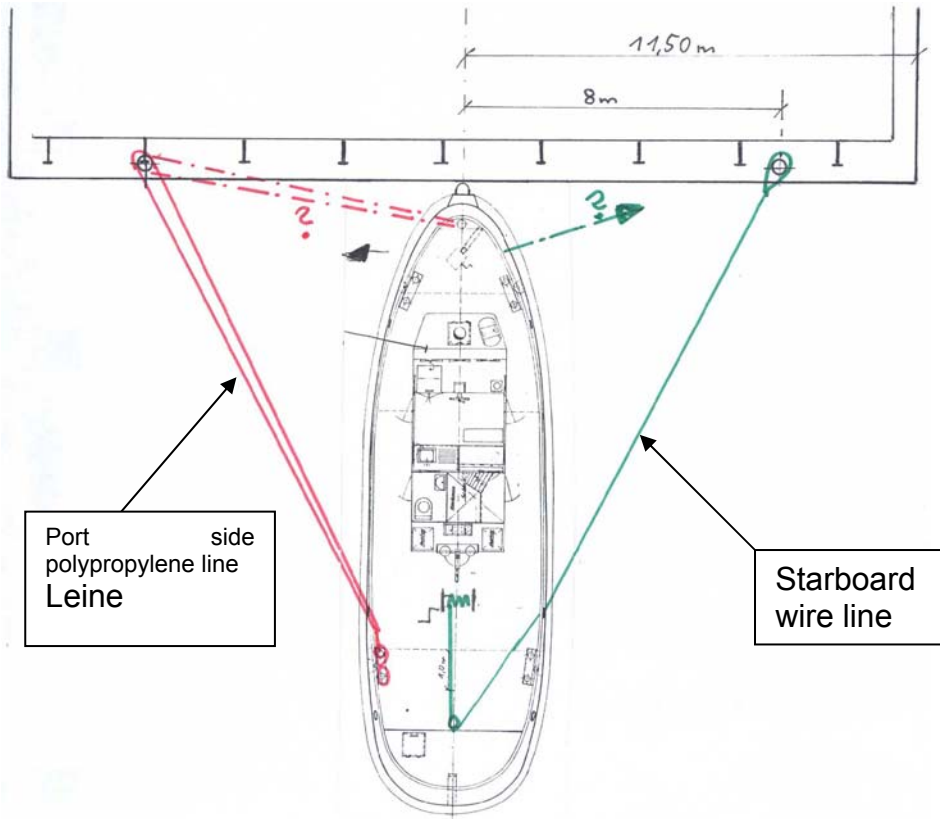
Figure 16: Top view, line arrangement

The above drawing shows the starboard side. The scraping marks mentioned below of the aft polypropylene line are on the port side:

- 1) wheelhouse,
- 2) edge of wheelhouse and
- 3) faceplate of the wheelhouse roof

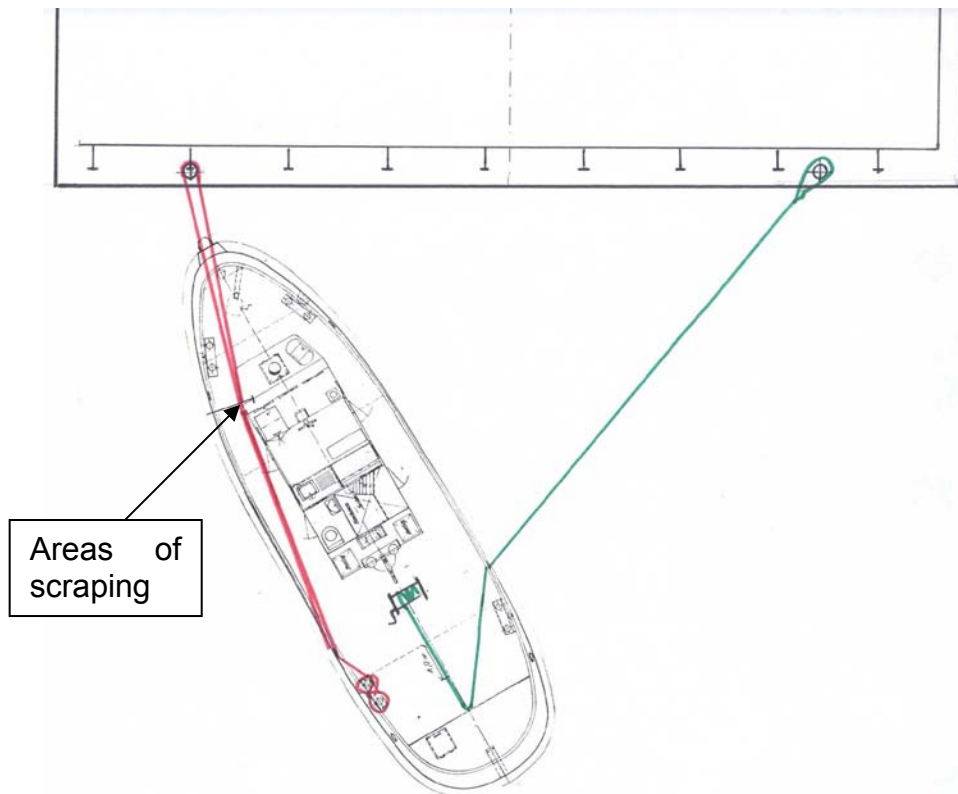
Figure 17: Situation directly before capsizing

The witnesses A and D further stated that after the tug had been fast, the Master had come out of the wheelhouse. Following a discussion about the line arrangement between them and the Master, the Master himself had made a line loose on the starboard foreship. When the tug had turned with its post to port during this work, he had thrown the forward line over board and run back to the bridge. However, the tug had turned further round to port and had heeled very strongly to starboard. In the course of the capsizing first the starboard fastening line had ruptured and then the port side polypropylene line. The tug had come to rest with its keel upwards and had then sunk via its stern.
