Bundesstelle für Seeunfalluntersuchung
Federal Bureau of Maritime Casualty Investigation
Bundesoberbehörde im Geschäftsbereich des Bundesministeriums
für Verkehr, Bau und Stadtentwicklung

Investigation Report 187/05

**Explosion and Fire
on board CMV PUNJAB SENATOR
in Hold No. 6
on 30 May 2005
on the way to Sri Lanka**

15 December 2006

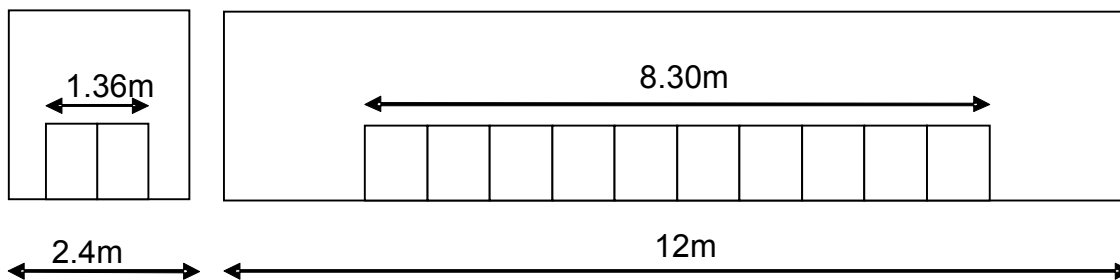
Figure 18: Reference situation in the real container

- number of packing units actually in the container 21/number of cartons per packing unit 41
- basis of calculation: 20 packing units and 40 cartons per packing unit
- cargo consists of two rows of 10 pallets each standing centred in the container
- number of cartons per pallet base area: 4; stacking height: 10

The volumetric calculation excluding the cardboard, without pallets, results in a cargo stack of 8.3 x 1.36 x 1 m.

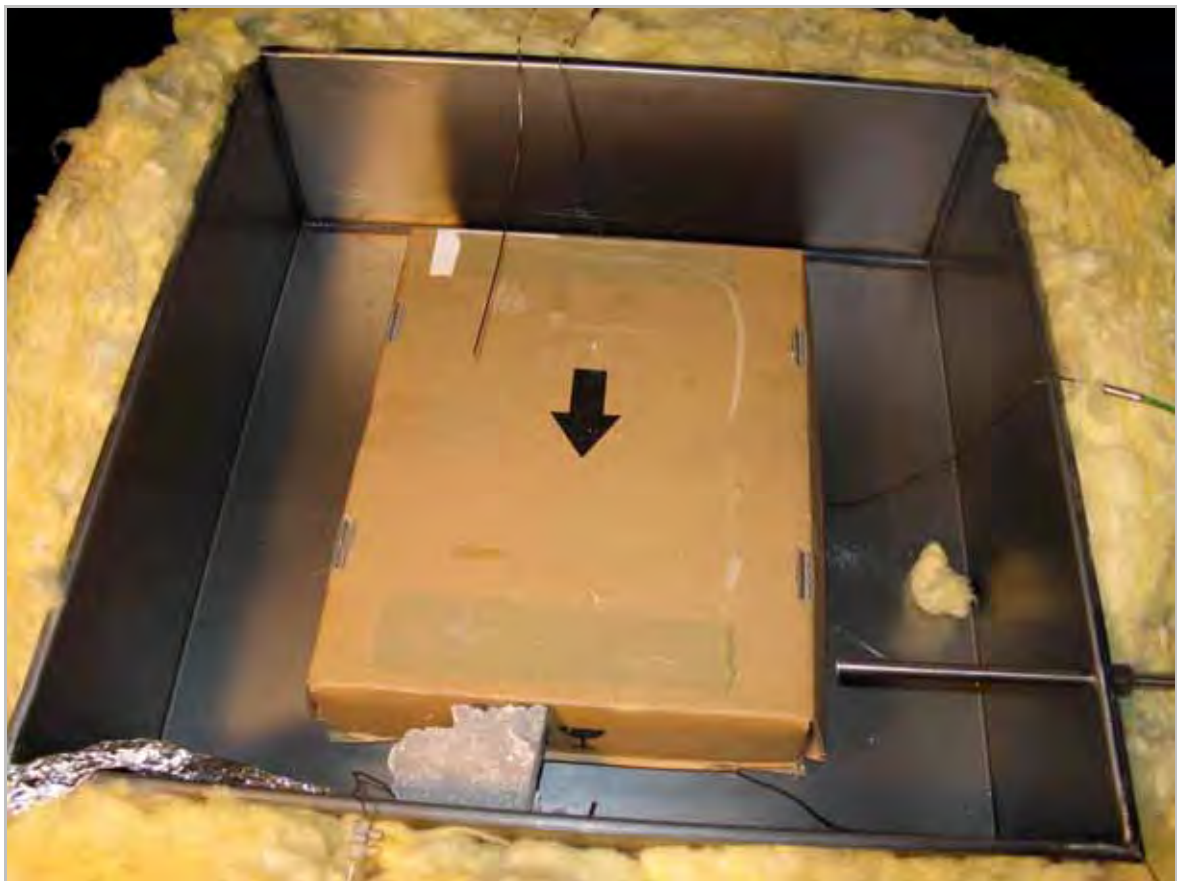
Figure 20: Experimental set-up opened

The container mock-up was warmed from the top and bottom with heating mats for the experiment in order to ensure uniform distribution of the heat in the interior. The complete insulation of the container prevented temperature differences at the side walls.

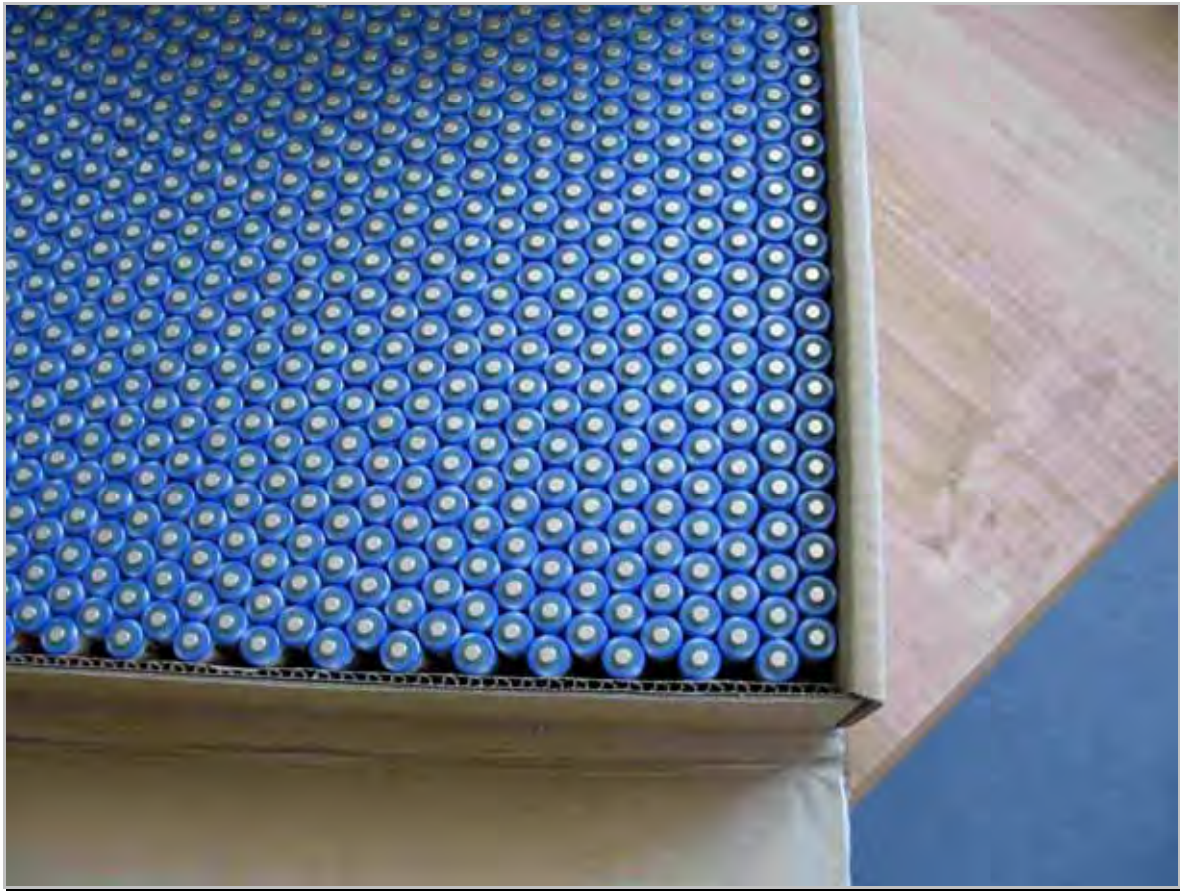
Figure 25: Rechargeable batteries, stored upright

The 620 NiMH rechargeable batteries were stored standing upright. The packing density allows slight movement between the rechargeable batteries in relation to each other.

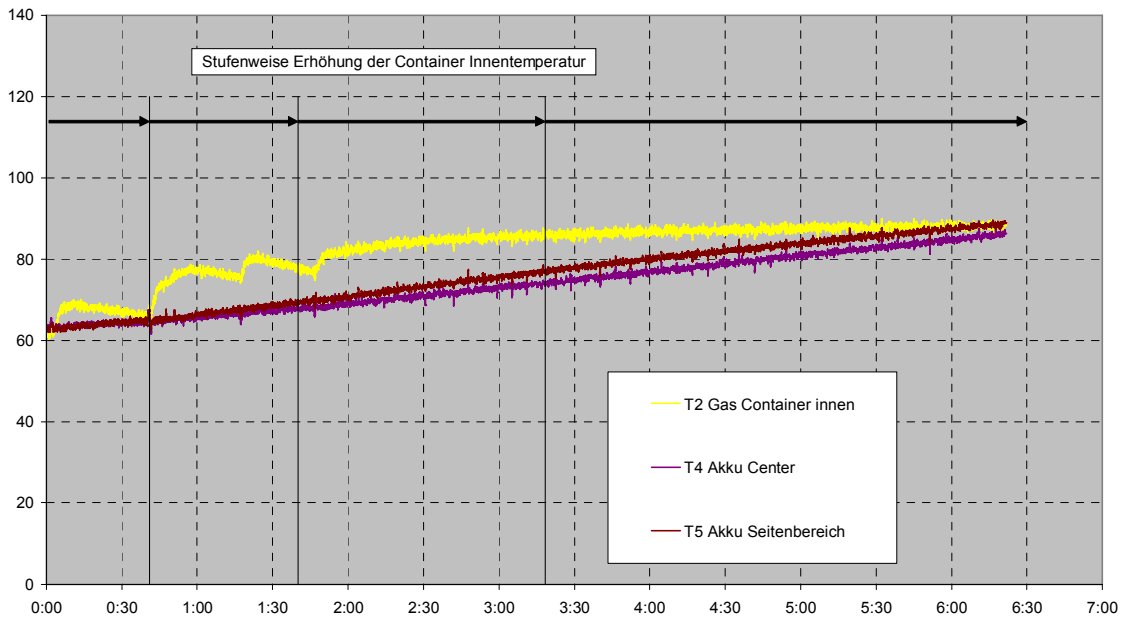
Figure 28: Temperature curves during warming

From the extensive data material available from the experiments, the temperature curves displaying the development of the rechargeable batteries' own temperature while the container space atmosphere temperature increased gradually until it was maintained constant at approx. 85 - 88 °C are shown here. Figure 29 also shows the curve of the hydrogen escaping.
