**Bundesstelle für Seeunfalluntersuchung**  
**Federal Bureau of Maritime Casualty Investigation**  
Bundesoberbehörde im Geschäftsbereich des Bundesministeriums  
für Verkehr, Bau und Stadtentwicklung

Investigation Report 203/04

**Very serious marine casualty**

**Foundering of SY ALLMIN and  
drowning of two sailors  
on 29 June 2004  
east of Rügen**

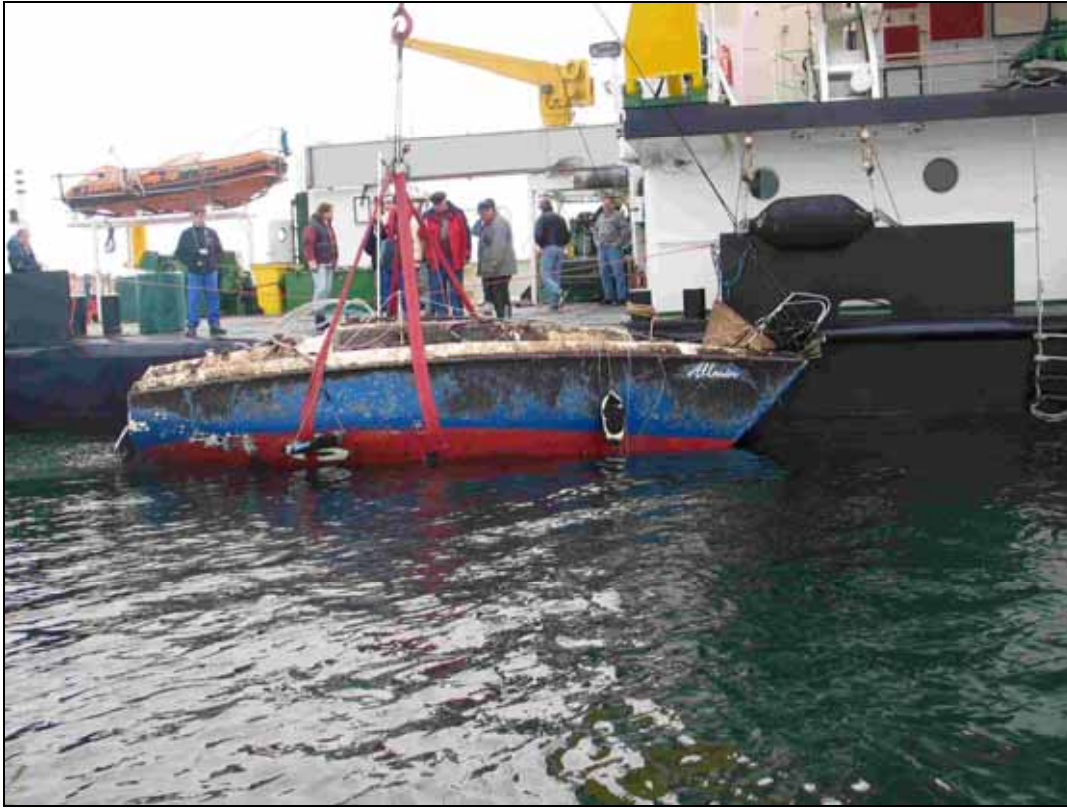
Figure 3: Salvage of SY ALLMIN by DENE B

On 23.03.2005 ALLMIN was salvaged by VWFS DENEK of the BSH in the way of official assistance for the Public Prosecutor's Office Stralsund (Figure 3). The salvage was accompanied by a team from the BSU.

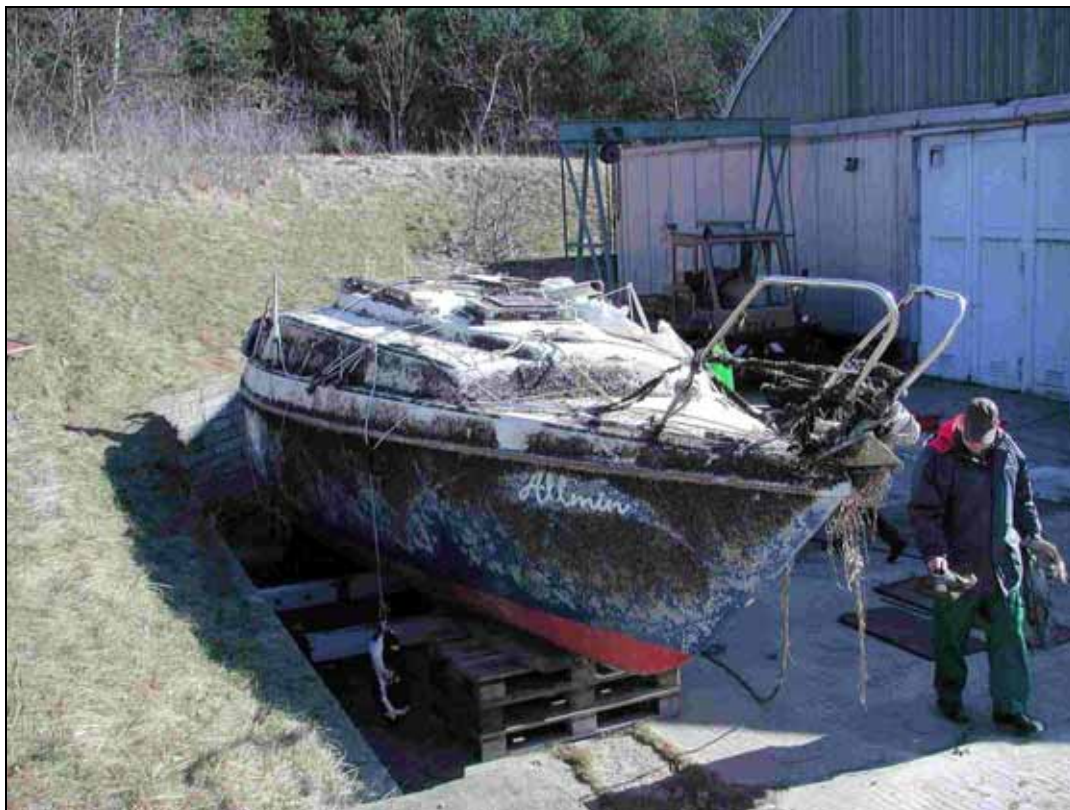
Figure 4: View from the bow

The yacht was chocked up so that it could be inspected well (Figure 4). It had been roughly cleaned and the sand involved had been sieved in order to filter out small parts.

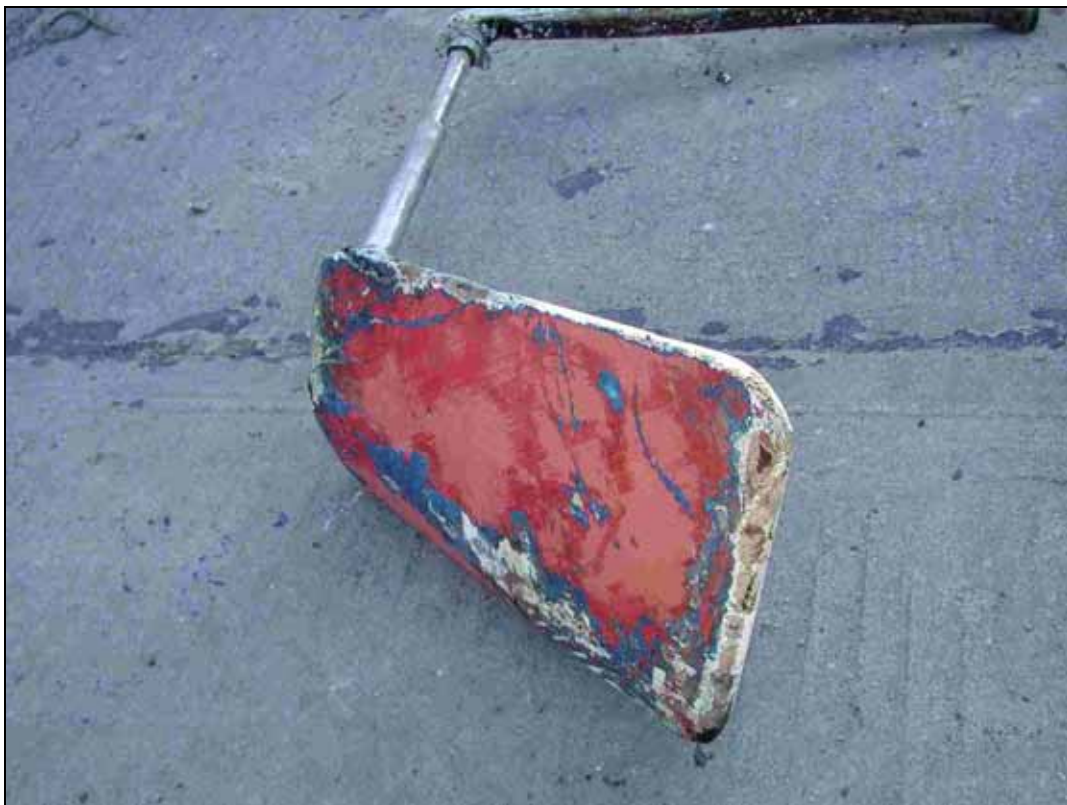
Figure 12: View of the steering gear

The crew of the fishing cutter had recovered the entire rudder with blade, head and tiller. The rudder blade showed signs of buckling in the upper part and strong abrasion in the lower part. The rudder head was bent above the rudder blade. The tiller was intact (see Figure 11, 12).

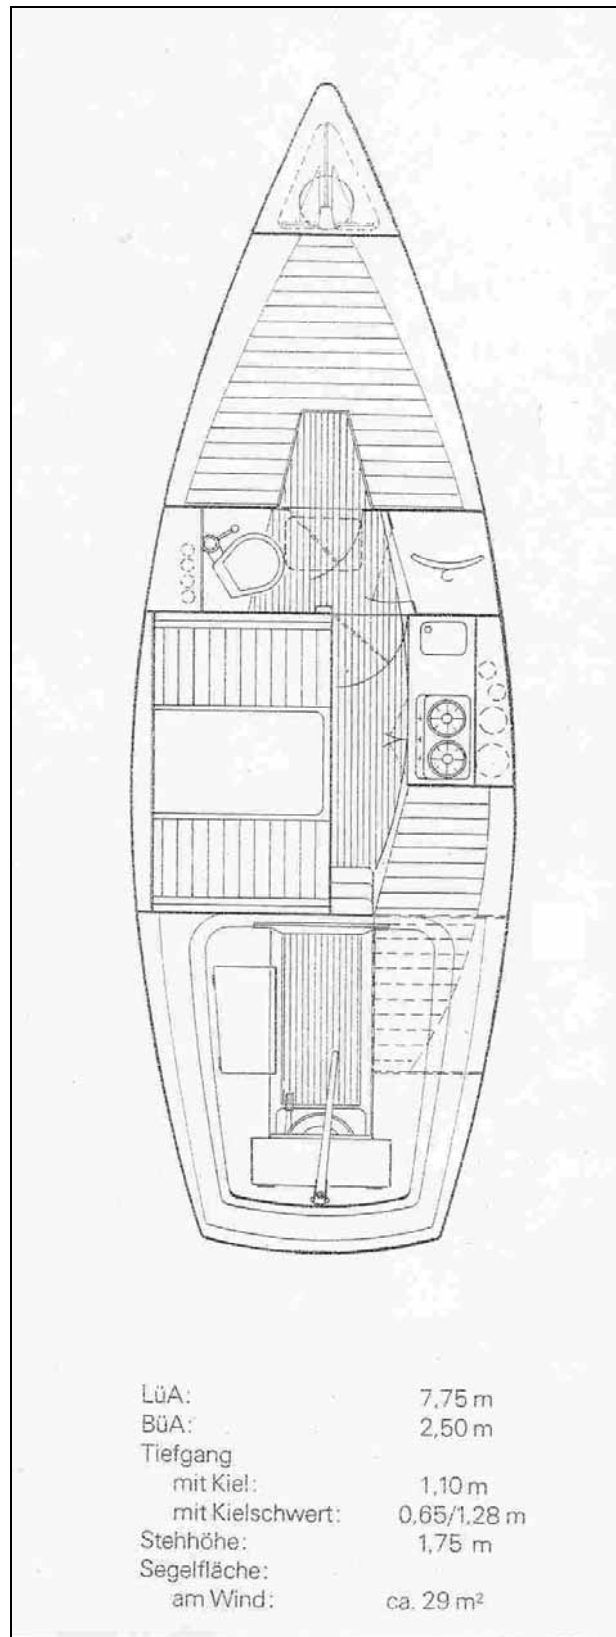
Figure 17: Layout plan Neptune 26

The inner furnishings of the yacht were almost identical with the layout plan (Figure 17). There was no collision bulkhead. The anchor box was simply a recess in the deck moulding. In the fore ship and on both sides of the interior, inner shells were laminated in place. The items of equipment in the saloon were mounted on the port and starboard sides on these shells. On the starboard side of the saloon this shell had been cut open in the way of the quarter berth in order to make space to fit a refrigerator on the right next to the cooker. Underneath the refrigerator the inner shell had an approx. 13 cm long crack. The quarter berth had been cut open further in the area beneath the cockpit. Thus additional stowage space had been created with a kind of chest.

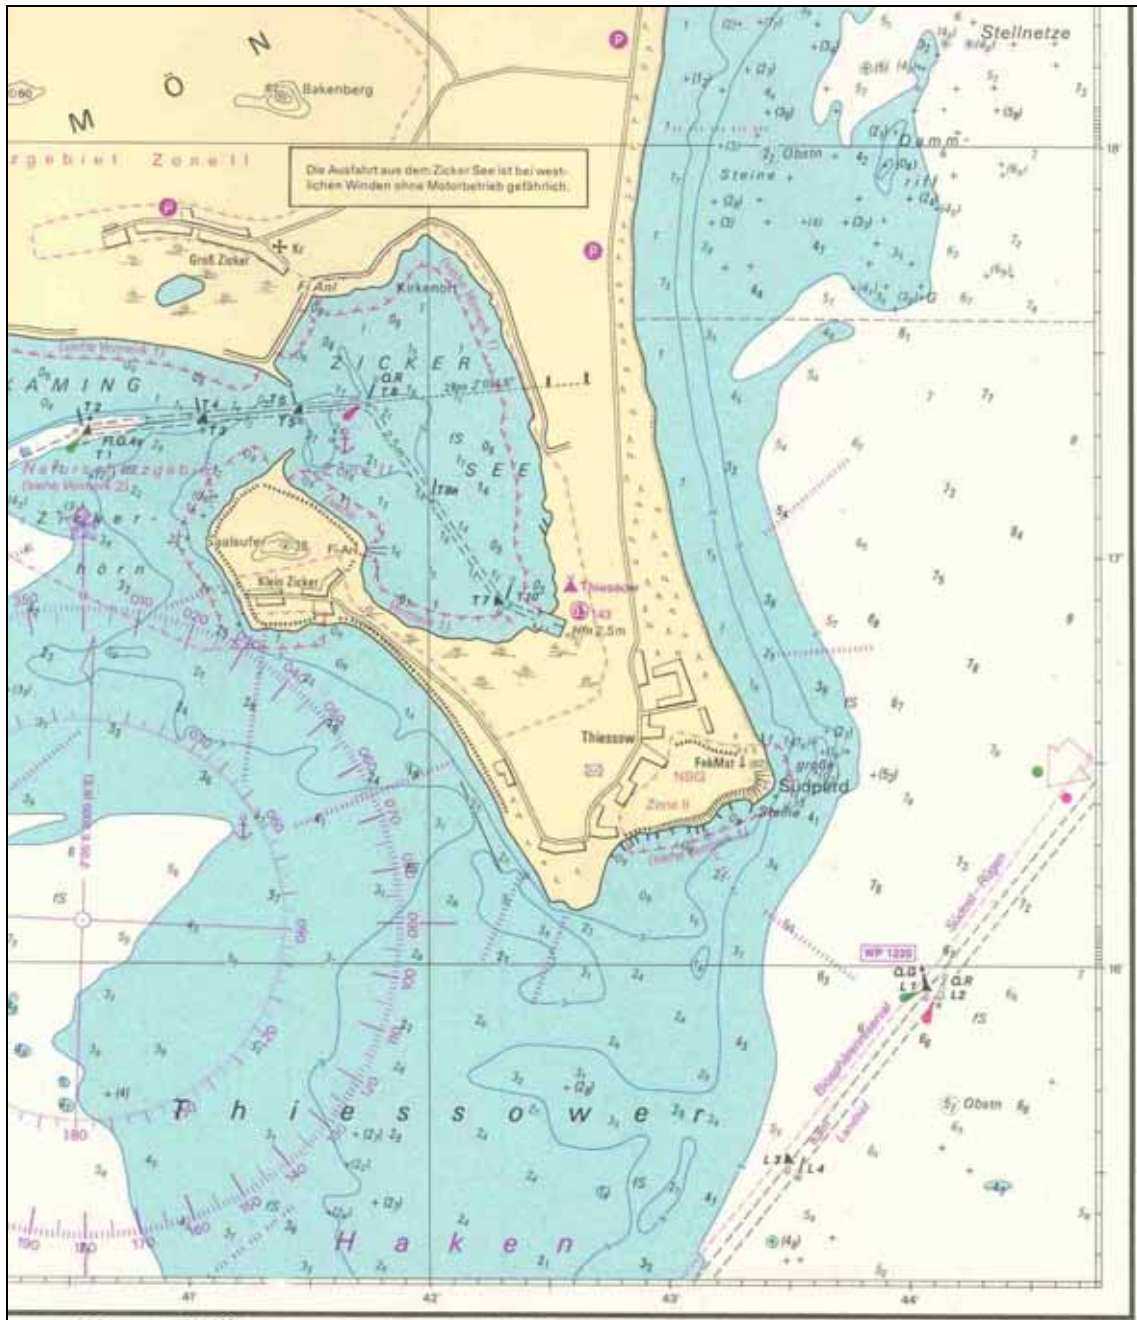
Figure 18: Excerpt from the official leisure shipping chart Series 3006, Sheet 5 (excerpt from (16)1578) of the BSH, scale 1:25.000

Using the Leisure Craft Chart Set 3006 of the BSH, Sheet 4, scale 1:50,000 or the detailed chart, Sheet 5, scale 1:25,000 would at least have made the dangers more clear through the lesser shallows (Figure 18). The largest part of the shallows shows depths below 3 m, within the 3 metre depth line there are some lesser shallows below 2 m marked. Using these charts for the direct passage through Thiessower Haken, the skipper would have satisfied the seamanship principle of always using the chart with the best scale<sup>14</sup>. Due to the lack of being able to find the position precisely on board ALLMIN, however, the direct passage through Thiessower Haken would have been unsafe even with this chart.

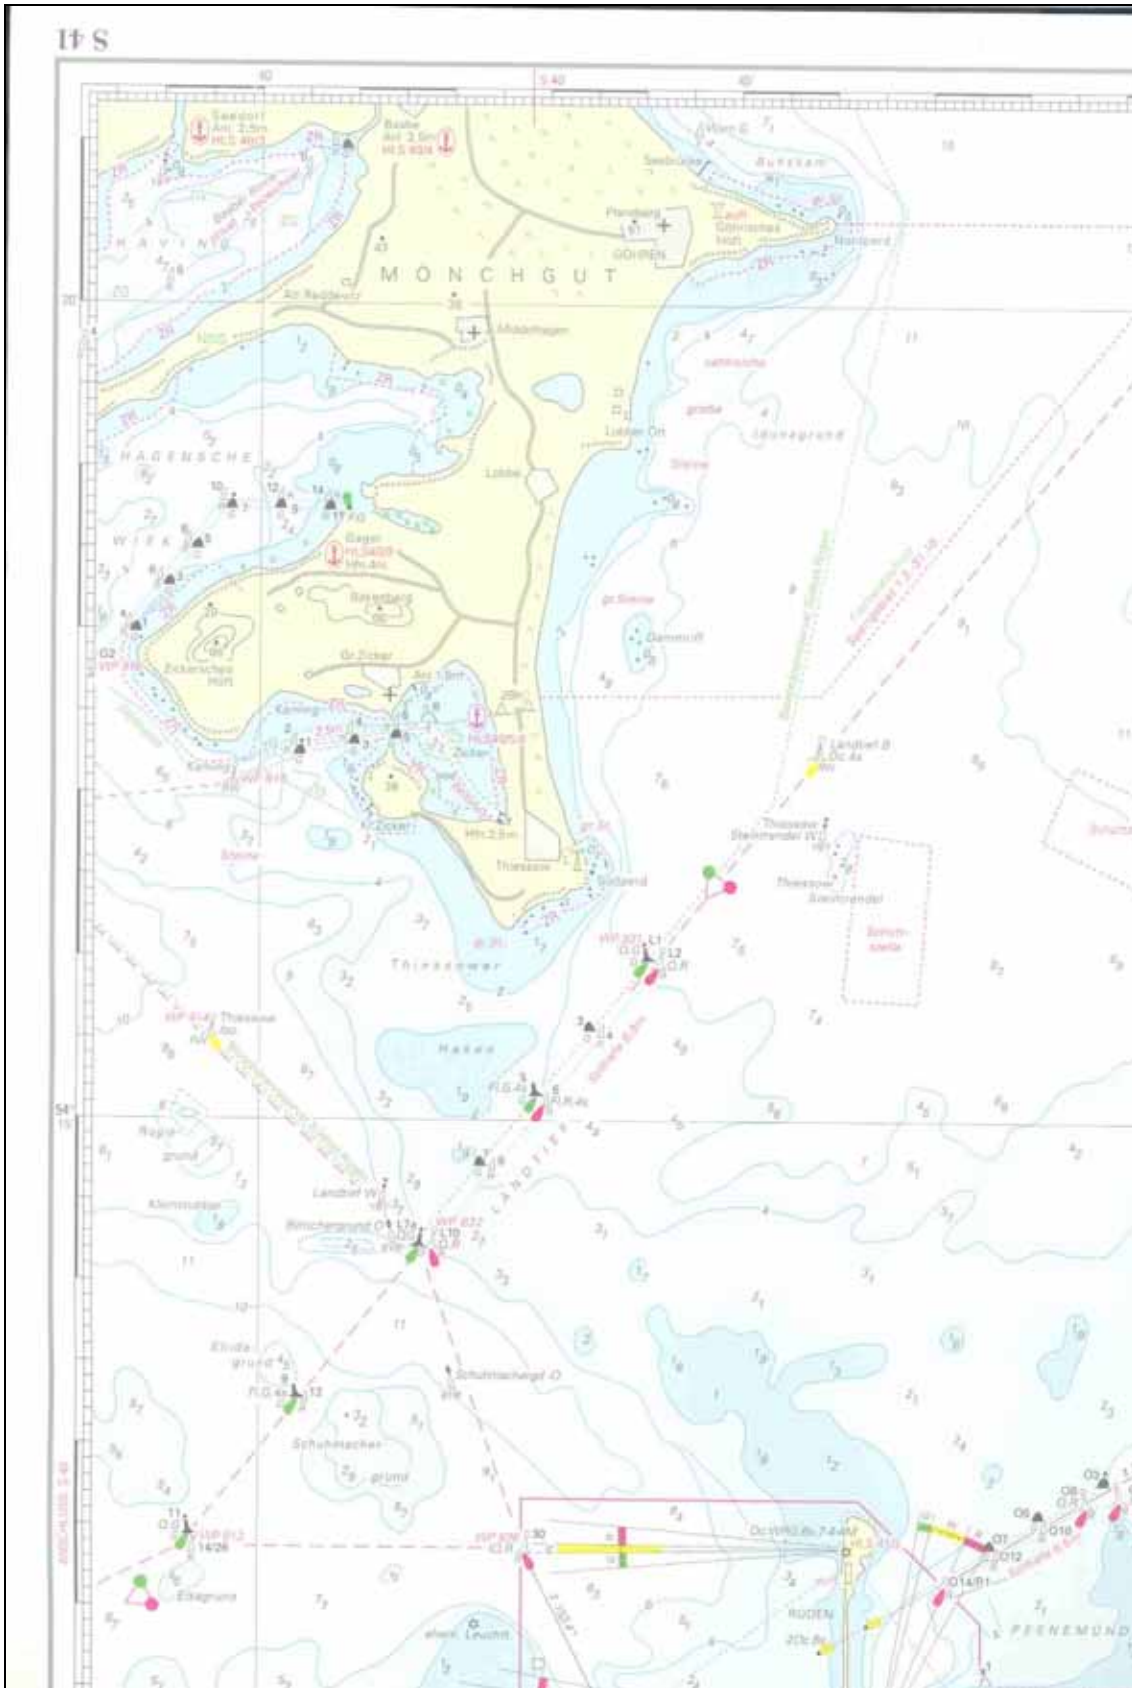
Figure 19: Excerpt from the leisure shipping chart "Greifswalder Bodden Ost", Series 4, Chart S 41, Nautische Veröffentlichung Verlagsgesellschaft mbH Arnis, scale 1:60.000

The Sea Chart S 41 of Series 4 (Edition 2003) of Nautische Veröffentlichung Verlagsgesellschaft mbH to scale 1:60,000 for the area to be sailed, Greifswalder Bodden/Thiessower Haken - coast from Südperd to Nordperd, was on board the yacht. Due to the scale-related density of information, the chart was unsuitable for passing the flat area between the Landtief navigation channel and Thiessow and according to the publisher not designed for this. The passage through the navigation channel would have been possible with the assistance of the chart on board without any problem, however (Figure 19).
