**Investigation Report 149/05**

**Very Serious Marine Casualty**

**Loss Over Board and Subsequent Death  
of the Skipper of SY INA 2 North of Wustrow  
on 1 May 2005**

1 April 2006

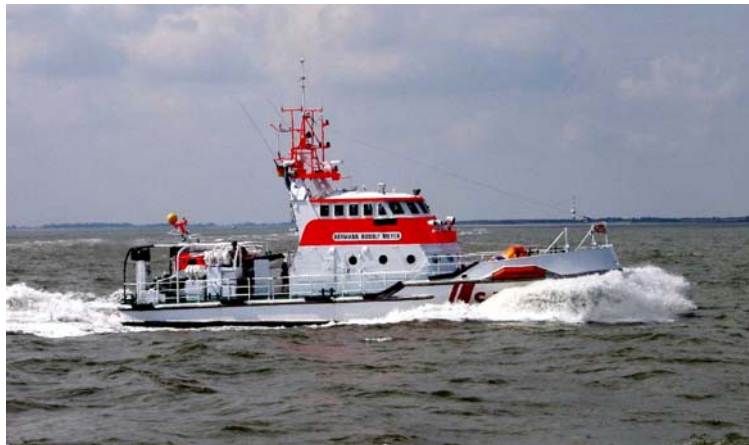
Figure 13: Rescue Cruiser HERMANN RUDOLF MEYER

A "person over board" manoeuvre was tried out on the rescue cruiser (see Figure 13) at Blexen Roads off Bremerhaven on 6 September 2005. A BSU staff member wearing an immersion suit went into the water for this and was recovered by the daughter boat of the rescue cruiser (see Figures 14 and 15). To this end the daughter boat was launched into the water via the carriage of the rescue cruiser.

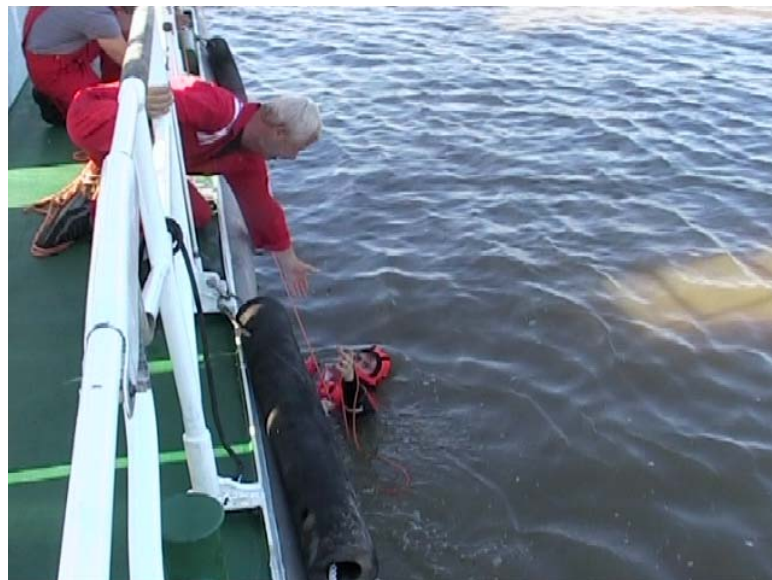
Figure 16: "Person over board" manoeuvre

The rescue was carried out without any problems in a calm sea. The test person could be taken on board through the gate of the daughter boat aft on the starboard side almost at the level of the waterline, swimming on his back, by a crew member holding fast to the rod mounted on the boat with one hand. After this the daughter boat went back onto the carriage of the rescue cruiser and was heaved up and secured. Without the daughter boat it was not possible to draw the test person from the water directly onto HERMANN RUDOLF MEYER (see Figure 16).

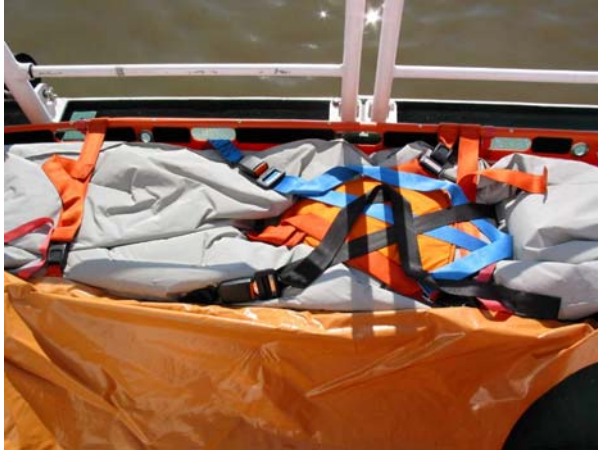
Figure 17: Stretcher Rescue Cruiser HERMANN RUDOLF MEYER

The German Sea Rescue Service has developed the rescue system with rescue cruiser and daughter boat in the course of time and 140 years of experience, and it has proved successful on the German coasts. In addition there is a stretcher with solid shell lining on board the sea rescue cruiser for transporting sick persons. This means that persons can be carried from board lying down (see Figure 17). A climbing rescue net is mounted

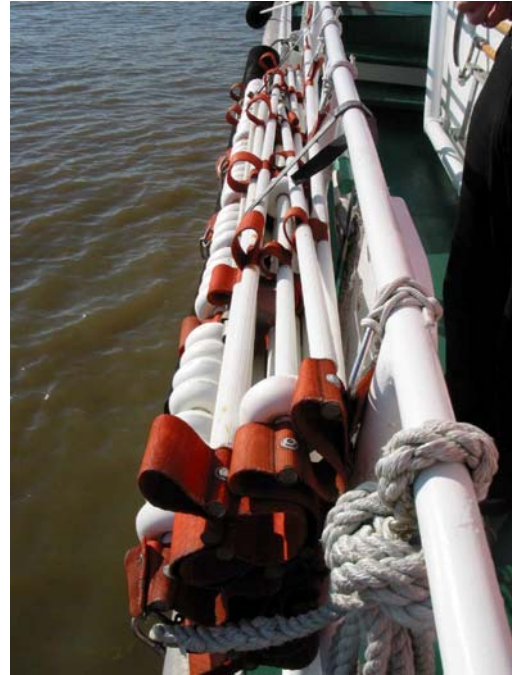
Figure 18: Climbing rescue net

midships on the port side and can be hung over board if needed. Persons who still have sufficient strength can climb on board using the net (see Figure 18). The freeboard is about 1.20 m. A rescue rod with loop is currently being serviced on shore and could not be presented. On other vessels the rescue rod has already been taken out of service as it is difficult to guide persons in the water to the boat with it.

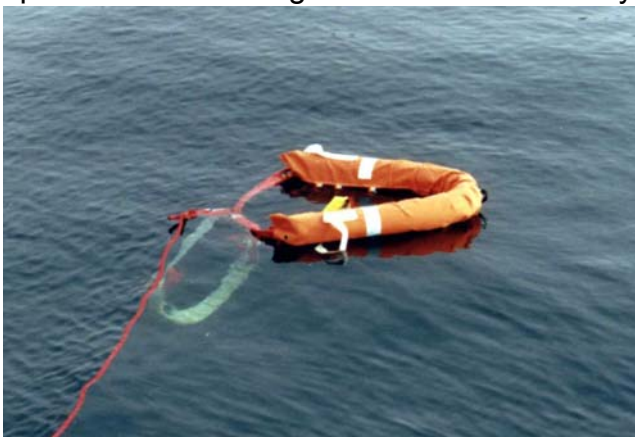
At the University of Applied Science Hildesheim/Holzminden/Göttingen a system with floating and sinking loop was developed within the framework of the "Rescue Lifting System" (RLS) research project (see Figure 23)<sup>10</sup>, that is also recommended by the See-BG (Marine Insurance and Safety Association) in Germany. The RLS also makes it easier for the helper to put it on a helpless person in the water.

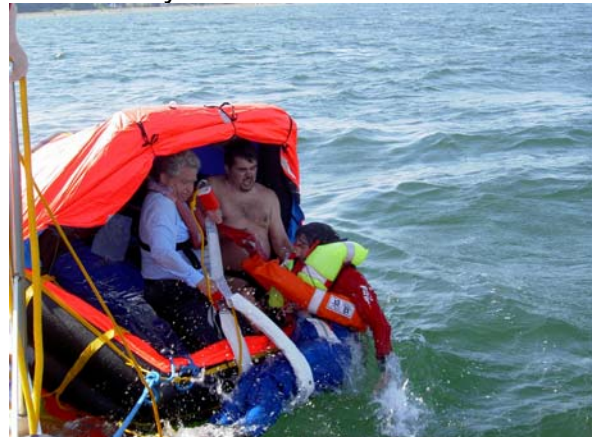
The person sustaining the accident could first be lifted into a life-raft in horizontal position with the aid of handles and without hoisting gear (see Figure 24)<sup>10</sup>. As an enormous effort is necessary for the crew to lift the injured person from the water, and the high wall of the yacht represents an almost insurmountable obstacle, an attempt could be made to draw the accident victim on board with the aid of the main sheet or the main halyard (see Figure 25)<sup>10</sup>. If the combination of a halyard and a winch is not sufficient to achieve the necessary force on an 8.50 m long yacht such as INA 2, a tackle - ideally with 6-fold shearing - on the main halyard should be used for help.
