Investigation Report 191/05

Very Serious Marine Casualty:

**Loss Over Board of the Skipper
SY ANDREA
on 28 May 2005
in Swedish Waters Near Ellös**

15 March 2006

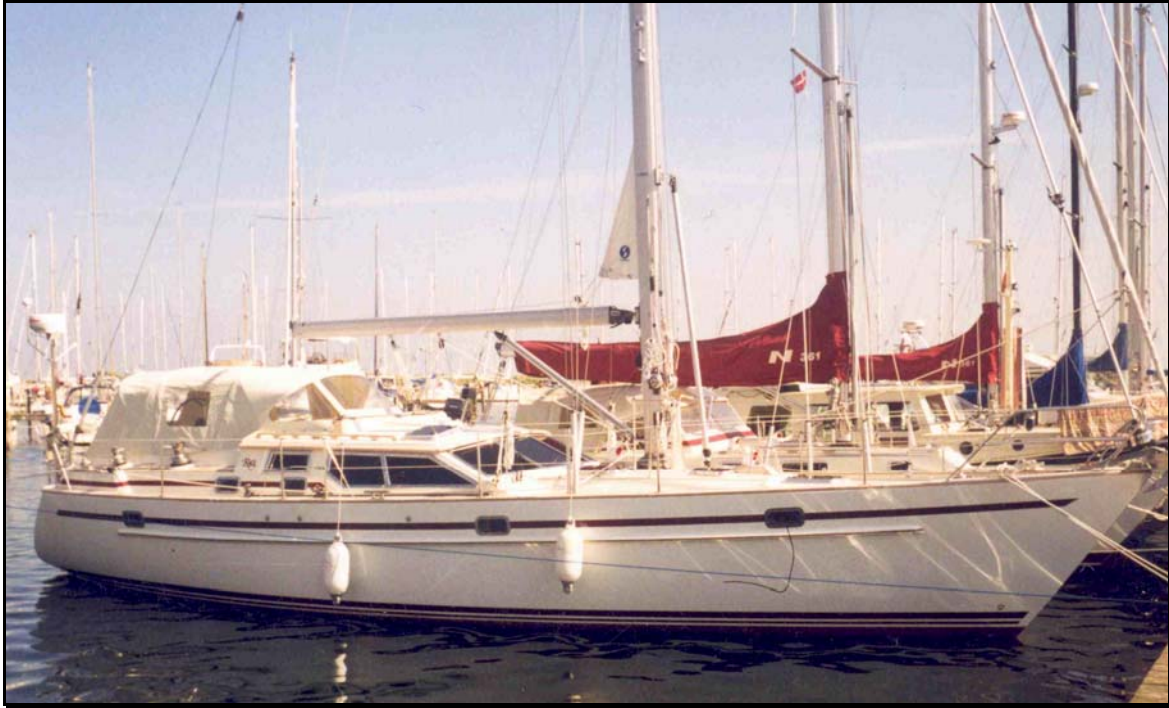
Figure 2: SY ANDREA

No visible damage was sustained by SY ANDREA. The owner died of the severe head injury in conjunction with water in the lung. The co-sailor suffered shock.

The skipper and the co-sailor had many years of sailing experience, especially in this region. Neither of them were fatigued and neither were under the influence of alcohol. The yacht was in a sound condition and the weather was good.
